# Performance Monitoring at the Galveston Island State Park Marsh Restoration and Protection (Phase I & Phase II) Project (CEPRA 1601)

Post Construction  
Monitoring Report: Year 5

8/31/2023

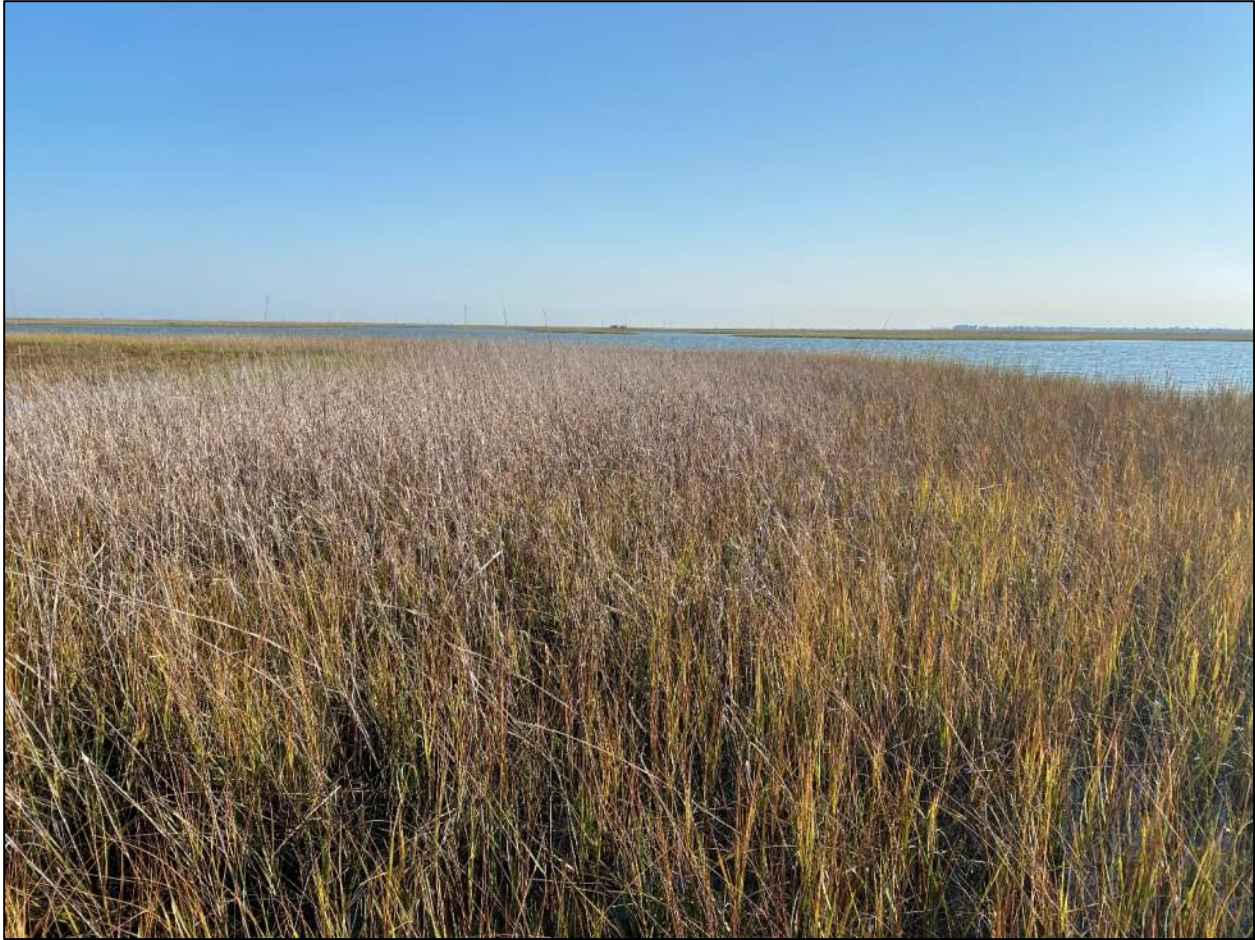
**Figure 6. Photograph of Mound CW6 facing southeast.**

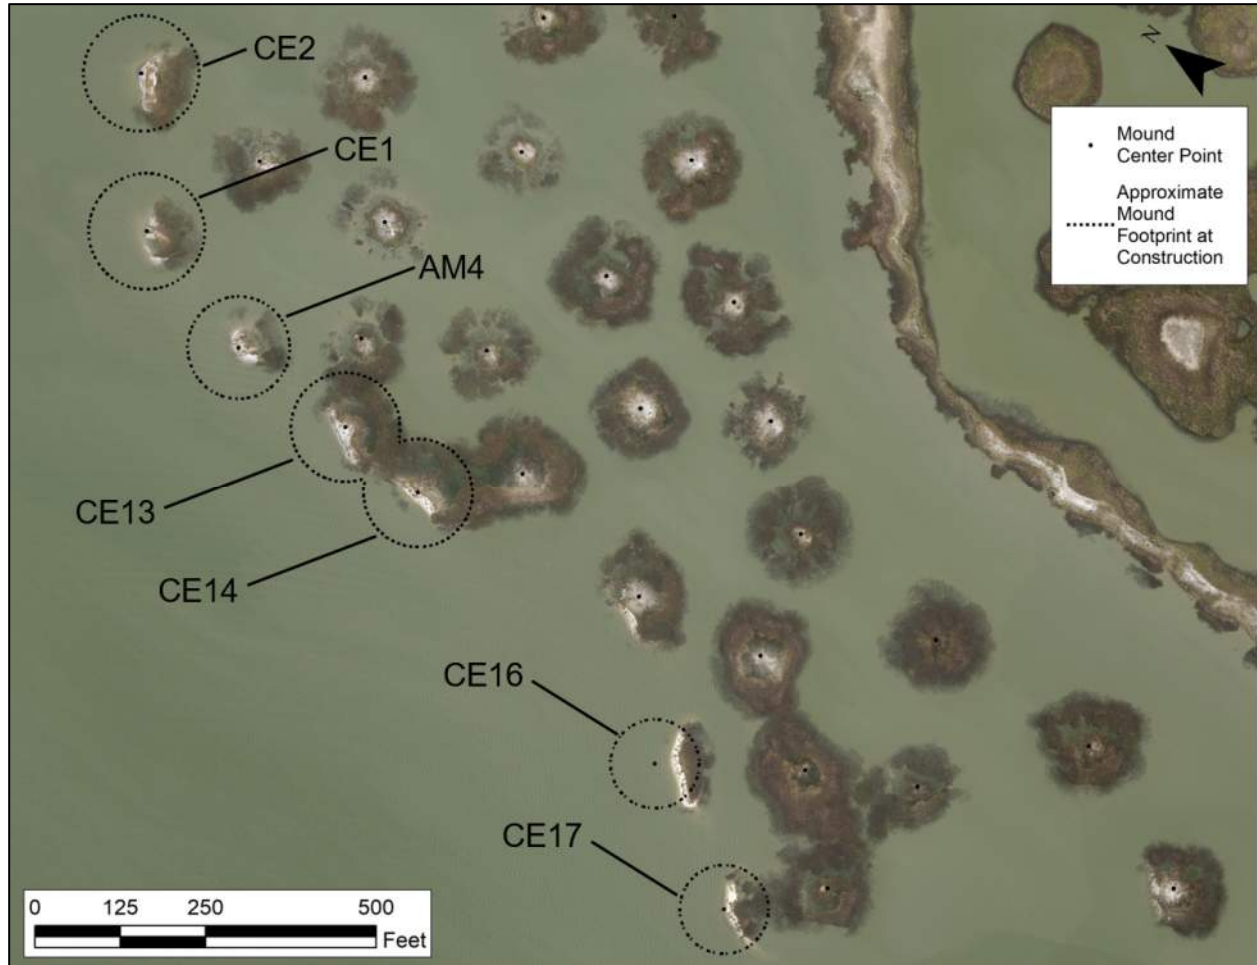
**Figure 10. Reshaping at perimeter mounds in Area A.**

understand elevations within the marsh complex. At the time of Year 5 monitoring, approximately 93% of the volume placed in the project footprint remains. A comparison of elevation change between the Year 0 survey and Year 5 survey is shown in Figure 13. Red areas show erosion which was generally observed along the perimeter of mound areas. Blue areas indicated accretion which was generally observed between interior mounds. Note that the mounds that experienced significant reshaping at the time of Year 2 monitoring have approximately retained that shape at the time of the Year 5 monitoring. All interior mounds are relatively stable.

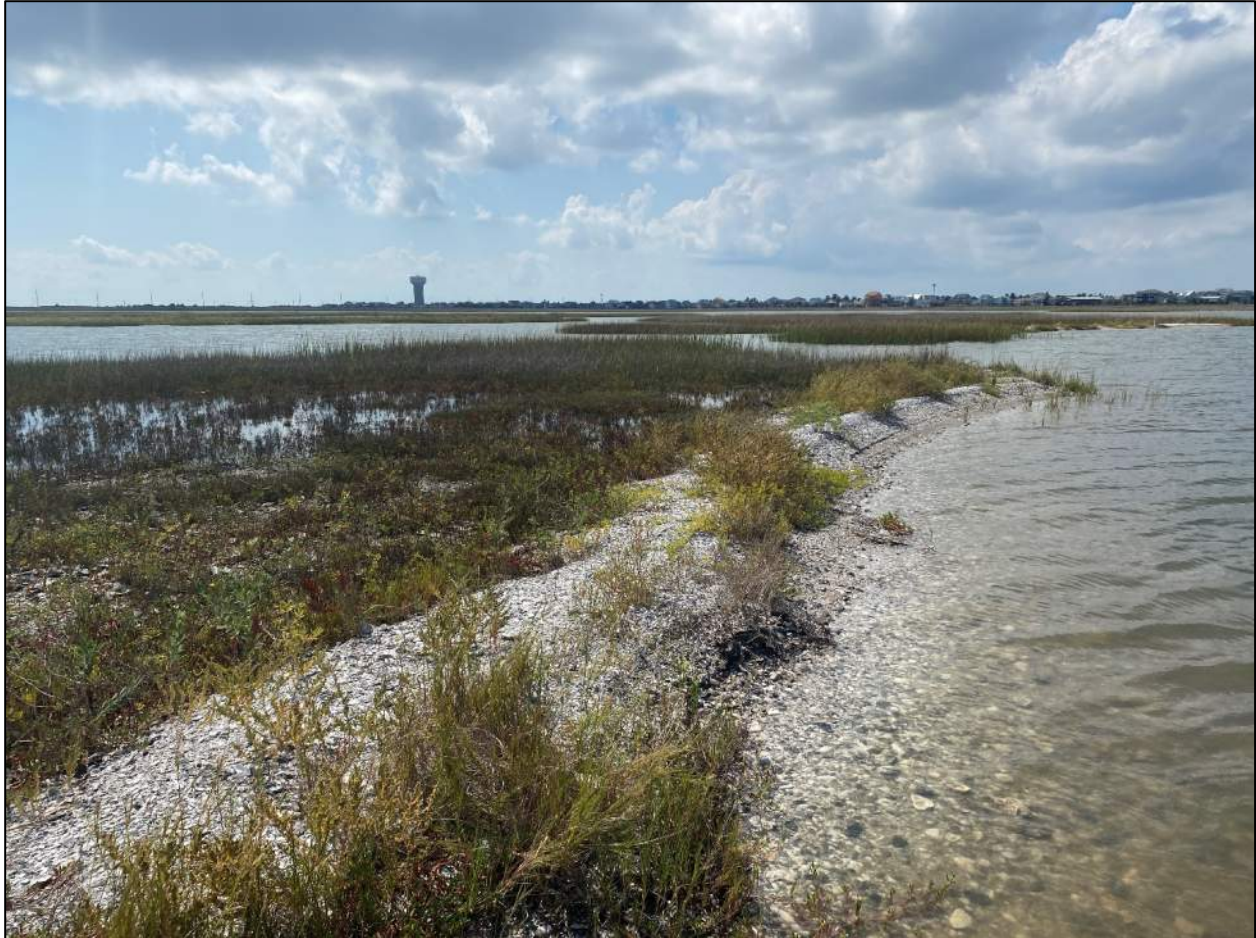
The sediment composition of each mound was observed to verify that the mounds are predominantly composed of sand, shell hash, and/or shell as opposed to silt and clay. All 81 mounds met this criterion and consisted of predominately firm non-cohesive sediments. The amount of shell hash and/or shell varied among the mounds. In general, more shell was visible in bayward perimeter mounds (see Figure 14), likely due to natural sorting of sediments caused by the greater exposure to wave action. Overall, the mounds in Area A typically contained more shell than mounds in other areas (for example, see Figure 15), likely due to variations in the borrow area.

**Figure 14. Shell ridge on Mound CE25 in Area A facing south.**

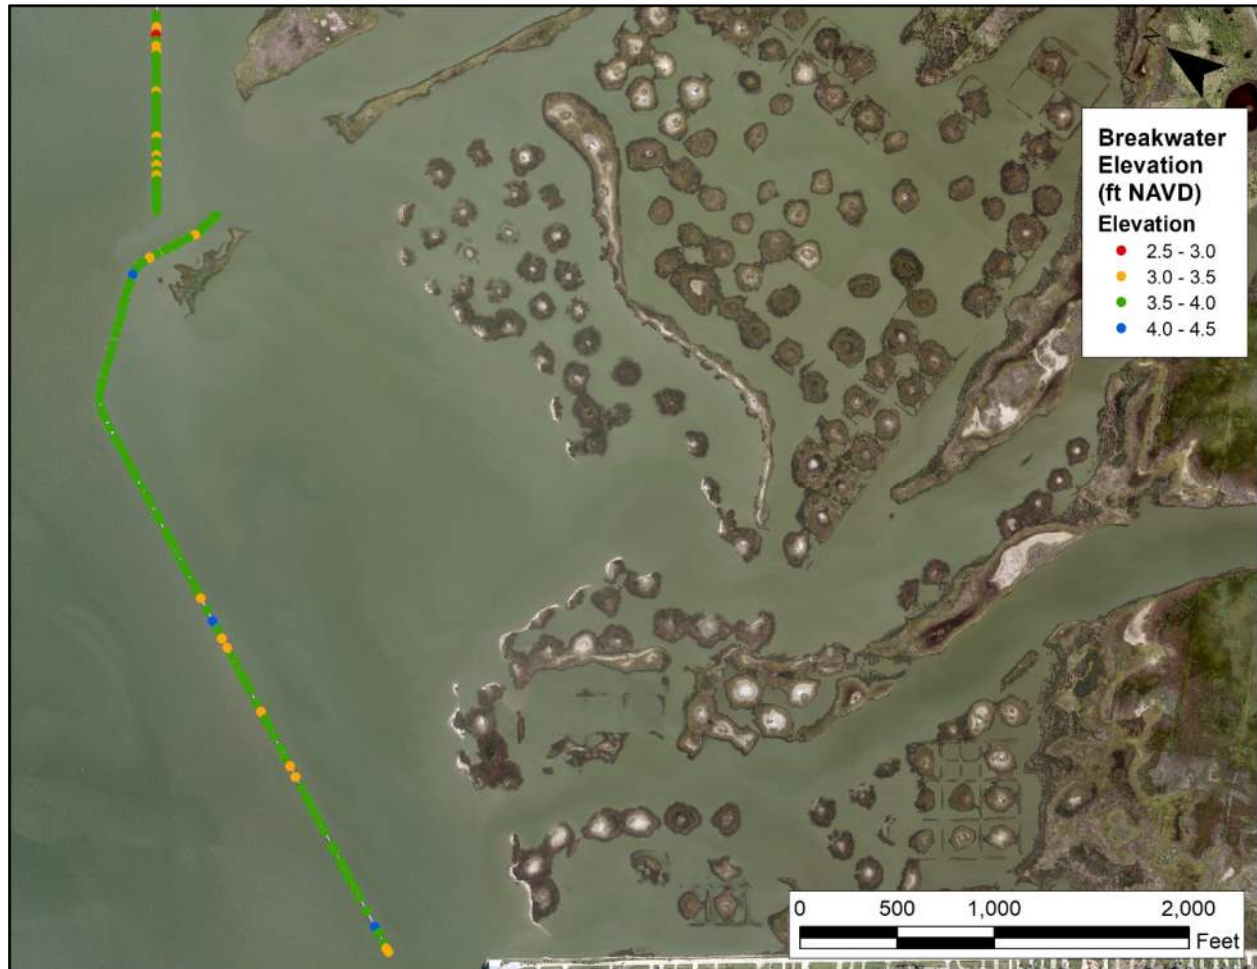
of the breakwaters and at corners where scour is most likely to occur. Additional observations were made along straight sections. Minor scour (less than 6") was noted at the eastern end of the Butterowe Bayou breakwater and the western end of the Carancahua Cove breakwater. Scour observations are approximately consistent with previous monitoring site visits. Scour of this magnitude is not expected to cause instabilities in the breakwater. The breakwaters appear to be in stable condition and are performing as designed.

Figure 19. Breakwater elevations measured using RTK GPS.

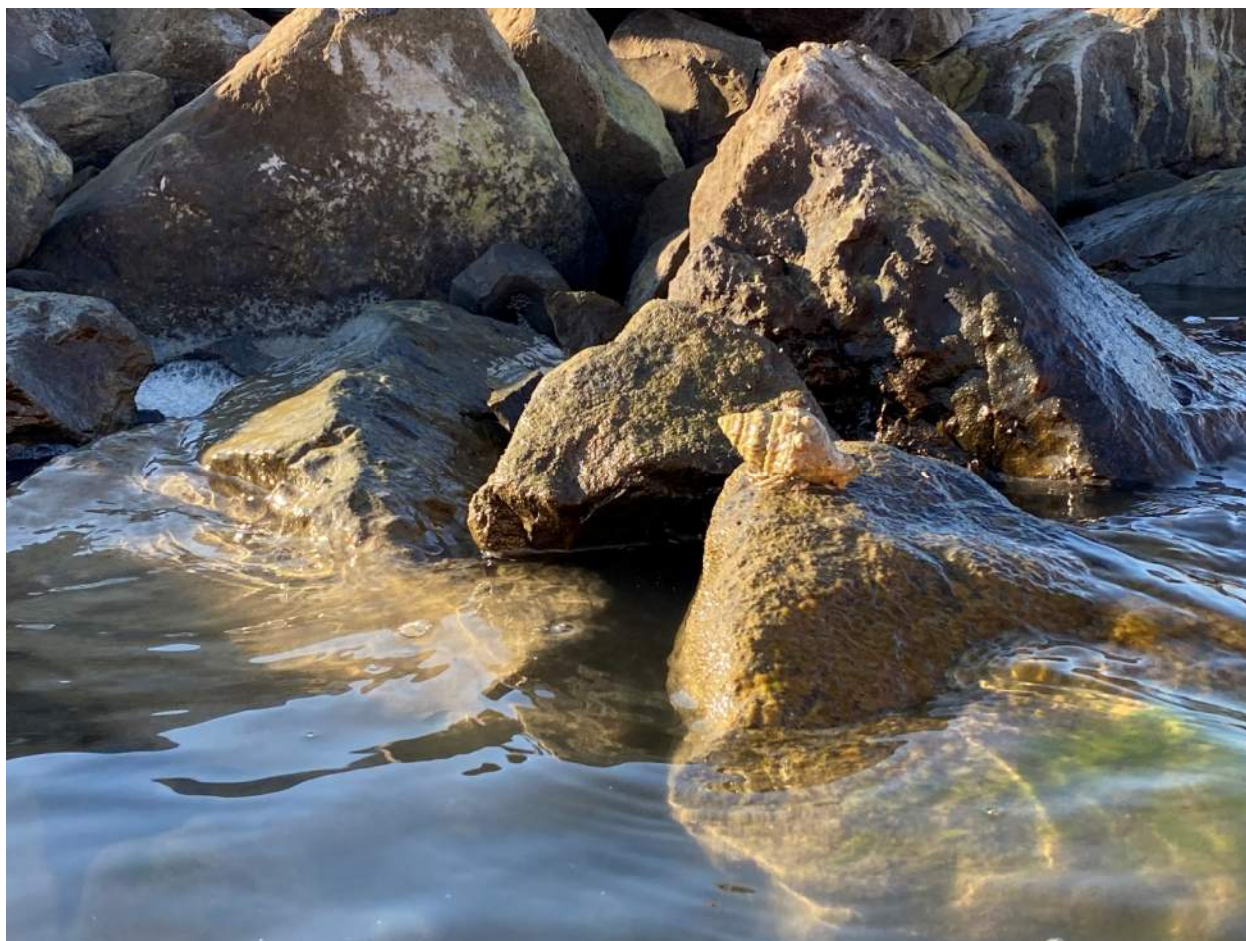
Field observations and field photography were applied to document the presence of encrusting species and algae attached to the breakwater (Figure 20). Observations were made along a total of 10,830 LF of breakwater (i.e., 4,415 LF along each side of the Carancahua Cove breakwater and 1,000 LF along each side of the Butterowe Bayou breakwater). Species presence and frequency were noted. The entire length of the breakwaters provided hard substrate habitat. Green algae species (*Chlorophyta*) and brown algae species (*Phaeophyceae*) were observed along both sides of the entire breakwaters. Eastern oysters (*Crassostrea virginica*) and barnacles were observed frequently along the Carancahua Cove and Butterowe Bayou breakwaters. Green algae was present more consistently than brown algae along the landward side of the Carancahua Cove and Butterowe Bayou breakwaters. Barnacles were abundant on both sides of the breakwaters. Oysters were more abundant on the landward side of the breakwaters. Hermit crabs (*Clibanarius vittatus*) were observed at a few areas along the Carancahua Cove breakwater.

**Figure 20. Hermit crab on bayward side of Carancahua Cove Breakwater.**

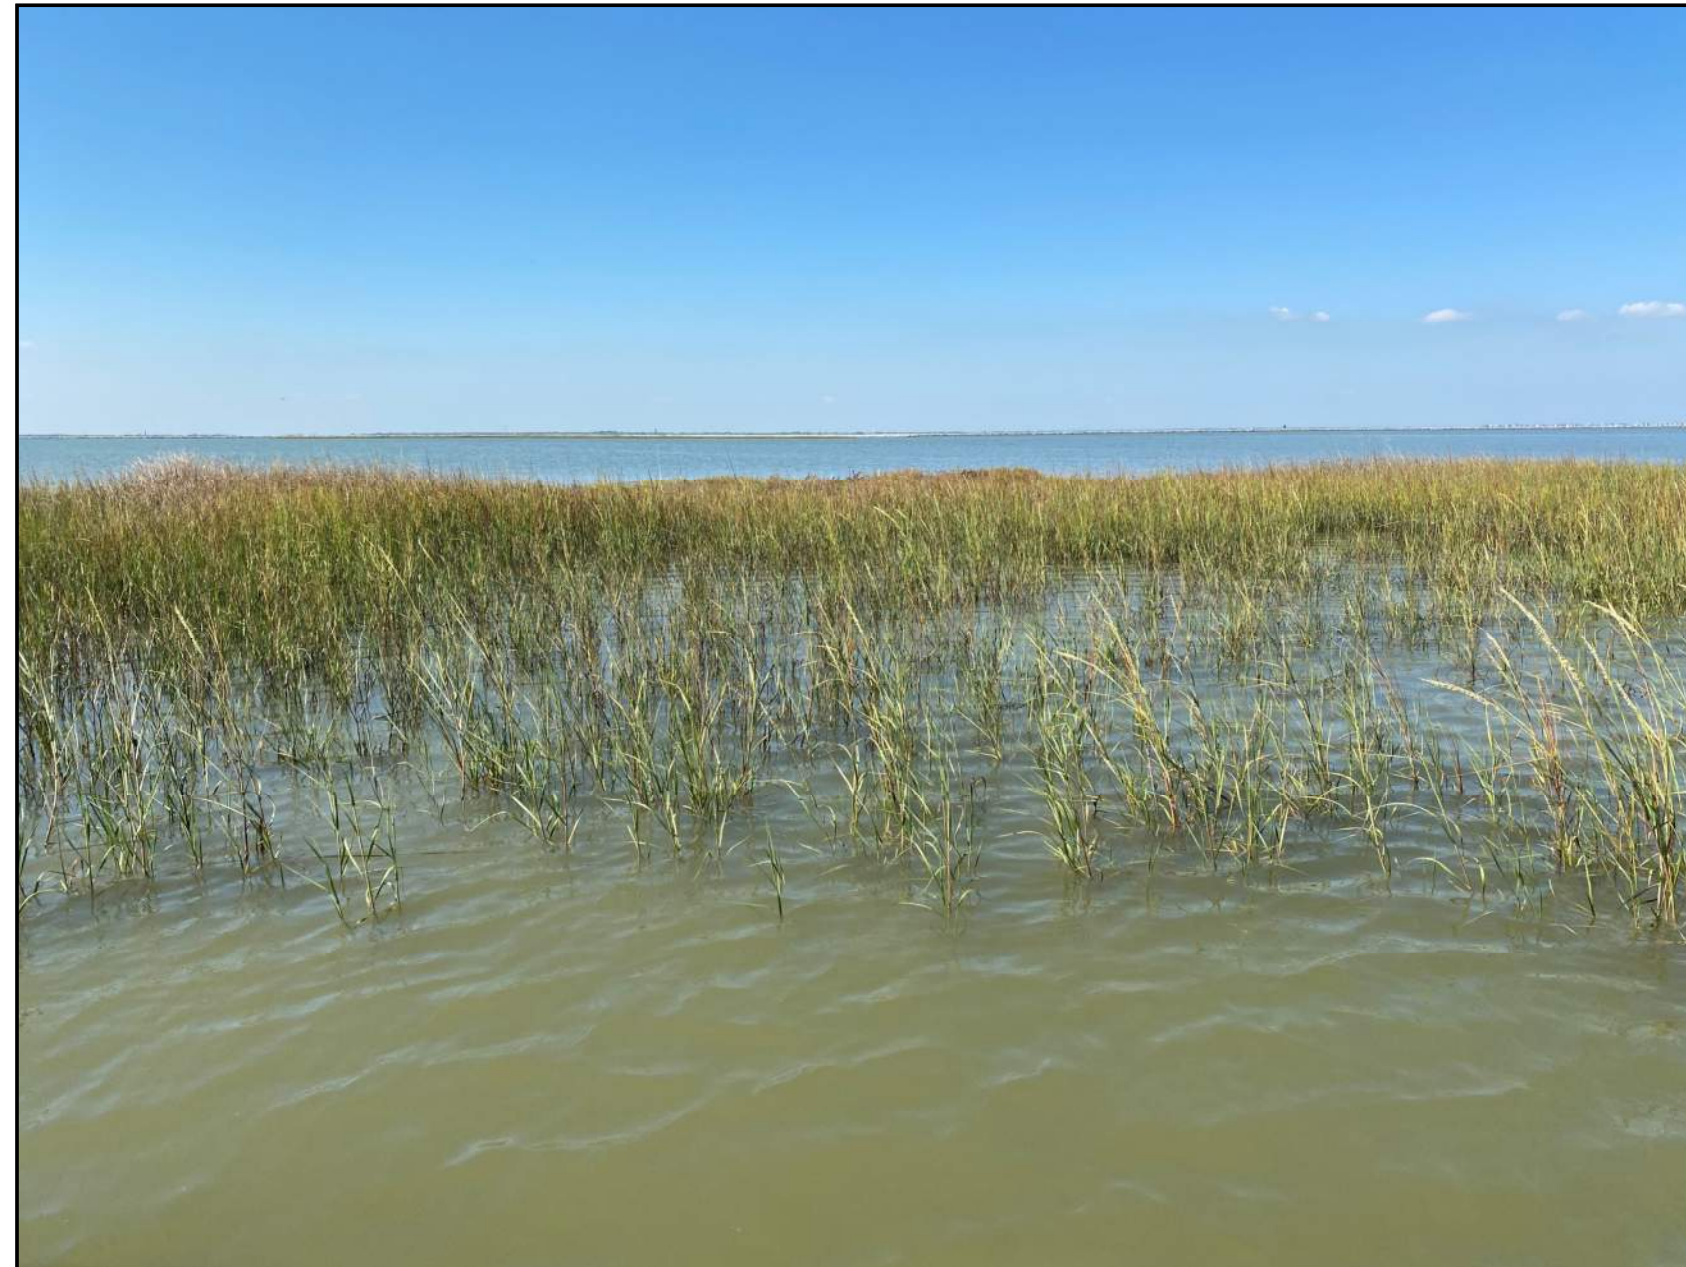
Figure A1. Area A: Mound CE1

| Mound | | Estimated Percent Coverage in Intertidal Region | | | | | Change | | | |
|---|---|---|---|---|---|---|---|---|---|---|
| A | CE1 | 20% | 45% | 45% | 45% | 50% | 25% | 0% | 0% | 5% |

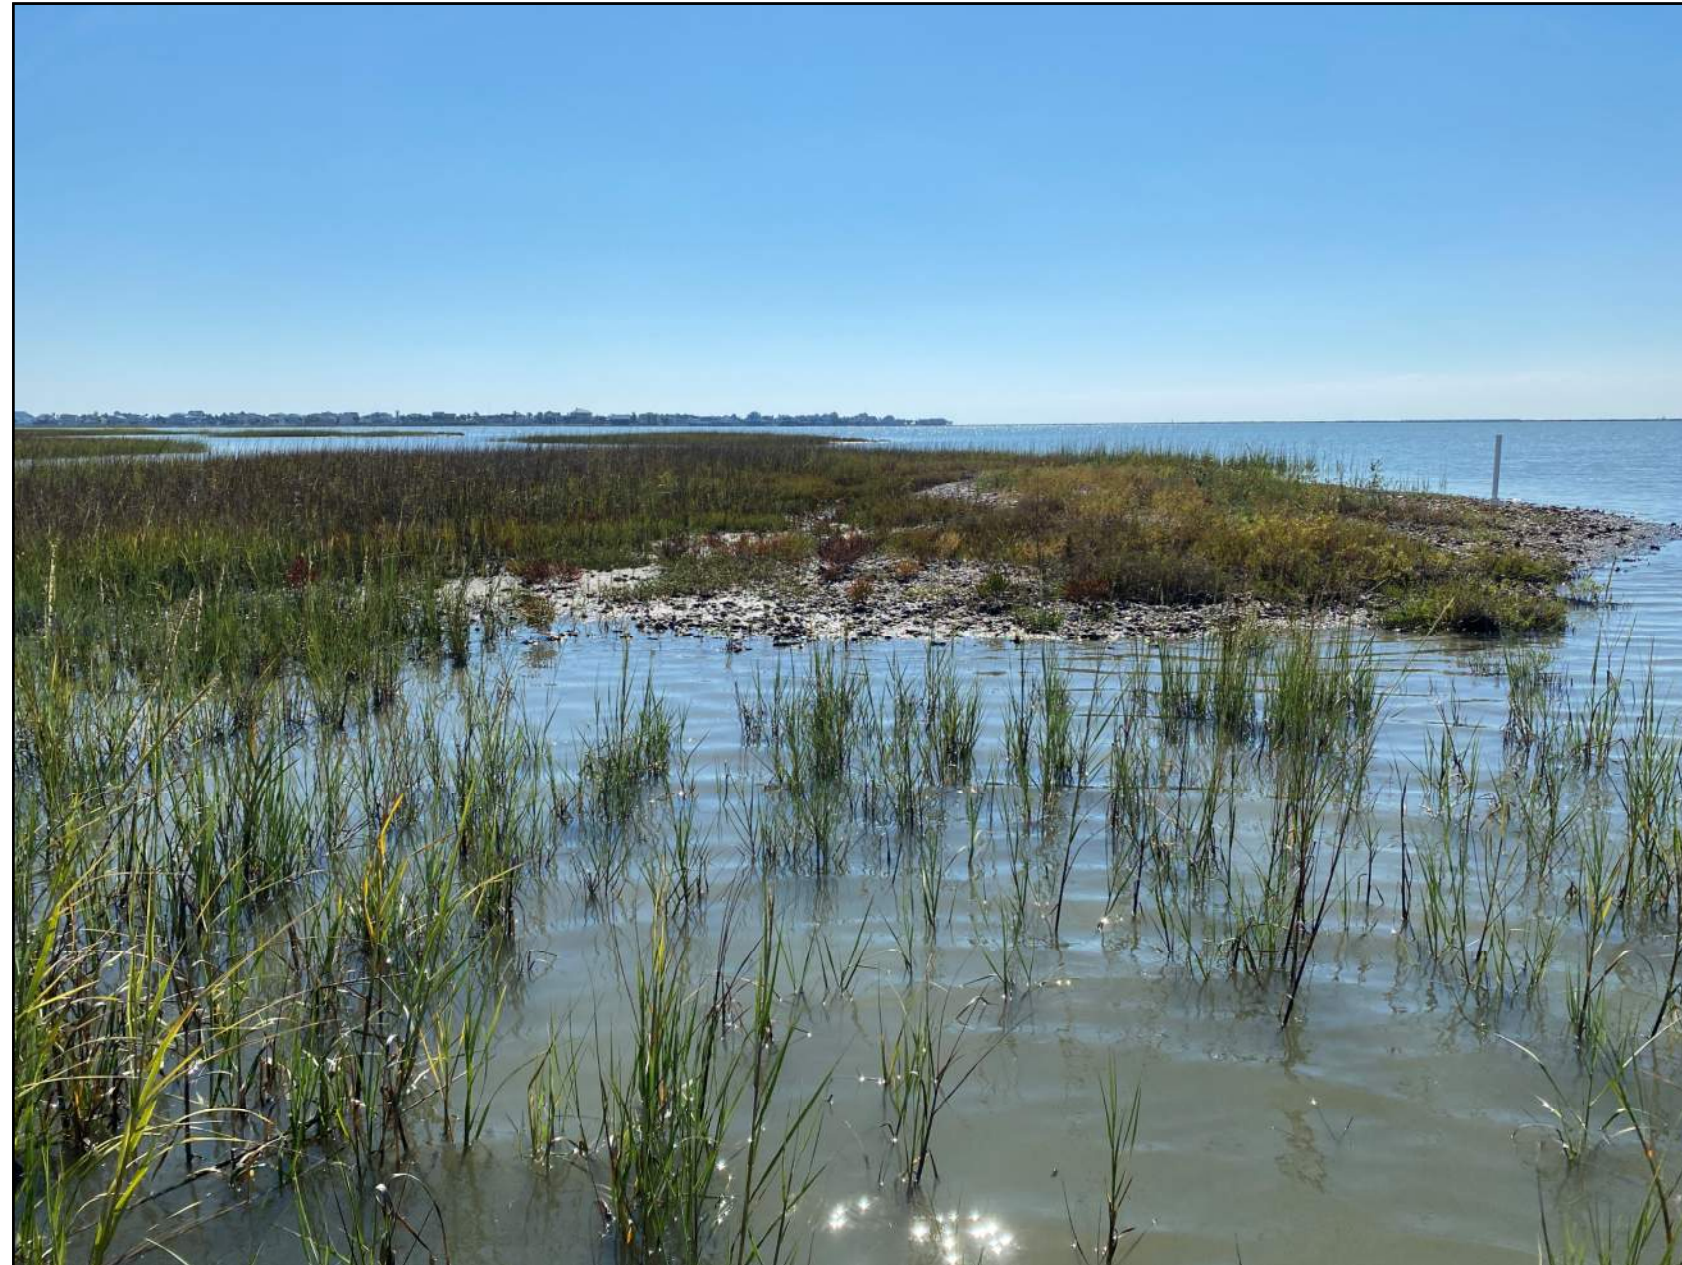
Figure A2. Area A: Mound CE2

| Mound | | Estimated Percent Coverage in Intertidal Region | | | | | Change | | | |
|---|---|---|---|---|---|---|---|---|---|---|
| A | CE2 | 25% | 55% | 35% | 40% | 45% | 30% | -20% | 5% | 5% |
