# DRAFT Post-Construction Monitoring Report: Year 4

Galveston Island State Park Marsh Restoration  
and Protection Phase III

CEPRA 1637

HDR Engineering, Inc.  
TBPELS Firm  
Registration No. F-754

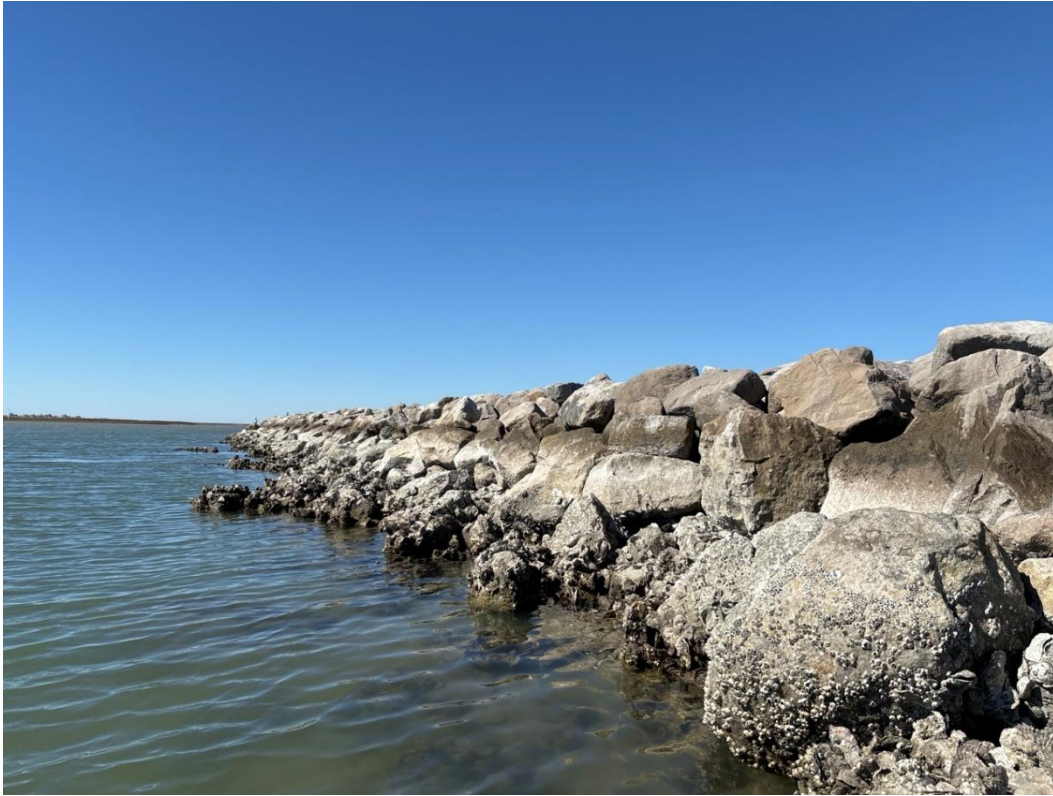
Figure 3. Typical ground digital photograph of the base of the Oak Bayou Breakwater (facing west).

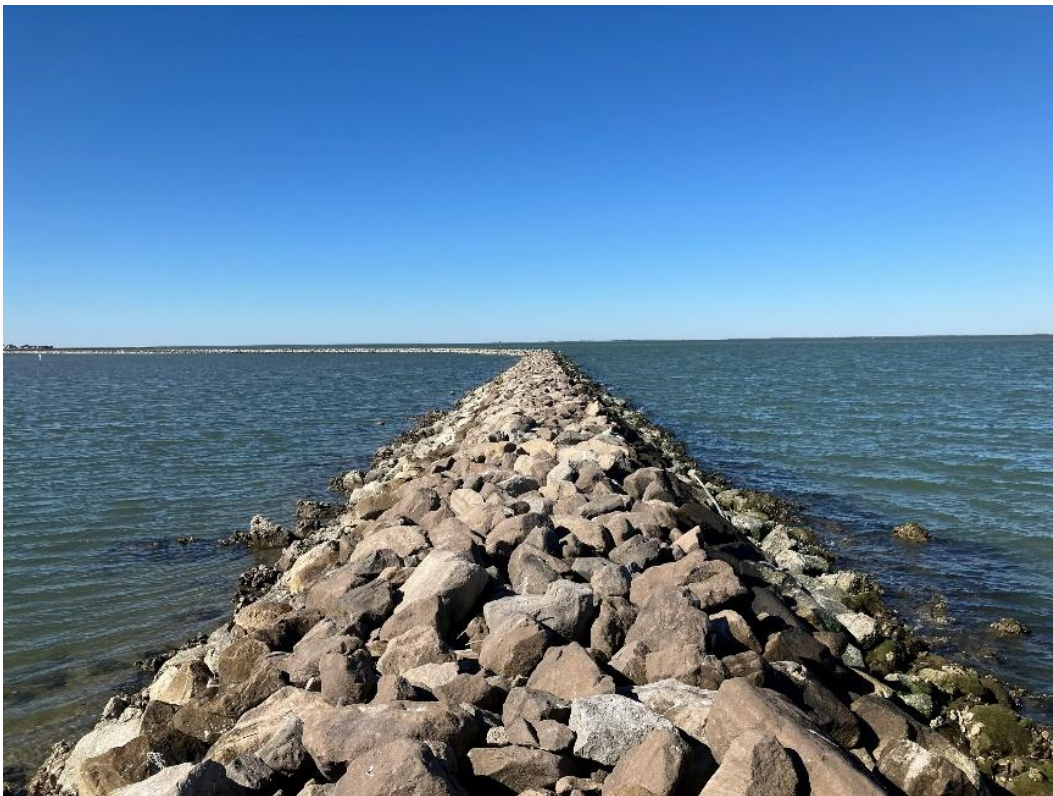
Figure 4. Typical ground digital photograph of the crest of the Oak Bayou Breakwater (facing west).

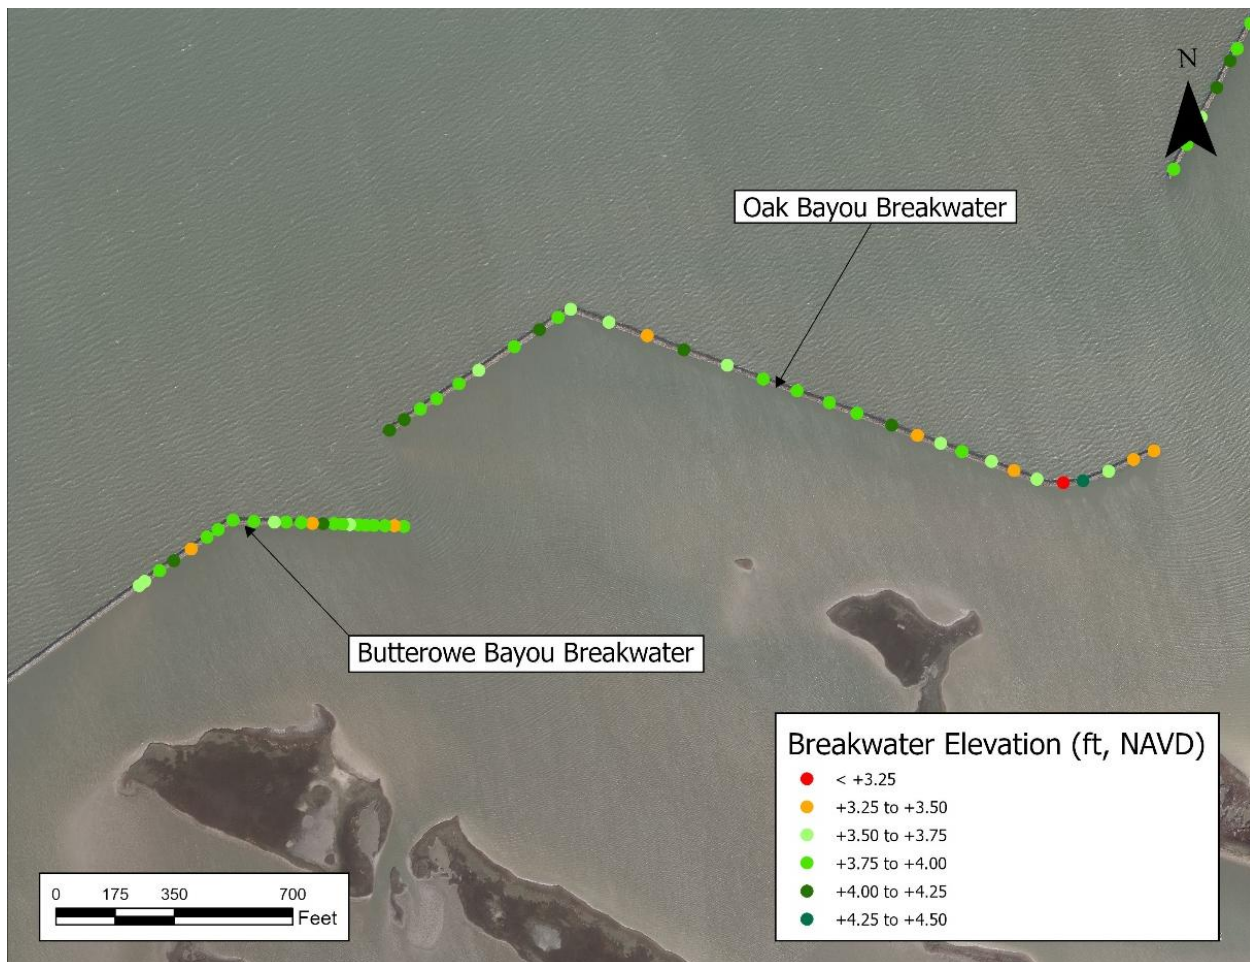
**Figure 8. Oak Bayou and Butterowe Bayou breakwater elevations measured using RTK GPS**

Figure 9 and Figure 8 show three points along the Oak Bayou and Dana Cove breakwaters where elevations fell between +3 feet NAVD and +3.25 feet NAVD. The Oak Bayou low point, shown in Figure 8, had an elevation of +3.2 feet NAVD. No scour or significant settlement was observed in proximity to this low point during the site visit. This low point is likely a localized variation in the crest elevation as opposed to an indicator of settlement or structural instability of the breakwater.

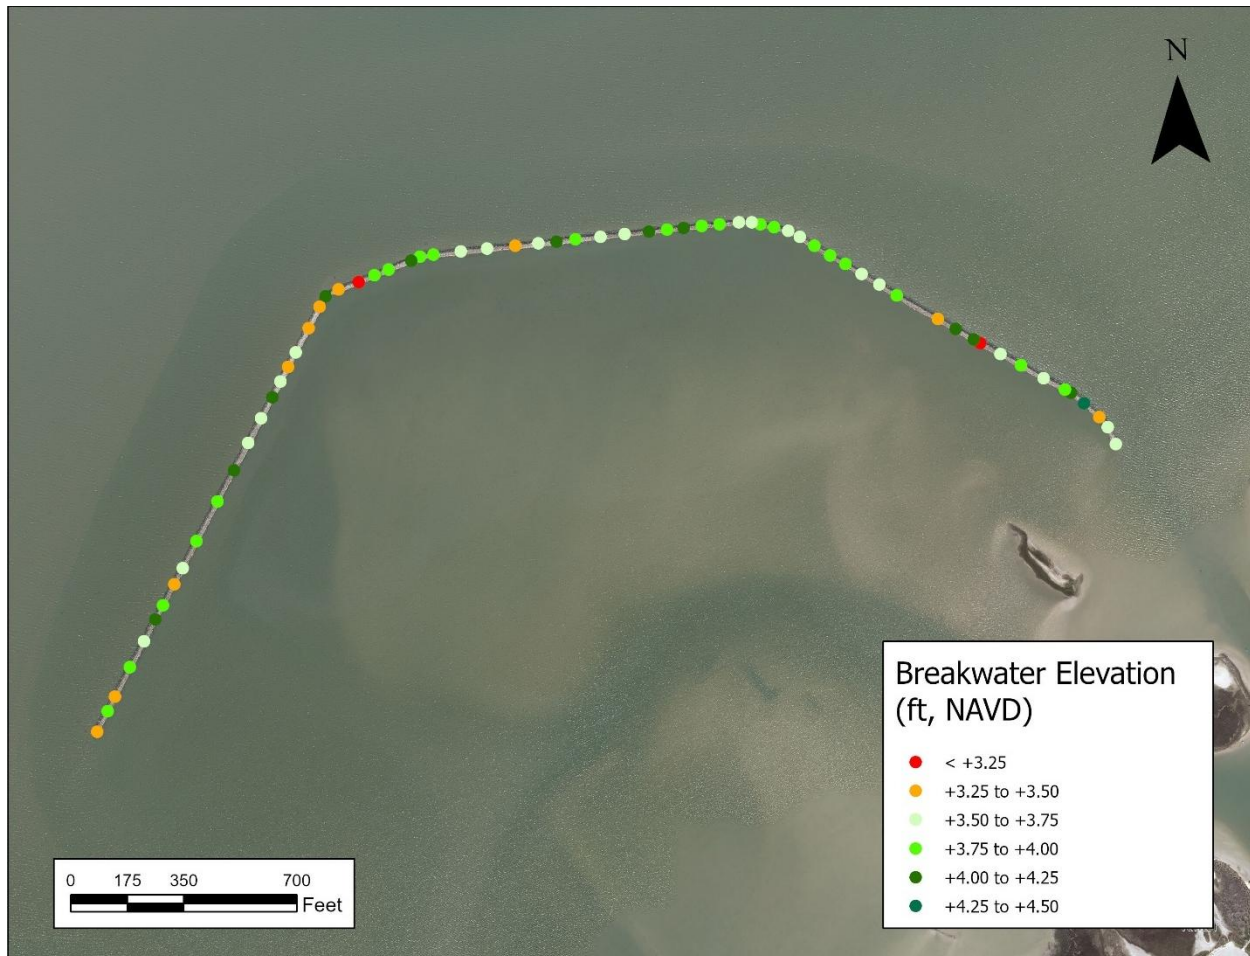
Figure 9. Dana Cove breakwater elevations measured using RTK GPS

The Dana Cove low points had elevations of +3.1 feet NAVD and +3.2 feet NAVD. These points were located at the western corner and eastern segment of the breakwater, respectively. The western corner of the Oak Bayou breakwater has been a consistent low area throughout the past monitoring periods, with the crest elevations ranging from +3.25 feet NAVD and +3.5 feet NAVD. Although the crest elevation is comparatively lower along this segment of the breakwater, the elevation has remained consistent throughout the past monitoring periods, indicating that the segment is stable. The low point along the eastern segment of the Dana Cove breakwater was in an area where elevations range between +3.5 ft NAVD and +4.0 ft NAVD. During the visit, there were no noticeable indications of settlement along this segment of the breakwater. Similar to the Oak Bayou Breakwater, the low points along the Dana Cove breakwaters are likely localized variations in crest elevation due to the lack of uniformity of placement across the cross-sections.

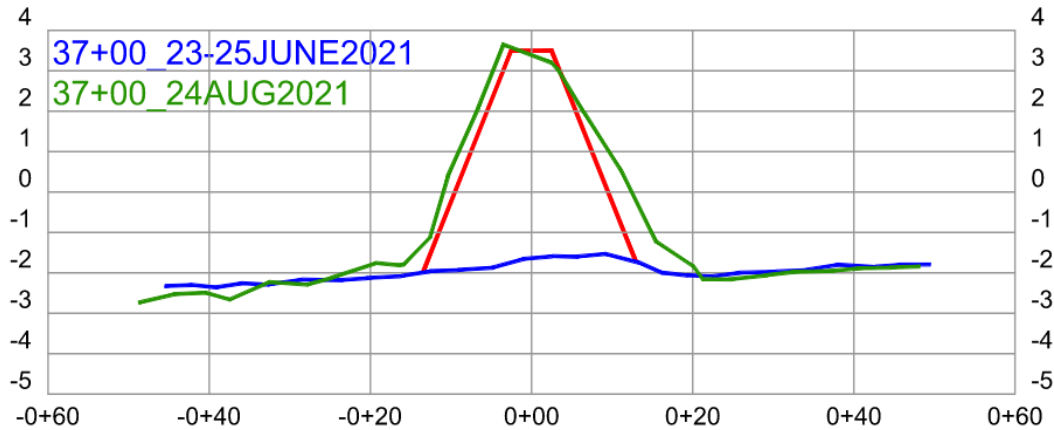
In areas where low points were identified, the corresponding cross-sections from the breakwater as-builts (Appendix C) were reviewed to check the baseline crest elevations. It was found that most of the corresponding cross-sections were constructed slightly below +3.5 feet NAVD88, and/or had side slopes that were slightly steeper in some segments than the 2H:1V design criteria but were within acceptable construction tolerance limits. These post-construction conditions could account for some of the Year 4 crest elevation measurements being below the design elevation, rather than being entirely due to settlement. Three cross-sections from the as-builts for the Dana Cove and Oak Bayou breakwaters are included in Figure 10 to Figure 12 to illustrate this point.

Figure 10. Eastern point near Sta. 38+00 cross-section of the Dana Cove Breakwater (red line showing design template)

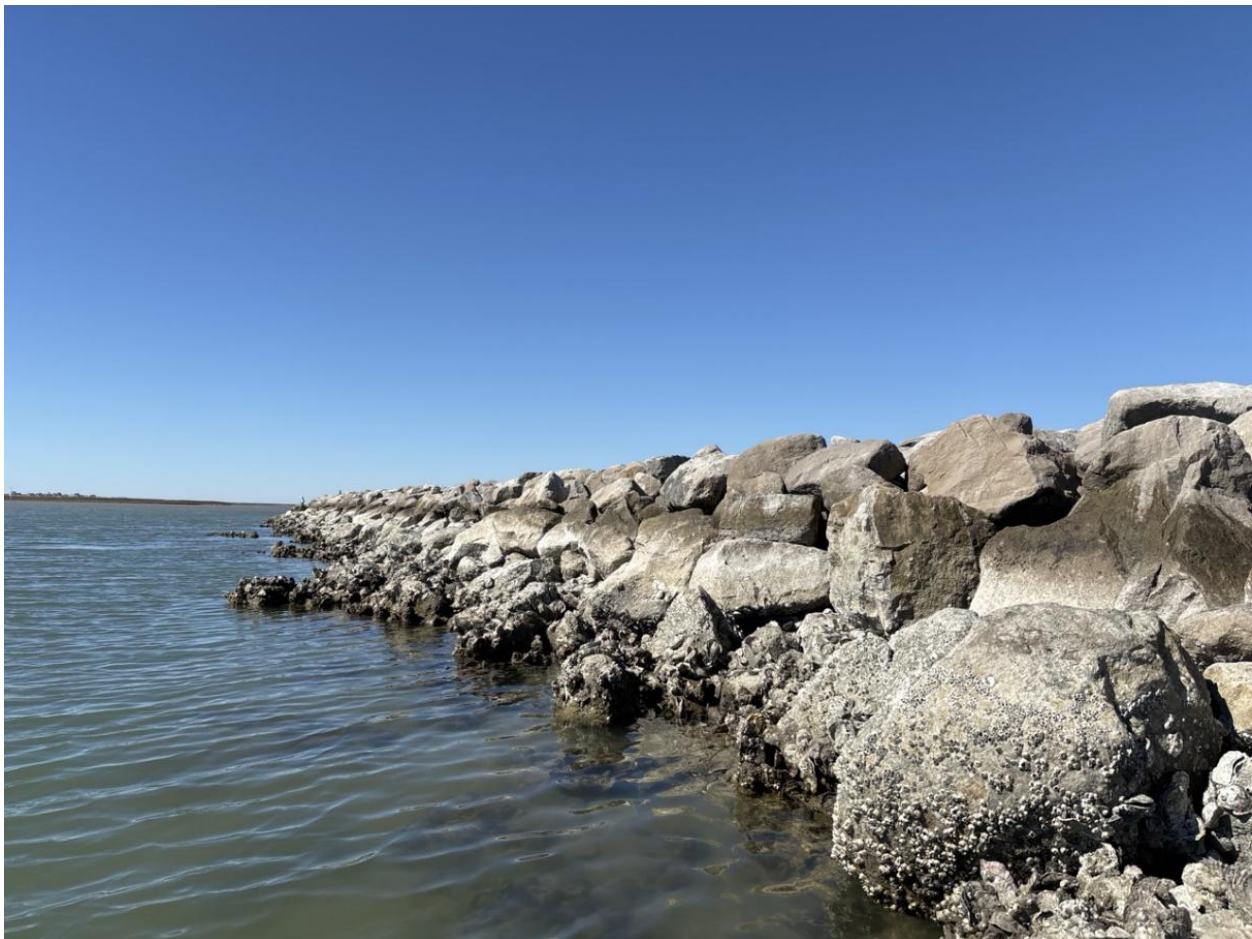
For Year 4 Monitoring, field observations and field photography were used to document the presence of encrusting species and algae attached to the breakwater. The low water level during the Year 4 Monitoring allowed for the observations of the full extent of oyster beds along a total of 15,500 LF of breakwater (i.e., 7,550 LF on each side of the breakwaters at the water's edge). Green algae species, Eastern oysters (*Crassostrea virginica*), and barnacle species were observed along the entirety of the three breakwaters. Hard substrate habitat on both sides of the Phase III breakwaters is shown in Figure 13 through Figure 15. Crustacean species were present on the breakwaters and throughout the marsh areas.

Figure 13. Oysters and barnacles on Oak Bayou Breakwater.

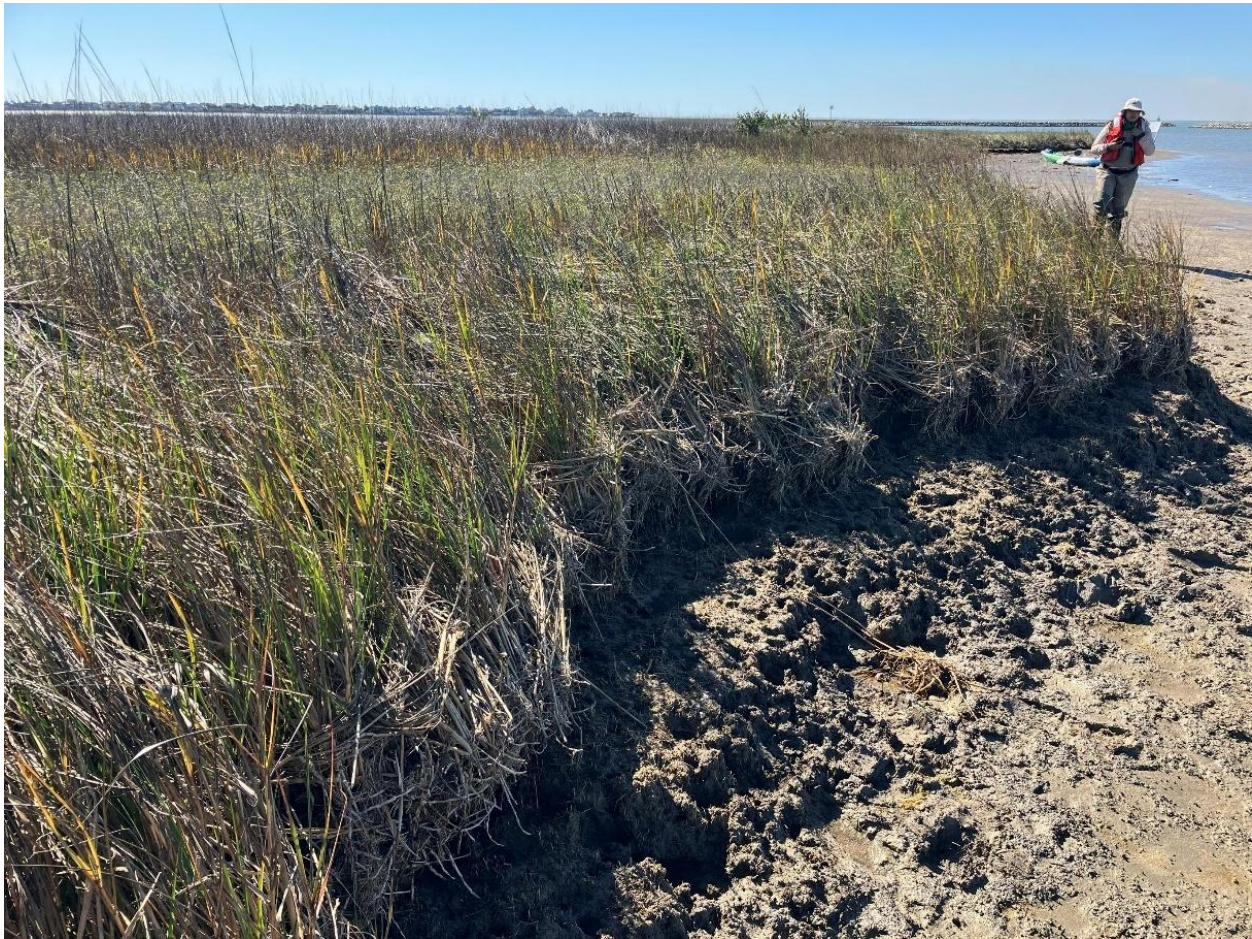
Figure 17. Vertical scarp along marsh shoreline at Area A.

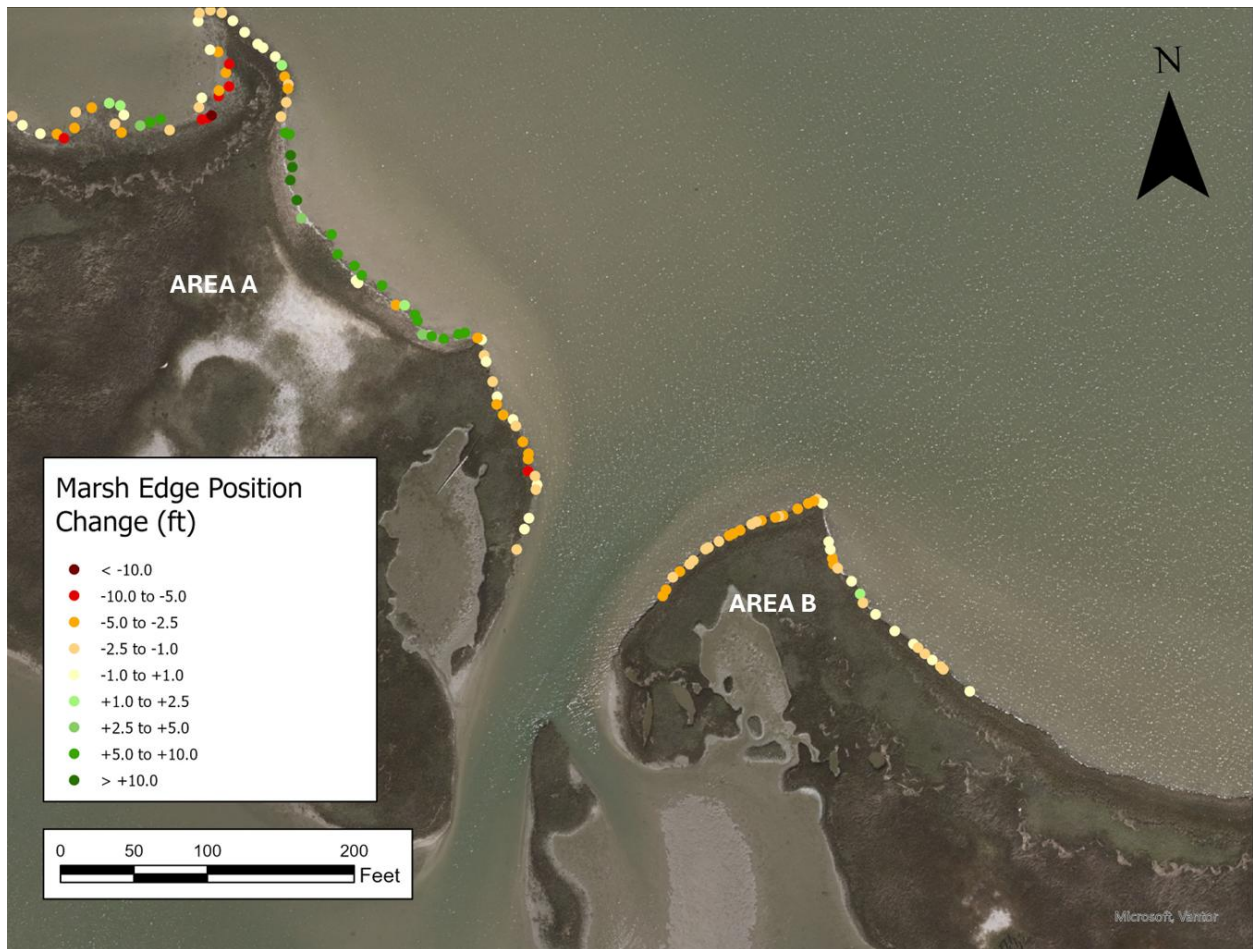
Figure 35. Marsh edge position change for Area B.

Per Year 4 Monitoring data, Area B has experienced an average of -1.9 feet of retreat of the marsh edge. The average recession during Year 4 reflects the trend observed during the Year 1 and Year 2 Monitoring periods. The average recession rate along the Area B marsh edge ranged from -1.0 foot to -5.0 feet (see Figure 35).

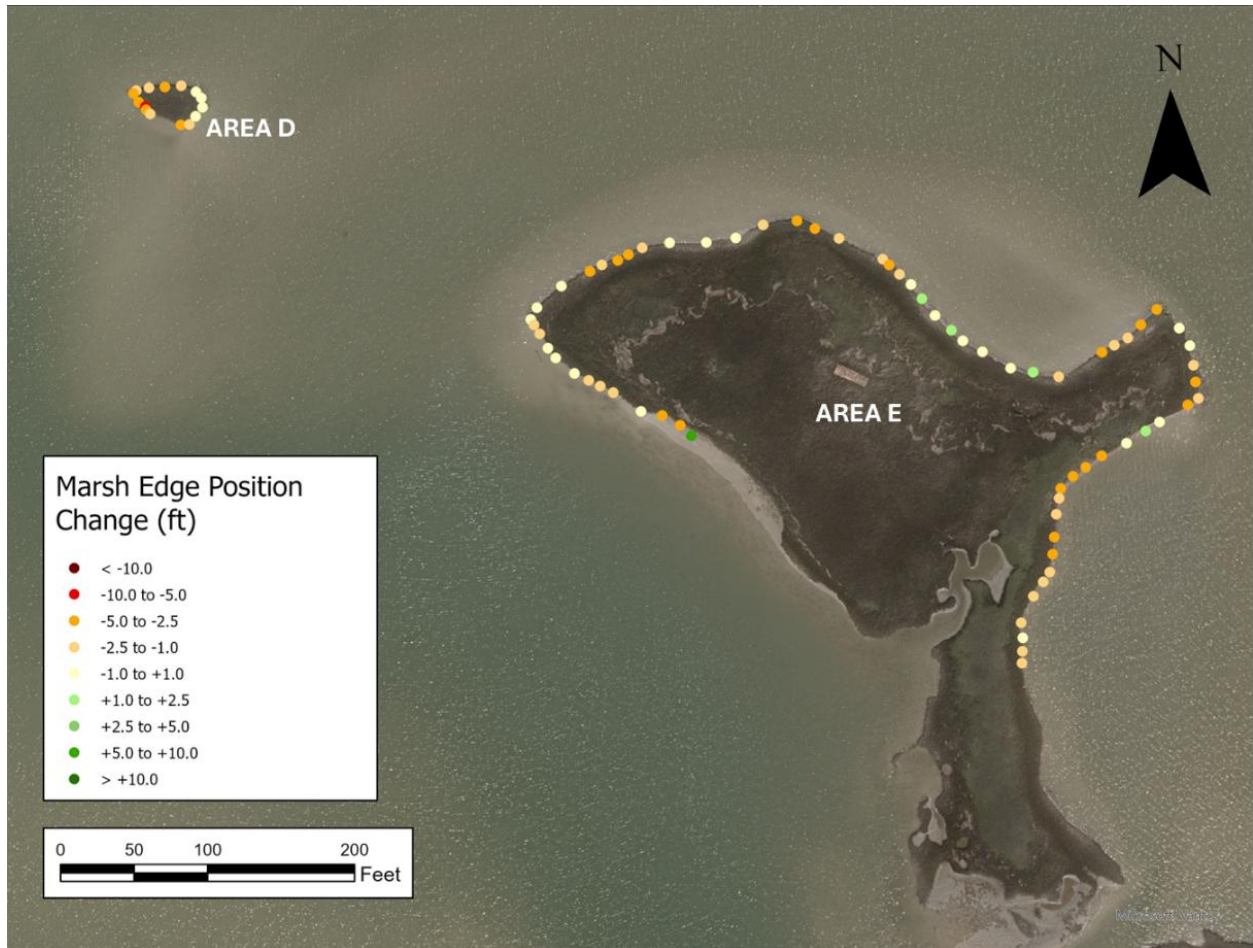
Figure 37. Marsh edge change for Area D and E.

During the Year 4 Monitoring period, Area E experienced an average of -1.4 feet of marsh edge recession. The largest of which occurred along the scarps observed during the site visit and ranged from -2.5 feet to -5.0 feet of recession. The damaged vegetation along these scarps had their roots exposed and stalks snapped. Some advancement did occur within the cove west of the land protrusion that ranges from +1.0 foot to +2.5 feet. From Year 3 to Year 4 there was noticeably more marsh edge recession (see Figure 37). However, the marsh edge recession rates did not exceed levels observed in Year 2.

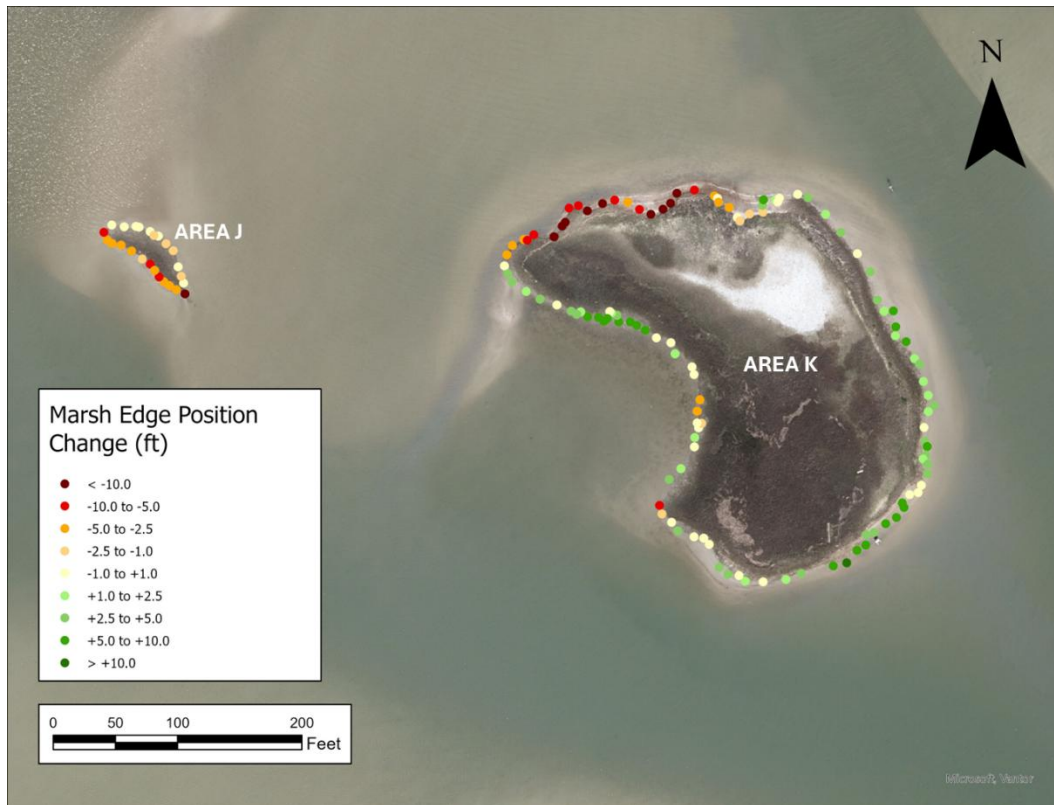
Historically, the Area J marsh edge has receded on all sides. During the Year 3 Monitoring period, the southwestern marsh edges experienced some advancements. During the Year 4 Monitoring period, the Area J marsh edge receded an average of -2.48 feet from its Year 3 position, continuing a trend observed during Year 1 and Year 2. The western marsh edges experienced -2.5 feet to -5.0 feet of recession. The eastern marsh edge experienced -1.0 feet to -2.5 feet of recession. The largest recession occurred at the southern tip of the islet where the marsh edge receded -11.7 feet from its Year 3 position (see Figure 41).

Figure 41. Shoreline change for Area K.

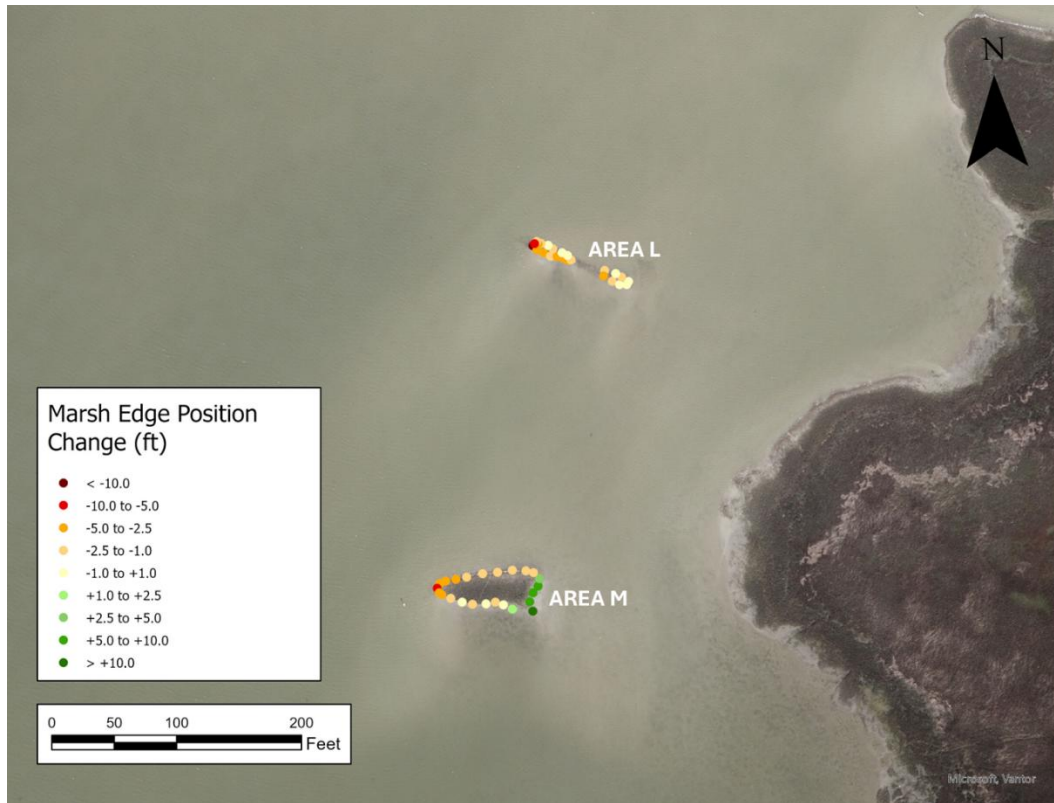
During the Year 4 Monitoring, Area L experienced an average of -2.5 feet of change in marsh edge position. The islet was separated into an eastern and western segment due to the loss of vegetation within the center of the islet (see Figure 44). Due to the damaged vegetation and the elevation relative to the surrounding land, the eastern segment of Area L is likely submerged during high tide. This segment experienced up to -5.0 feet of marsh edge recession from its Year 3 position. The western segment is still covered by some partially submerged low marsh vegetation. The shoreline along this segment are scarped and experienced up to -5.0 feet of recession from its Year 3 marsh edge position. The most significant recession occurred at its northwest tip where the marsh edges receded -10.5 feet.

During the Year 4 Monitoring, Area M experienced -0.2 feet of change in marsh edge position with a peak of -6.8 feet of recession occurring at its western end. The southeast end of the island accreted up to +12.6 feet due to a patch of submerged vegetation not present during Year 3 returned during Year 4. The western marsh edge of Area M is scarped but transitions into a gently sloping shoreline along its eastern end. The low marsh vegetation previously present on the islet was still present during the Year 4 Monitoring.

Figure 43. Shoreline change for Area L and M.
