# **Tern Rookery Island Protection and Restoration, Phase I: Feasibility Study & Alternatives Analysis**

**GLO Contract No. 21-060-008-C668**

## **Final Report**

**September 30, 2023**

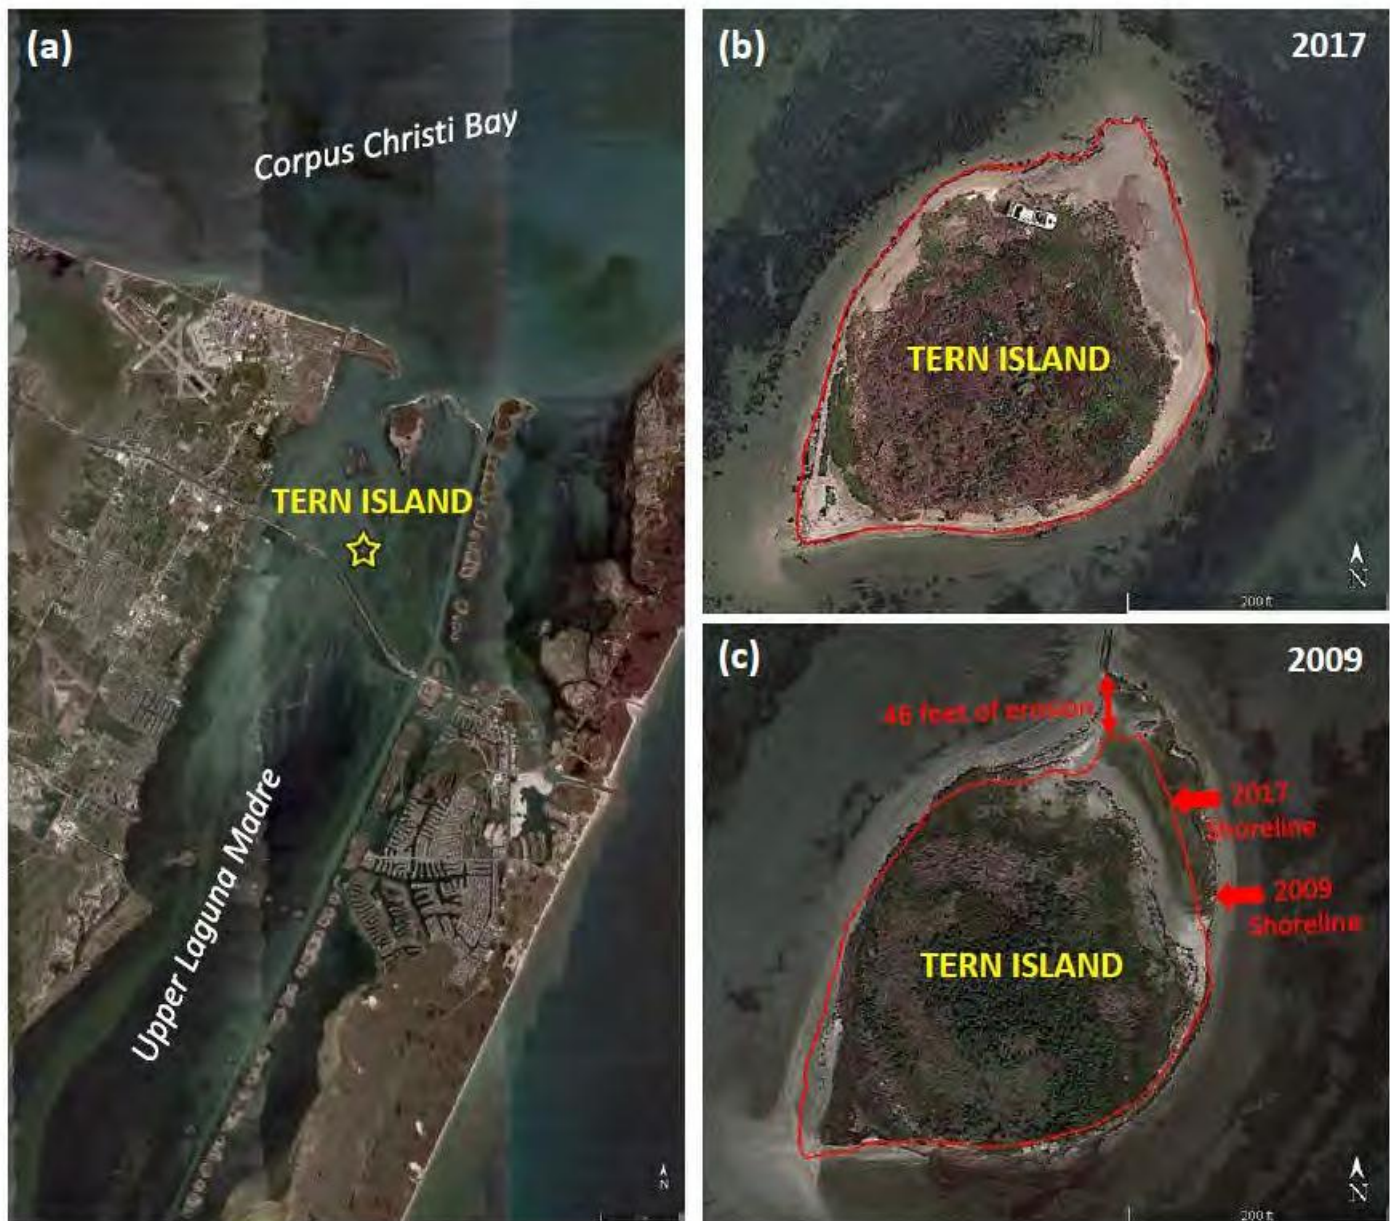
Figure 1. Vicinity map and aerial images of Tern Island depicting effects of erosion 2009 – 2017.

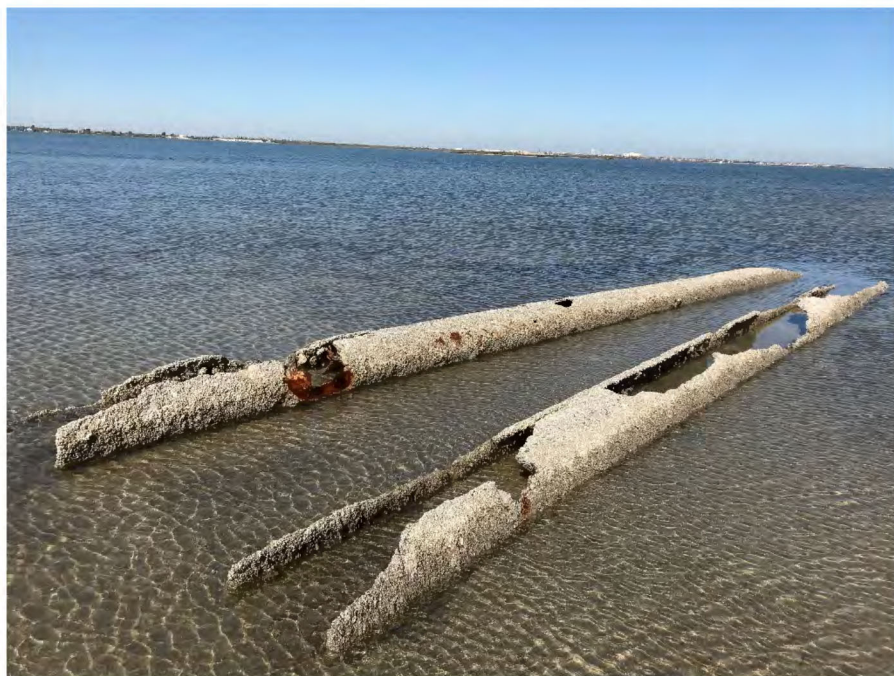
**Photo 2 –** Submerged  
debris observed  
between T1 and T2  
located north of Tern  
Rookery Island and  
facing north.

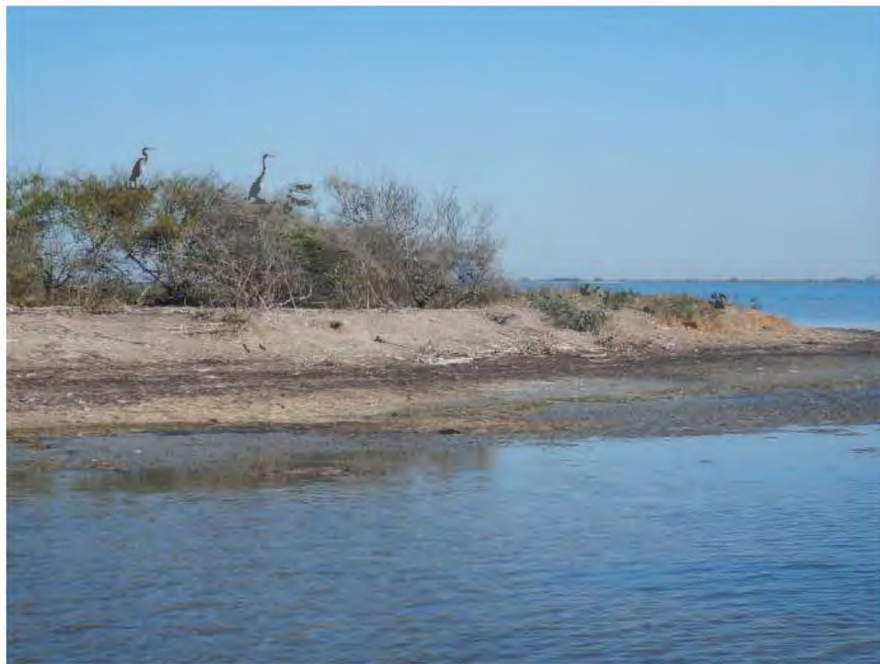
Photo 2: Close up of scarp face present on eastern side of Tern Rookery Island. Photo taken facing Flour Bluff.

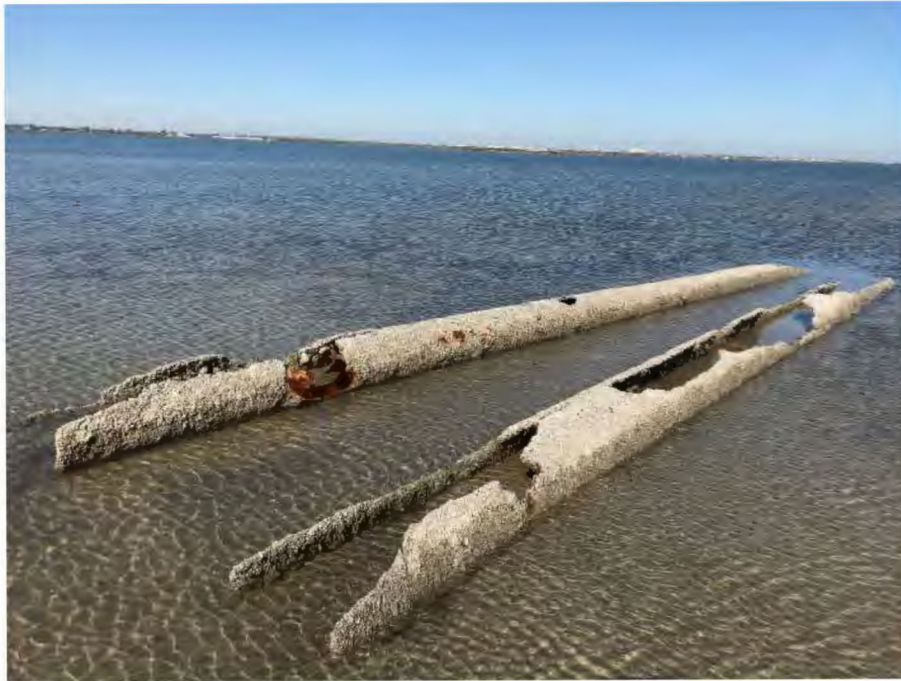
Photo 9: Deteriorating pipes on north side Tern Rookery Island.

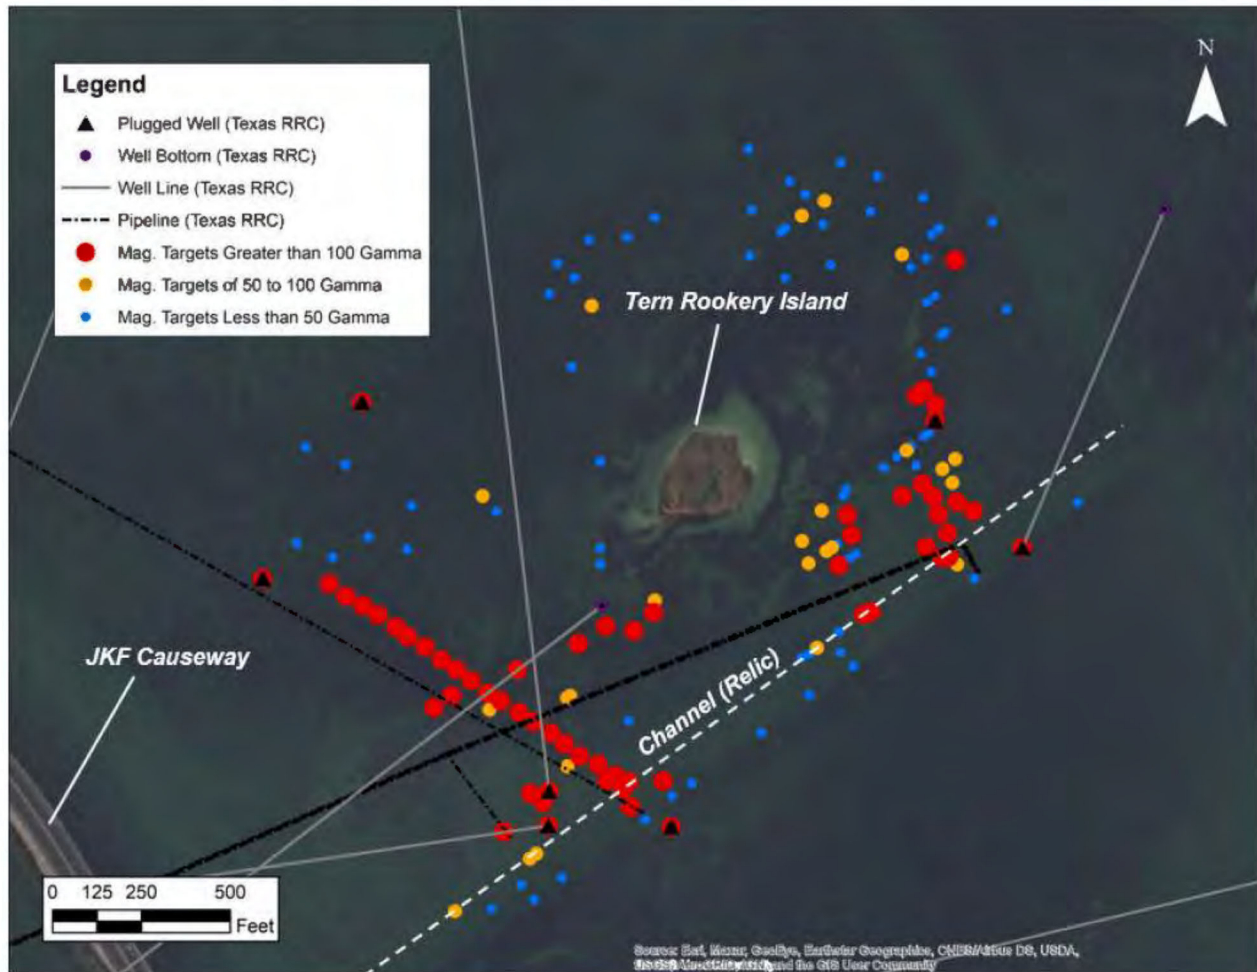
Figure 7. Hazard survey results for project area

Magnetometer survey results are shown in Figure 6 and Figure 7. These figures indicate several anomalies around the island. Included in the anomalies identified by TBS are 7 gas wells and 3 pipelines. A map of the existing pipelines was obtained from the Railroad Commission of Texas (RRC) online mapping system to help identify the anomalies. The RRC database indicates that the wells are plugged, and the pipelines are abandoned. It should be noted that the intensity of the magnetometer measurement value (expressed in the unit “gamma”) decreases exponentially with distance from the target, so individual readings do not necessarily reflect size of the object. Additional probing is recommended during later project phases to provide more accurate horizontal and vertical locations of oil and gas infrastructure at the project site.

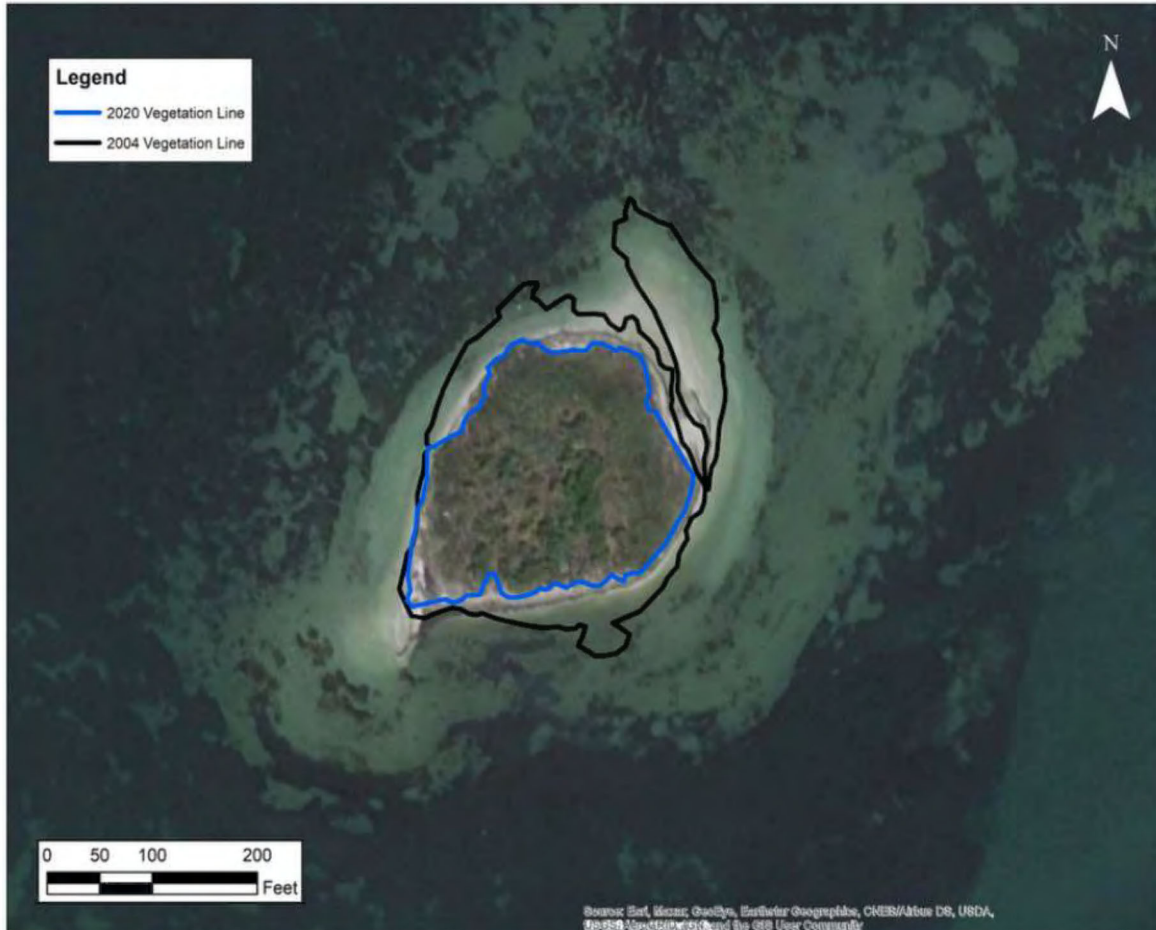
Figure 10. Comparison of vegetation lines in 2004 and 2020

A review of historical aerial photography from 2004 and 2020 indicates that the northern shoreline retreated approximately 45 ft (Figure 10), which equates to a rate of approximately 3 ft/yr.
