## GULF REEF REHABILITATION

A Project of the  
Coastal Management Program Cycle 27  
Contract No. 22-131-008-D571

Final Report  
April 2026

**Final Report  
For  
Marine Multibeam Sonar Survey of the RGV Reef PS-1105**

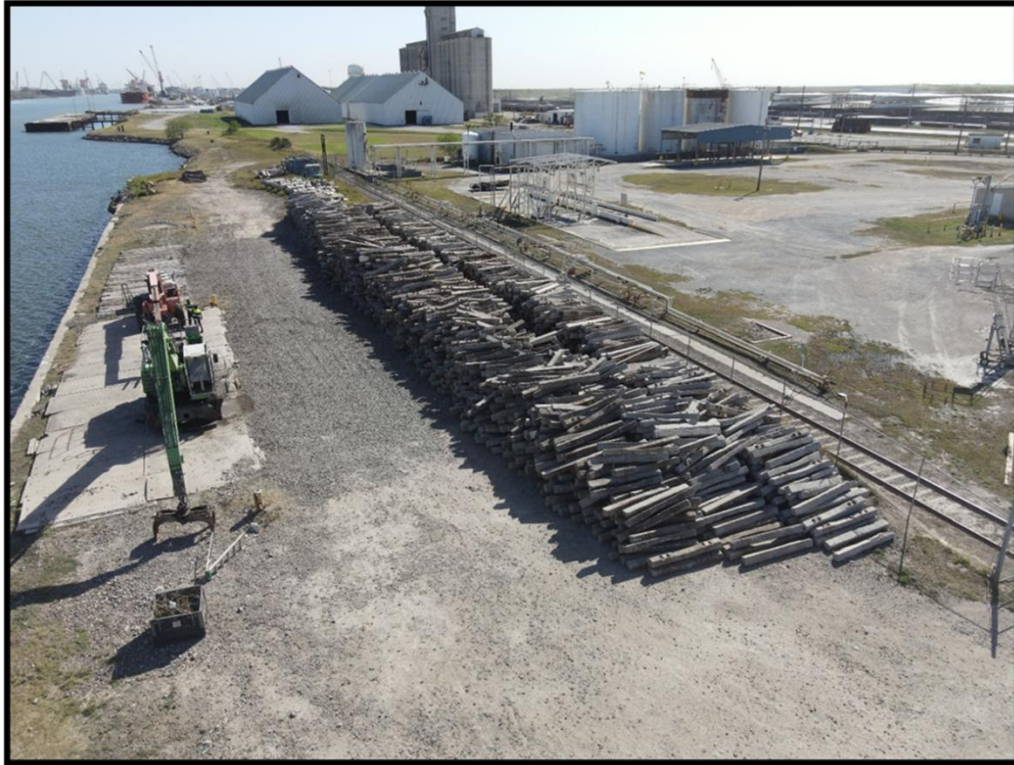
Drone image of stacked railroad ties, material handler at left

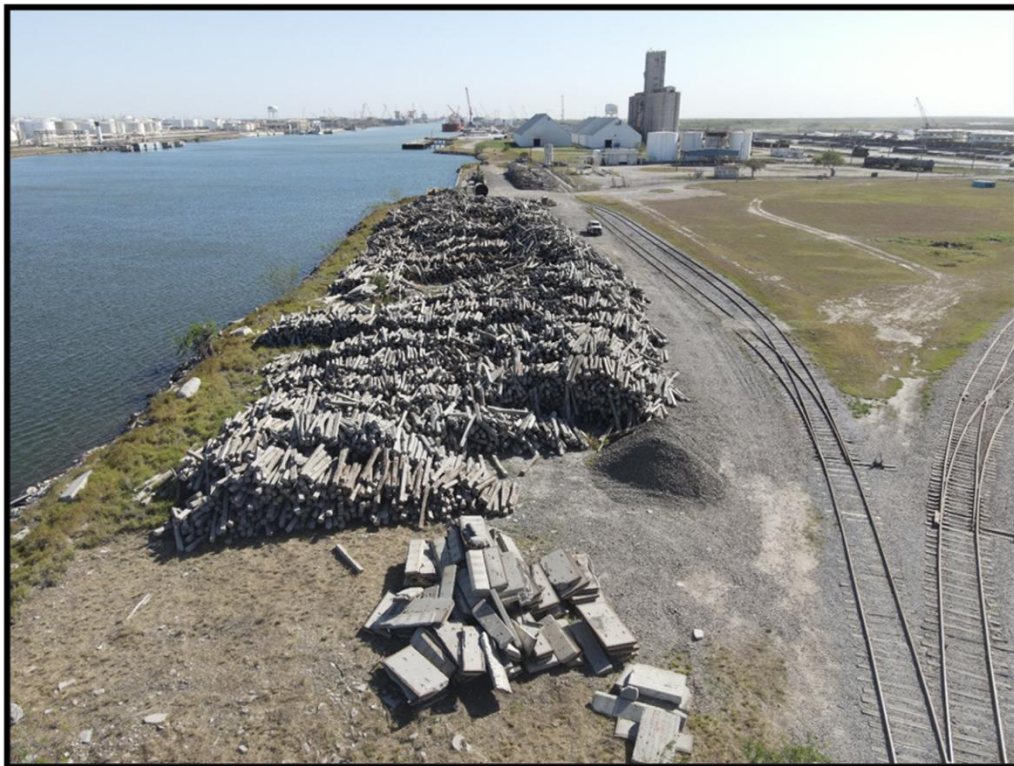
Drone image of stacked railroad ties and concrete blocks

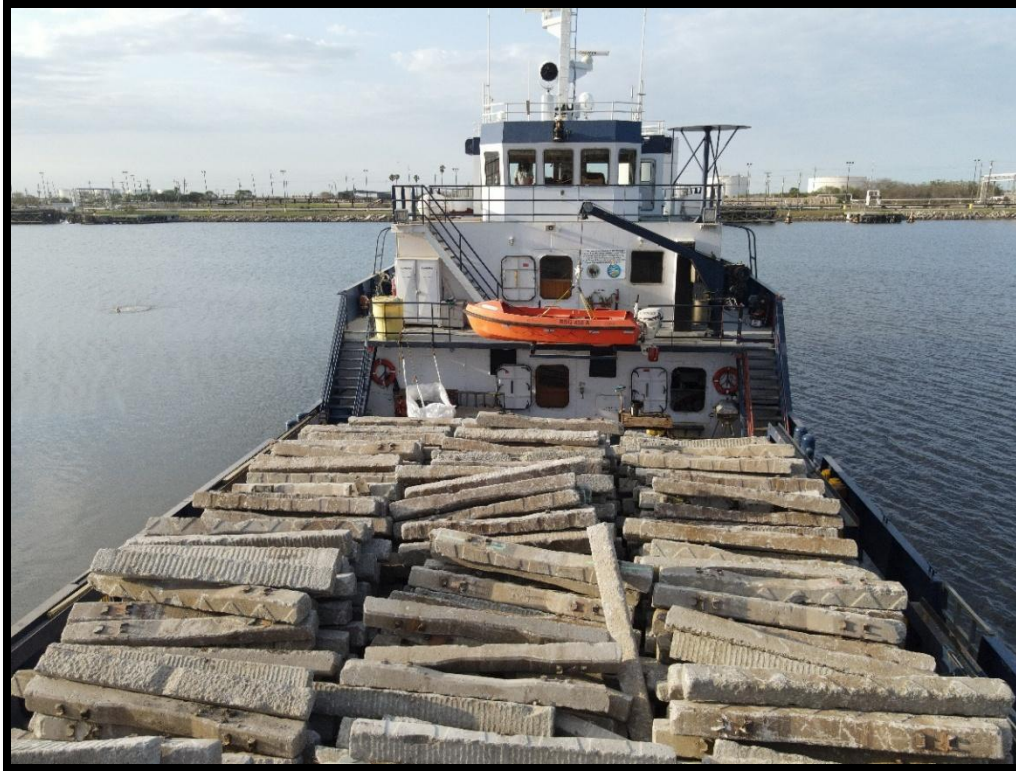
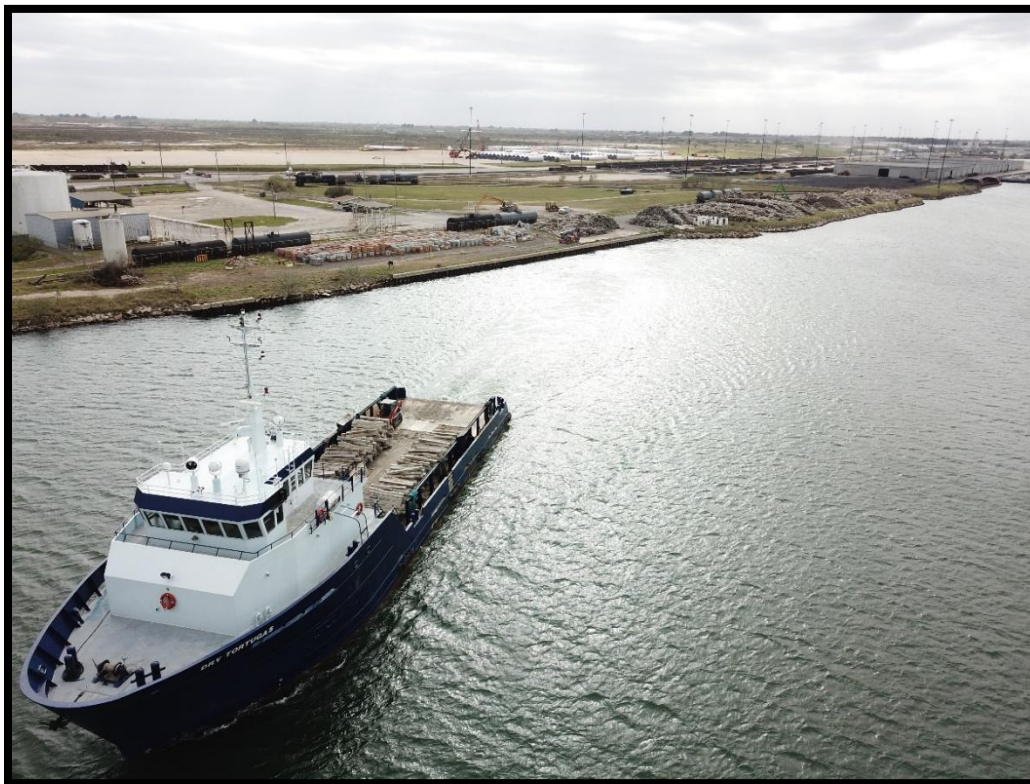
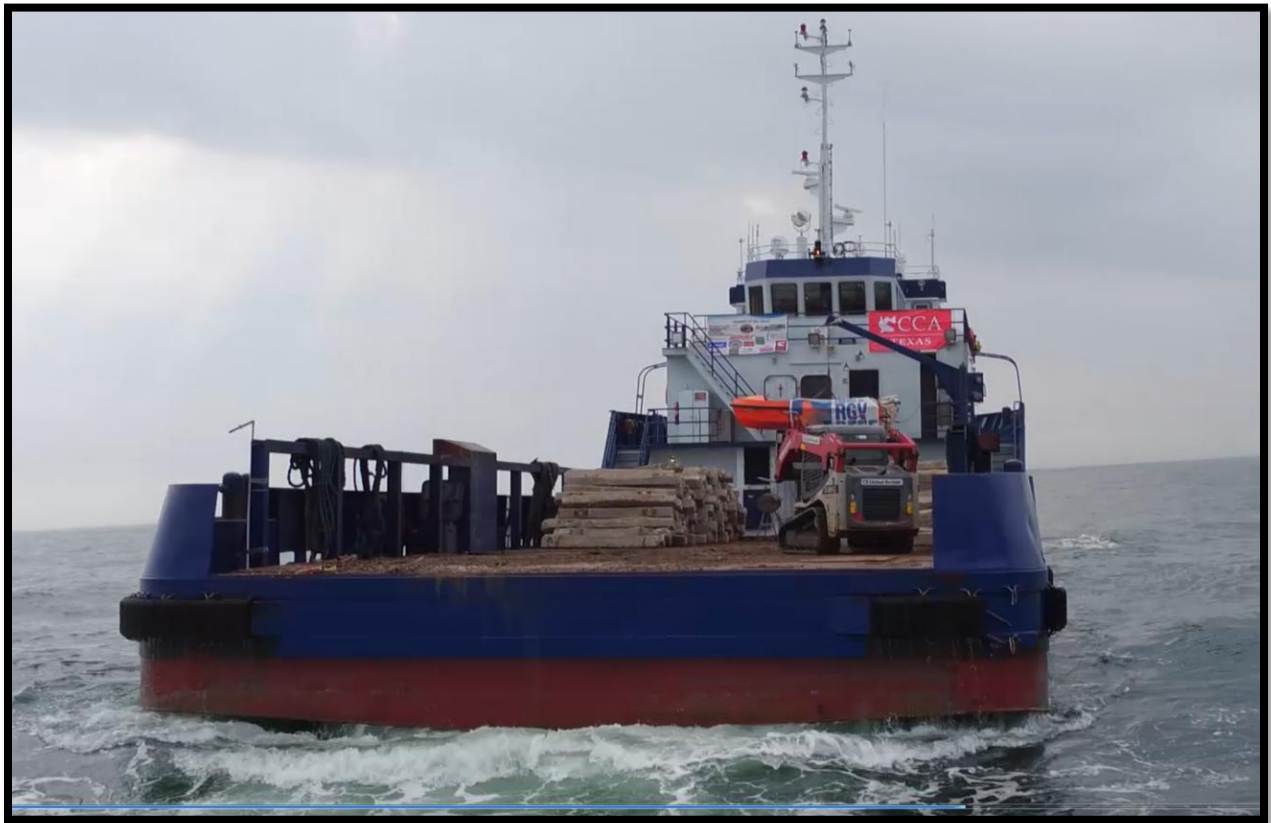
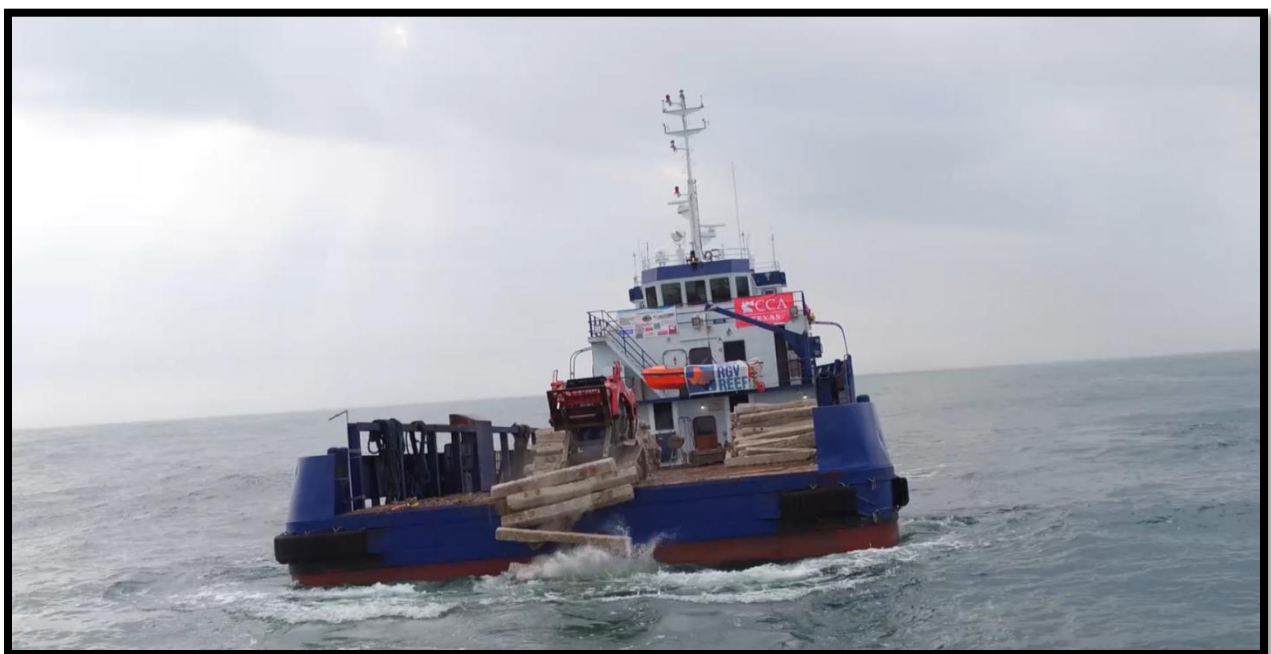
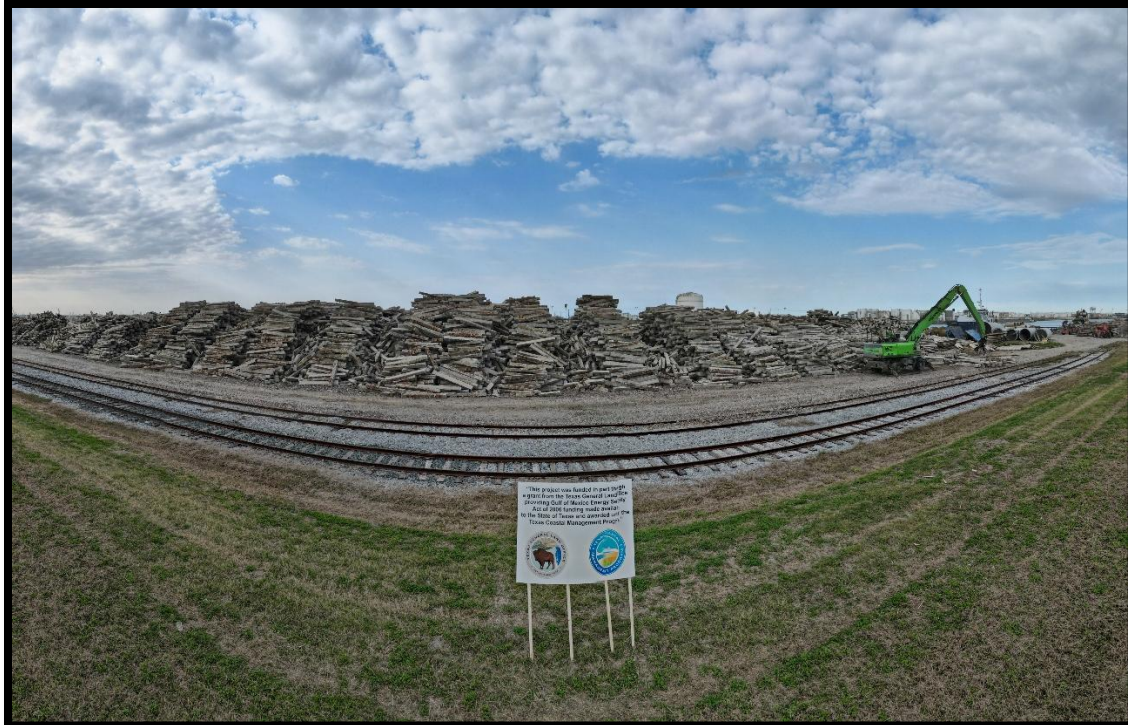
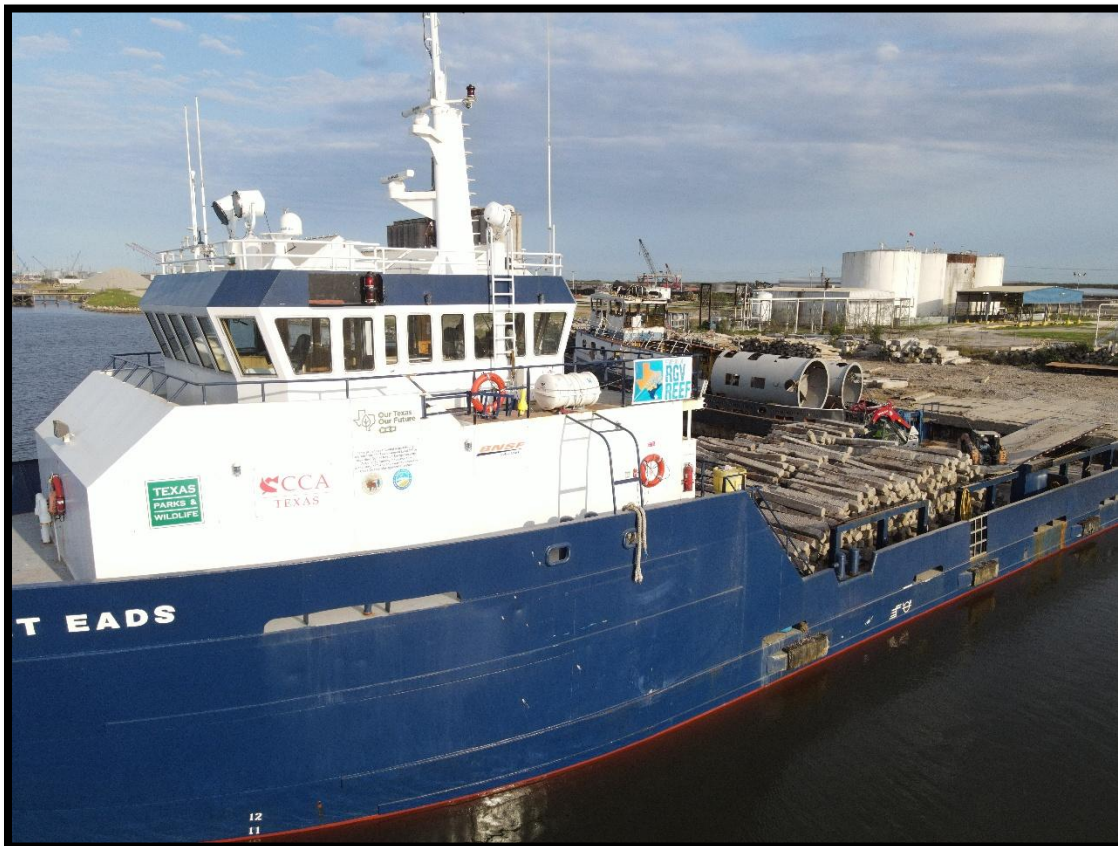
**Appendix 2** Photos courtesy of Curtis Hayungs, Port of Brownsville and Gulf of Mexico (RGV Reef), February/March 2025

In October 2024 FRGVR requested proposals for the marine transport portion of the project but received only one bid from Romeo Papa LLC. In February and March 2025, Romeo Papa provided marine transport services with a 170-foot dynamic positioning vessel and placed approximately 9,250 tons of reefing material on the seafloor at precise locations using coordinates approved by TPWD for this project. In accordance with TPWD, FRGVR coordinated the deployment date with TPWD to allow a TPWD staff member or observers approved by TPWD to be on the vessel during material deposition. FRGVR also installed temporary CMP signage on the deployment boat and posted CMP funding acknowledgement on the FRGVR website. Photographs of the material deployment and signage are presented in Appendix 2.

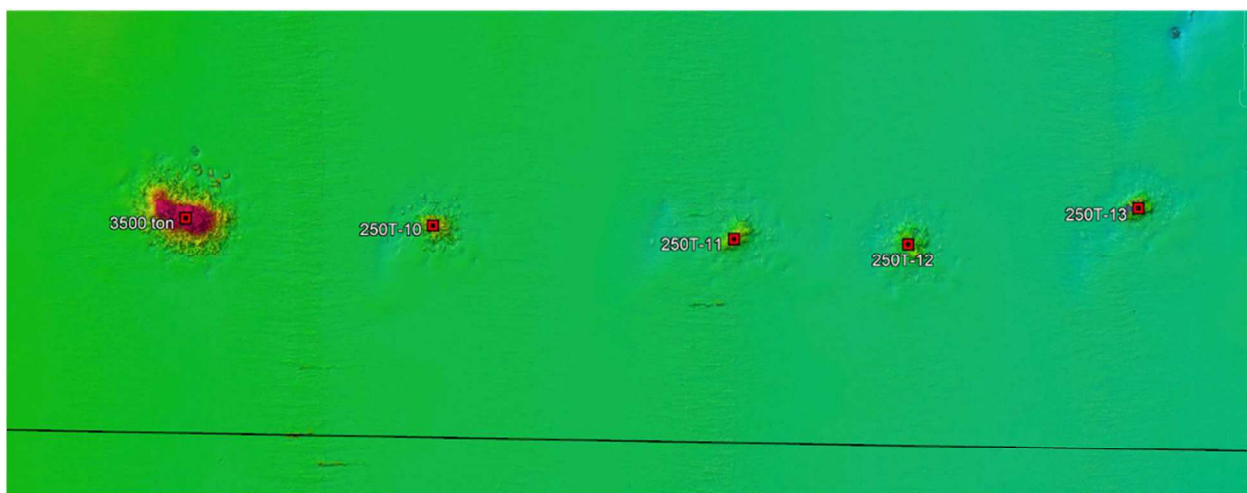
**Figure 8.** Overview of the 250-ton railroad tie patches (10-13) and the 3500-ton pile at the Rio Grande Valley Reef (PS-1105). Image was generated from 400 kHz multibeam recordings in August 2025.

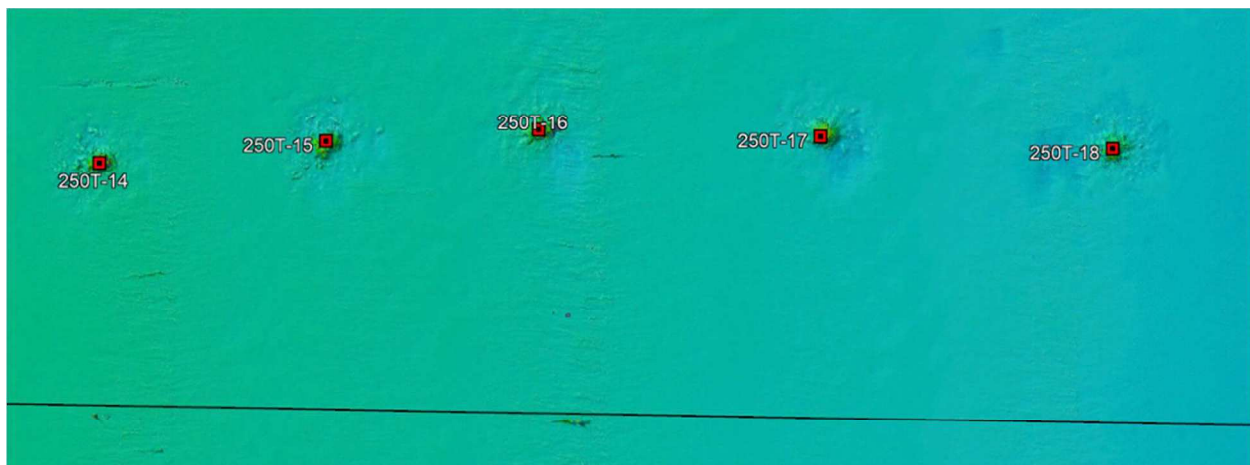
**Figure 9.** Overview of the 250-ton railroad tie patches (14-18) at the Rio Grande Valley Reef (PS-1105). Image was generated from 400 kHz multibeam recordings in August 2025.
