# **Tern Rookery Island Protection and Restoration, Phase I: Feasibility Study & Alternatives Analysis**

**GLO Contract No. 21-060-008-C668**

## **Final Report**

**September 30, 2023**

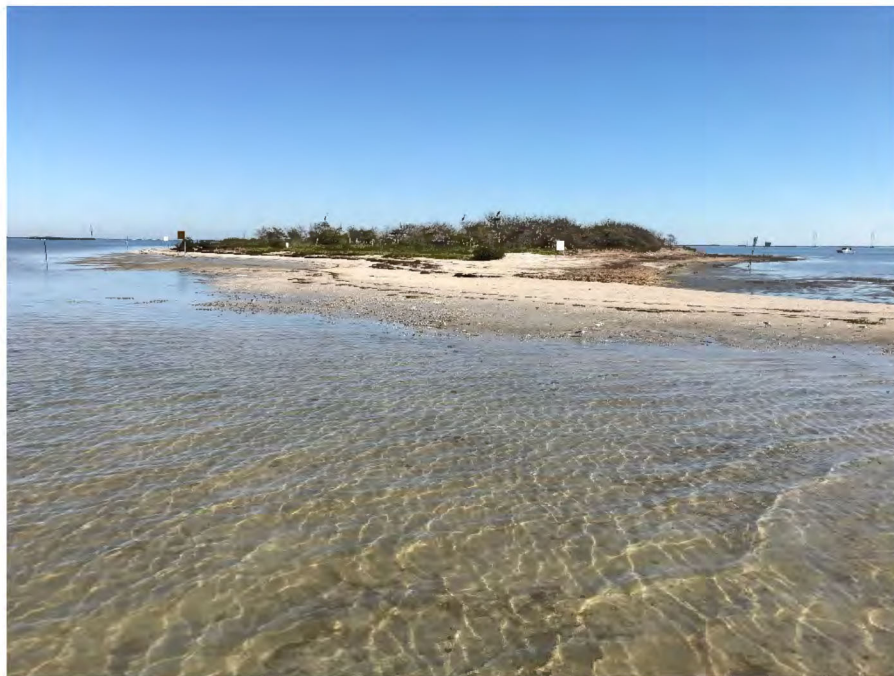
**Photo 1 –**  
Representative photo  
of Tern Rookery  
Island. Photo taken  
near T12 and south of  
the rookery island  
facing north.

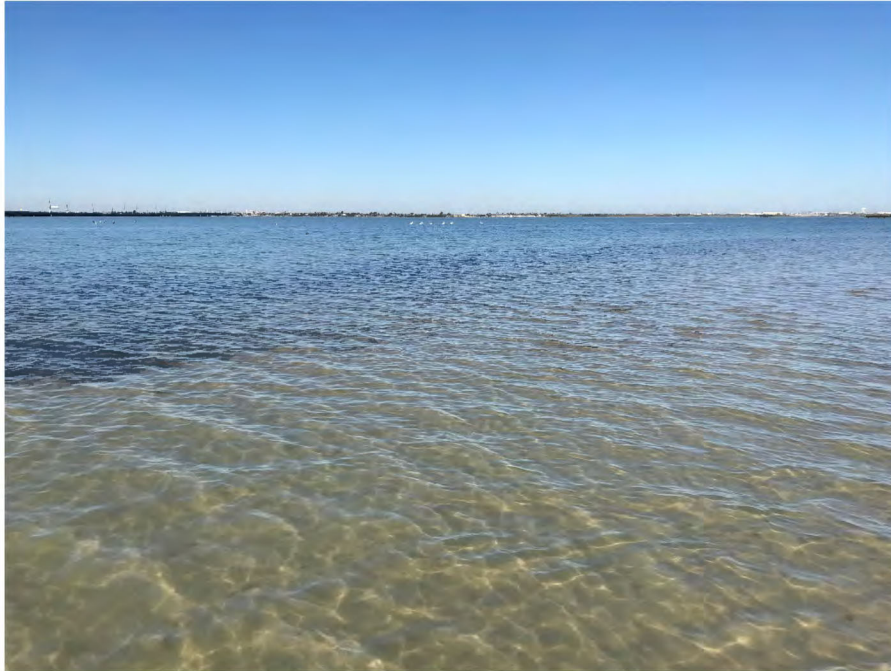
**Photo 3 –**  
Representative photo of bare bottom areas within shallow water (foreground) which transitions into patchy seagrass beds (background) located south of Tern Rookery Island. Photo taken along T11 facing south.

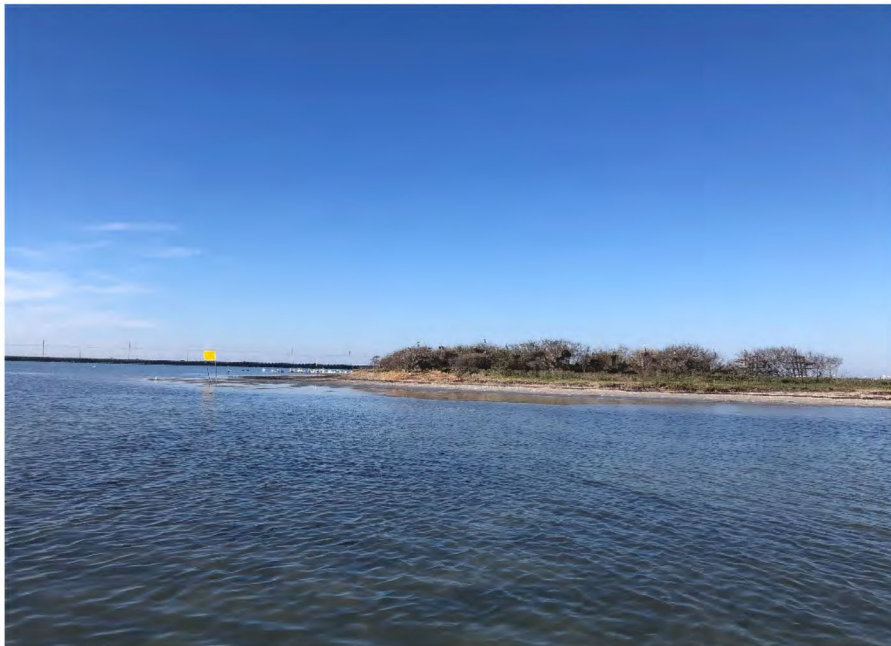
**Photo 4 –** Photo taken within a dense seagrass area along T6 east of Tern Rookery Island. Photo faces southwest.

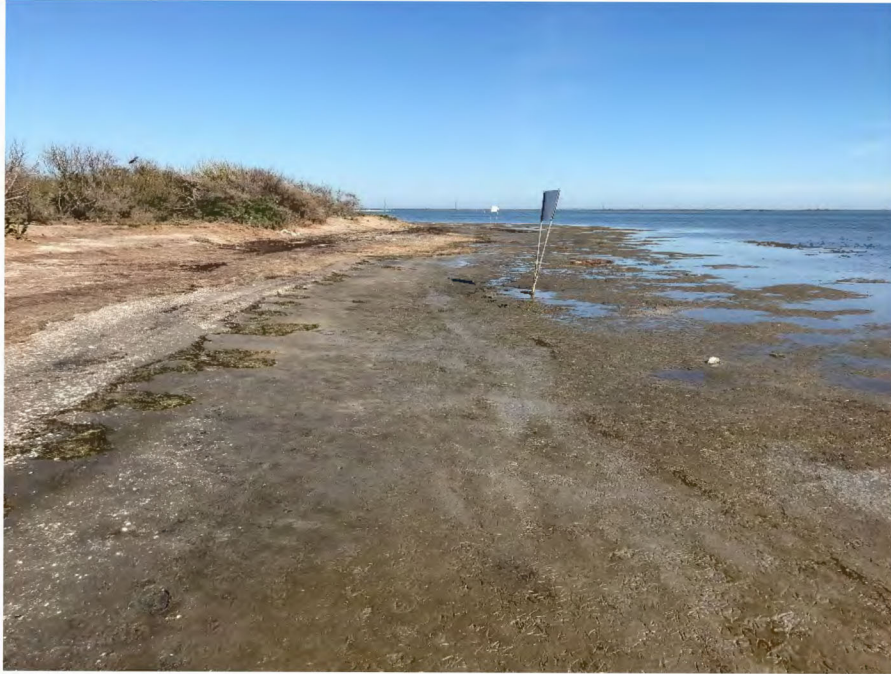
**Photo 5 –**  
Representative photo  
of the shoreline along  
Tern Rookery Island  
near T9 and facing  
northeast.

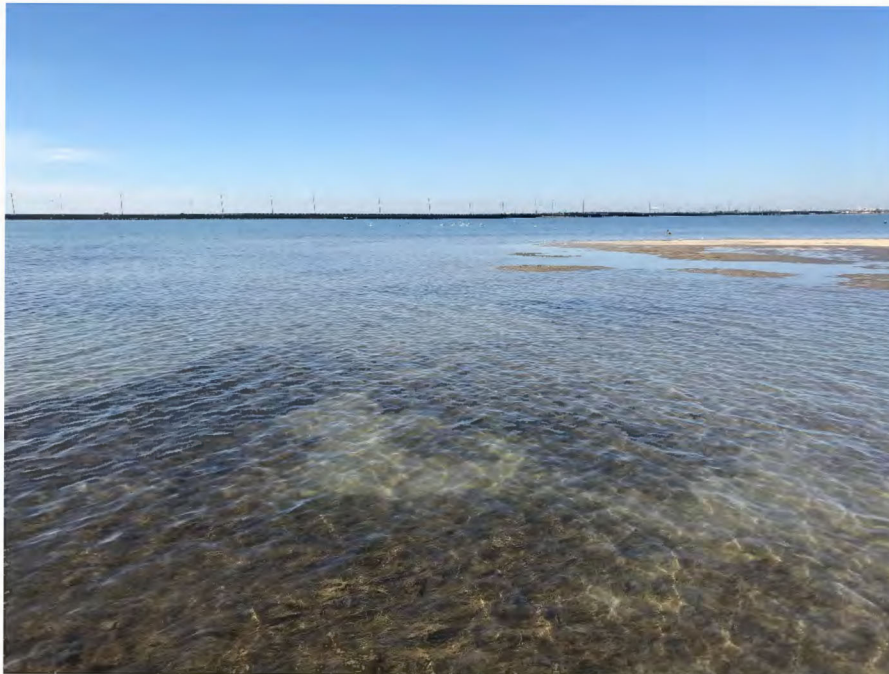
**Photo 6 –**  
Representative photo  
of patchy seagrass  
beds located south of  
Tern Rookery Island  
(right). Photo taken  
along T9 and facing  
west.

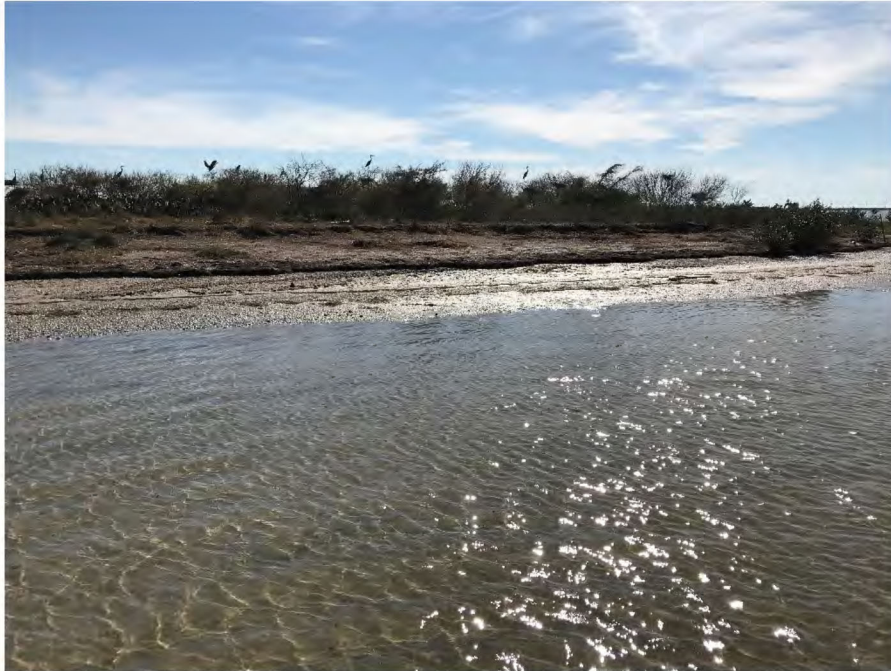
**Photo 7 –**  
Representative photo  
of bare ground  
(foreground) and great  
blue herons (*Ardea  
herodias*) beginning to  
roost on Tern Rookery  
Island (background).  
Photo taken along T15  
west of the Rookery  
Island facing east.

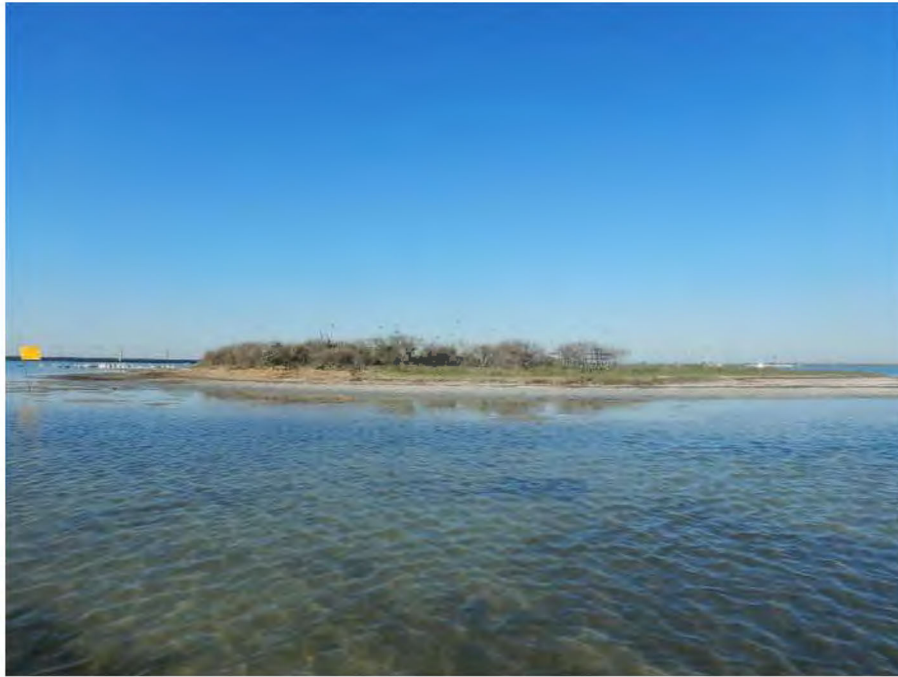
Photo 1: Northeastern side of Tern Rookery Island. Photo taken facing towards Flour Bluff and JFK Memorial Causeway.

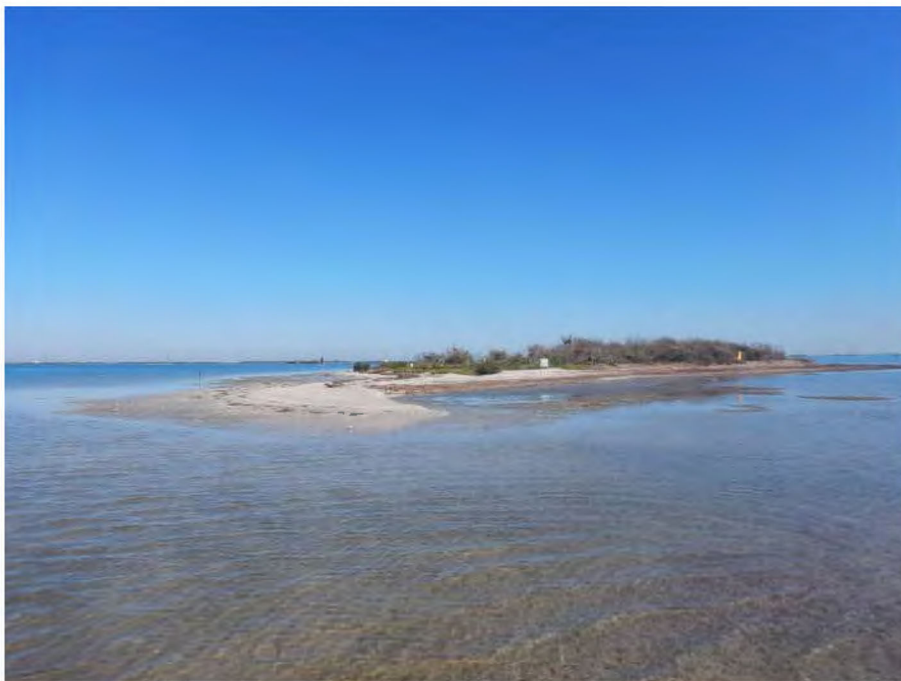
Photo 3: Southern spit of Tern Rookery Island facing north/northwest.  
Sparse seagrass beds visible.

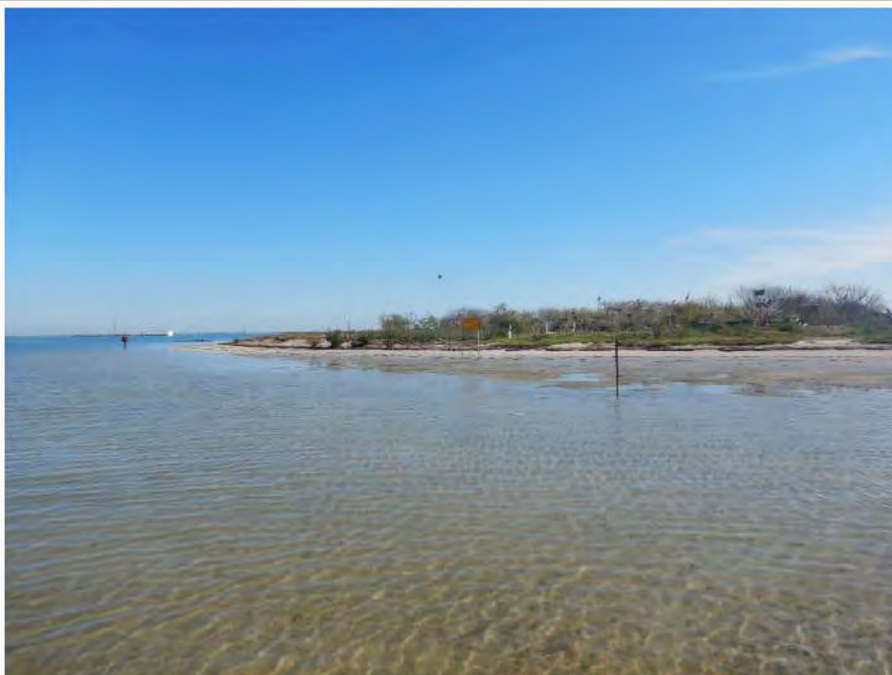
Photo 4: Southwestern side of Tern Rookery Island.  
Photo taken facing northeast.

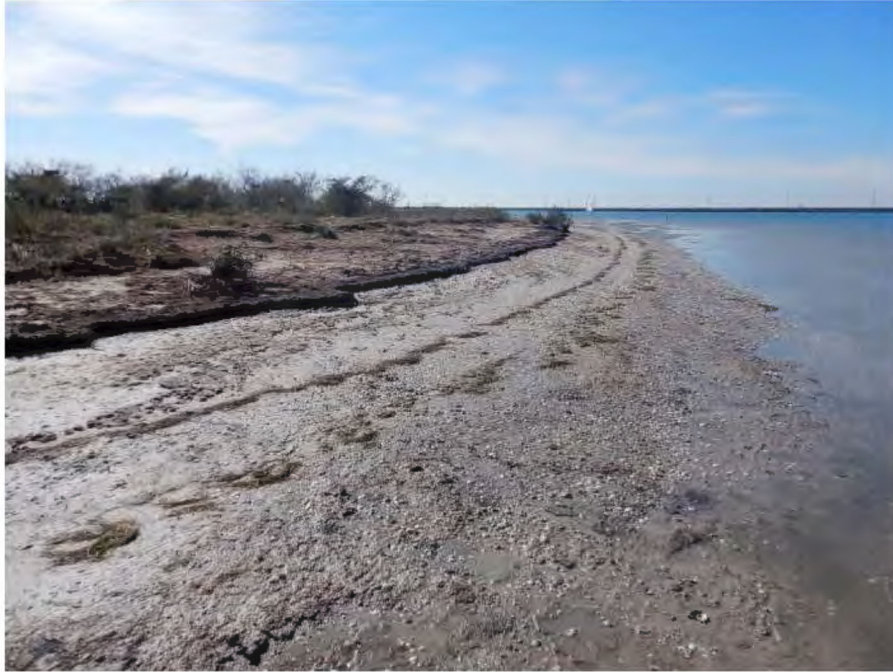
2. Scarp face noticeable along eastern shore of Tern Rookery Island and to a lesser extent on the western side of the island (several layers of wrack lines present) suggesting wave induced erosion and forcing taking place. See Photo 2 (eastern side) and Photo 5 (western side).

Photo 5: Close Up of wrack lines present along western side of Tern Rookery Island. Photo taken facing JFK Memorial Causeway.

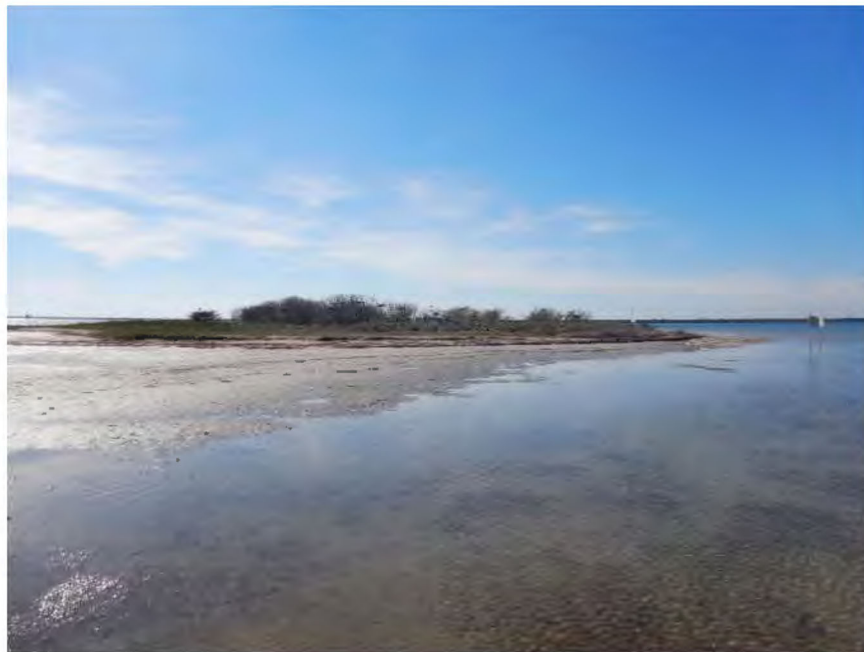
Photo 6: Northern beach of Tern Rookery Island. Photo taken facing southeast towards JFK Memorial Causeway.

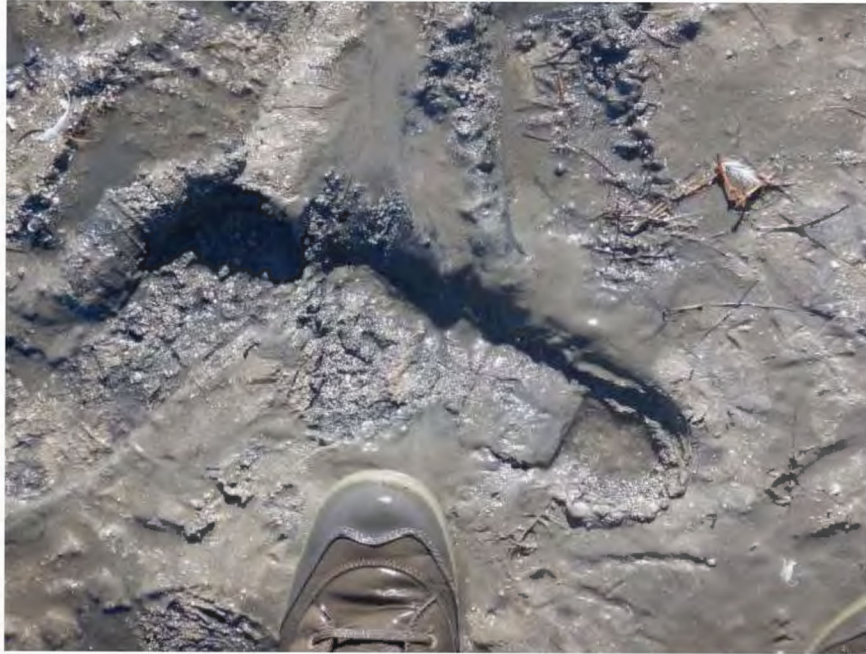
Photo 7: Example of cohesive soils around Tern Rookery Island.

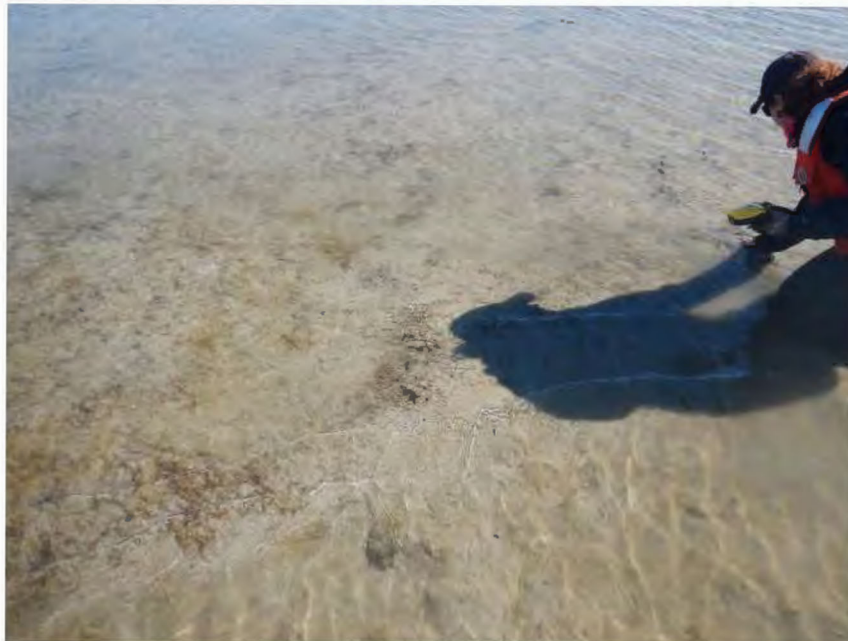
3. Seagrass beds of varying coverage densities surround Tern Rookery Island. Several clear patches are present along the southern and eastern side. Seagrass beds found in sparse outcroppings in shallow depths (1-2 ft) around Tern Rookery Island. See Photo 8.

Photo 8: Example of sparse seagrass coverage found at shallow depths off Tern Rookery Island.

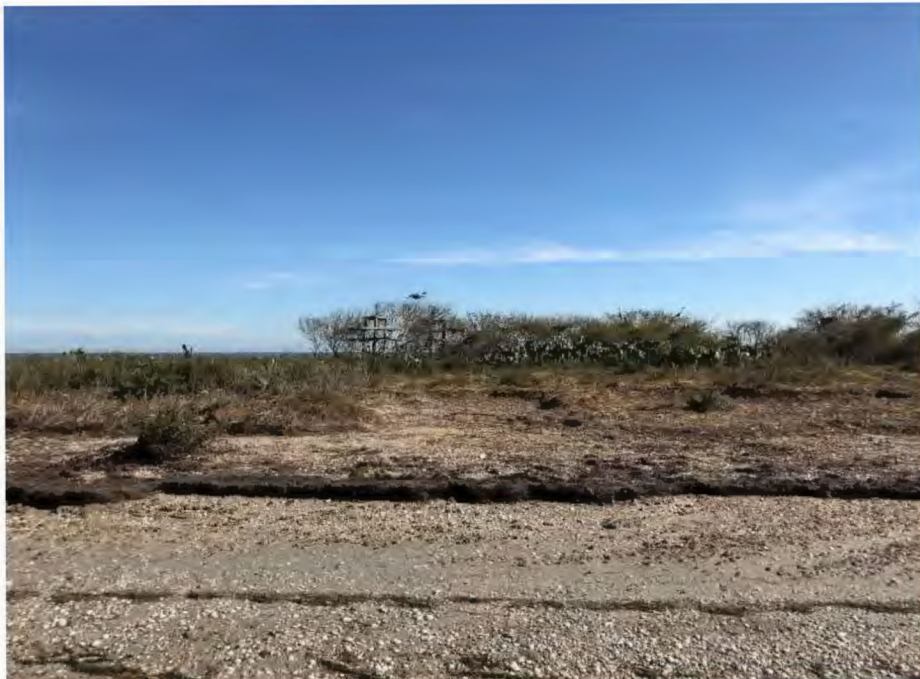
Photo 10: Nesting platforms on Tern Rookery Island.

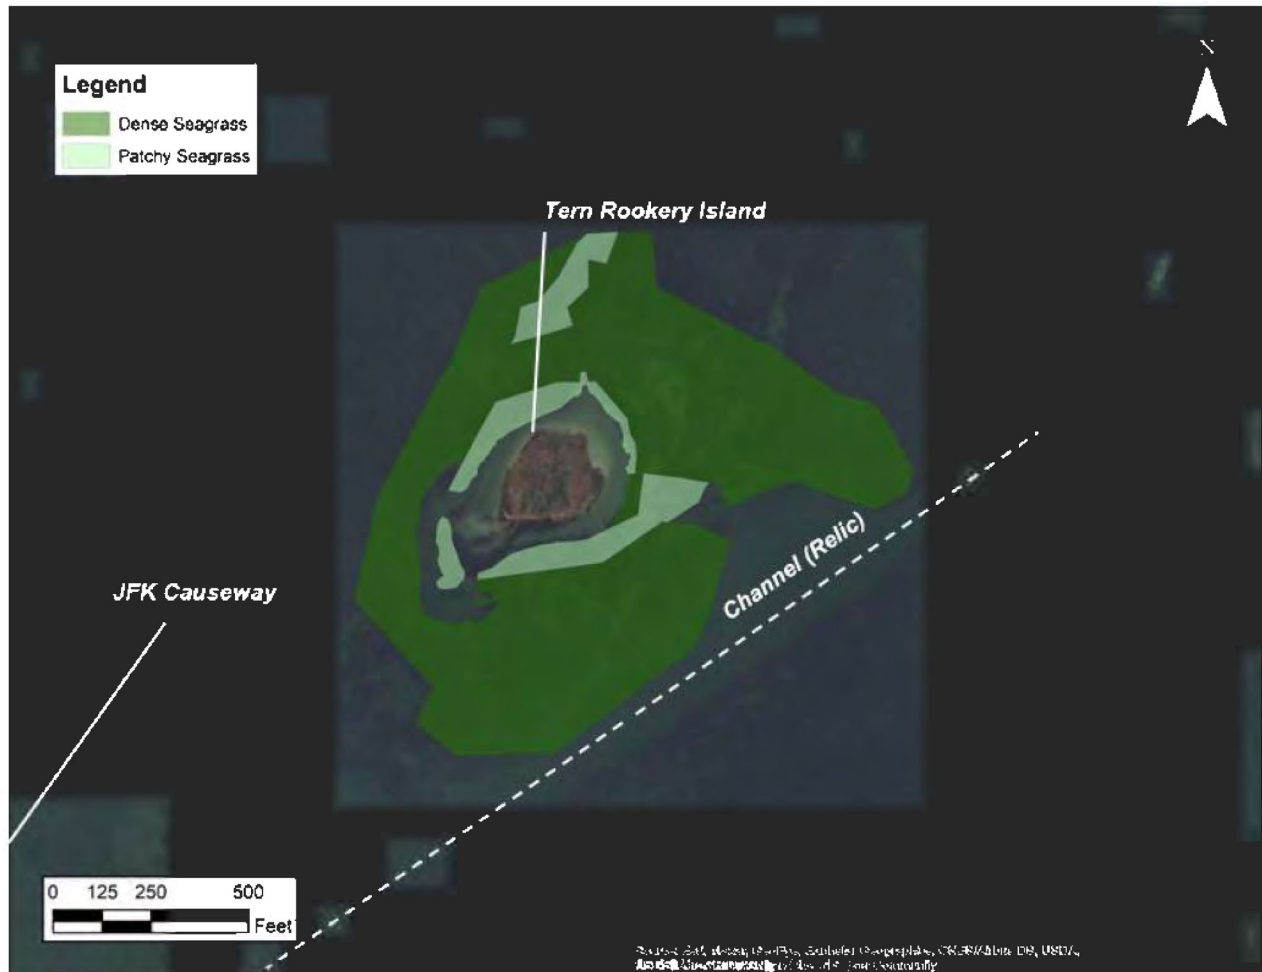
**Figure 3. Habitat assessment summary**

Seagrass was observed along all transects mostly within water depths from approximately 0.0 to 4.0 ft, and up to a depth of 5.0 ft at one location. Seagrass beds covered approximately 20.4 acres of the approximately 26-acre study area. Shoal grass (*Halodule wrightii*) was the most observed seagrass species, followed by patches of manatee grass (*Syringodium filiforme*) and star grass (*Halophila engelmannii*) occurring primarily within the northeastern portions of the study area. Patchy seagrass beds were observed within proximity of the island's northern shoreline, about 10 to 20 feet bayward of the island. Less than 10 percent cover was observed in these patchy areas and consisted of mostly shoal grass with short leaf lengths. Patchy seagrass beds transitioned to denser beds with distance bayward of the island, starting at distances ranging from 40 to 100 feet from the shoreline. Dense seagrass beds covered the majority of the study area. Bare bottom was observed adjacent to the shoreline at water depths less than 1 foot, as well as a few small patches southwest and east of Tern Rookery Island. No seagrass was observed within the relic channel located southeast of the rookery island. See Figure 3 for the approximate limits of seagrass observed. Note that the seagrass assessment documented the existing conditions during the site visit which are not necessarily the same as the conditions shown in the aerial in Figure 3. Some darker areas near the island, particularly southwest of the island, that are not mapped as seagrass were observed to be algae/etc.

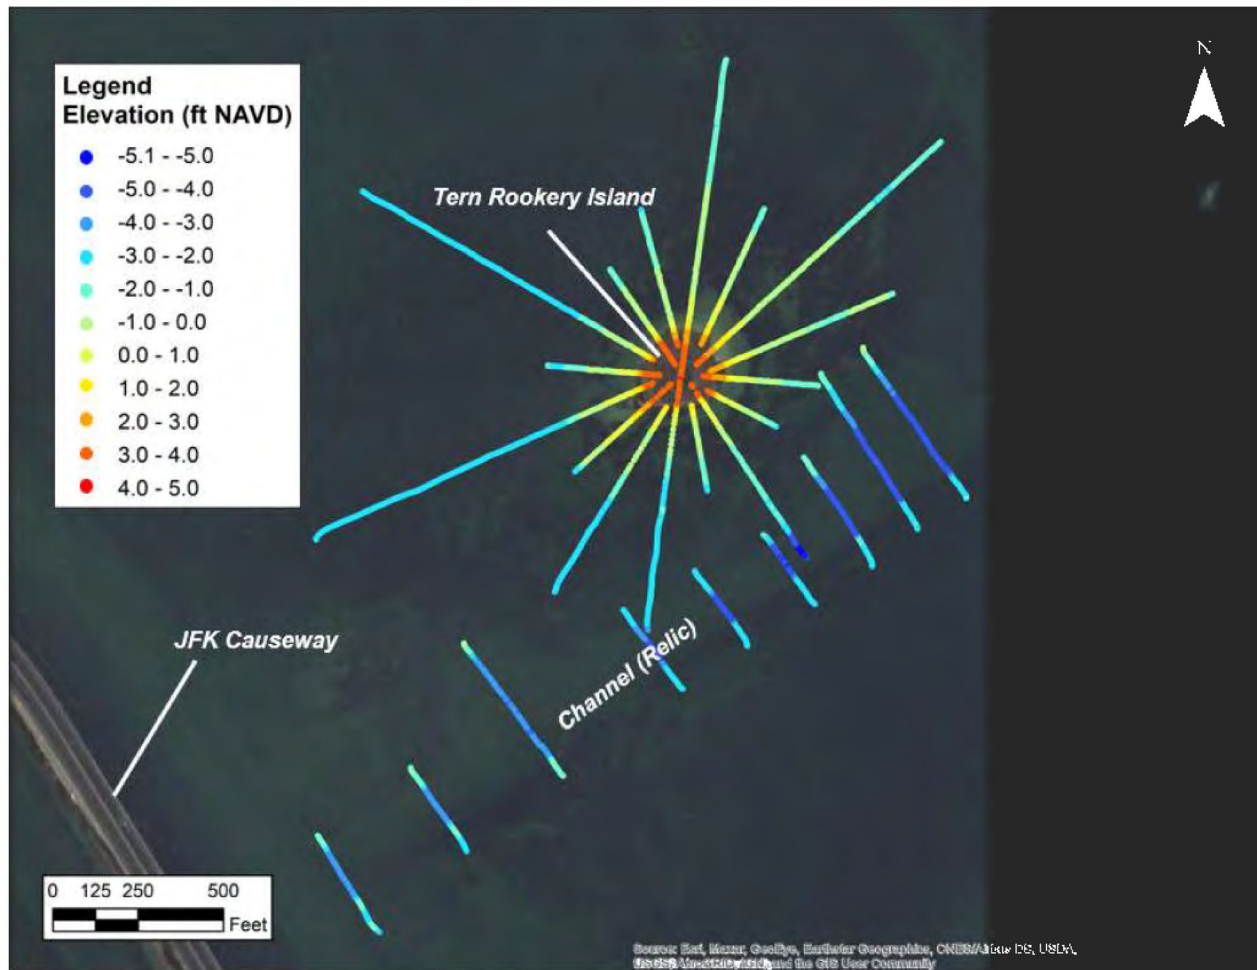
Figure 4. Bathymetric and topographic survey data for project area

+0.7 ft. On the northern side of the island the beach extends out around 70 ft from the vegetation line, whereas the southern facing shorelines are more abrupt and show evidence of scarping and wave action. The highest measured elevation of +4 ft was observed in the center of the island.

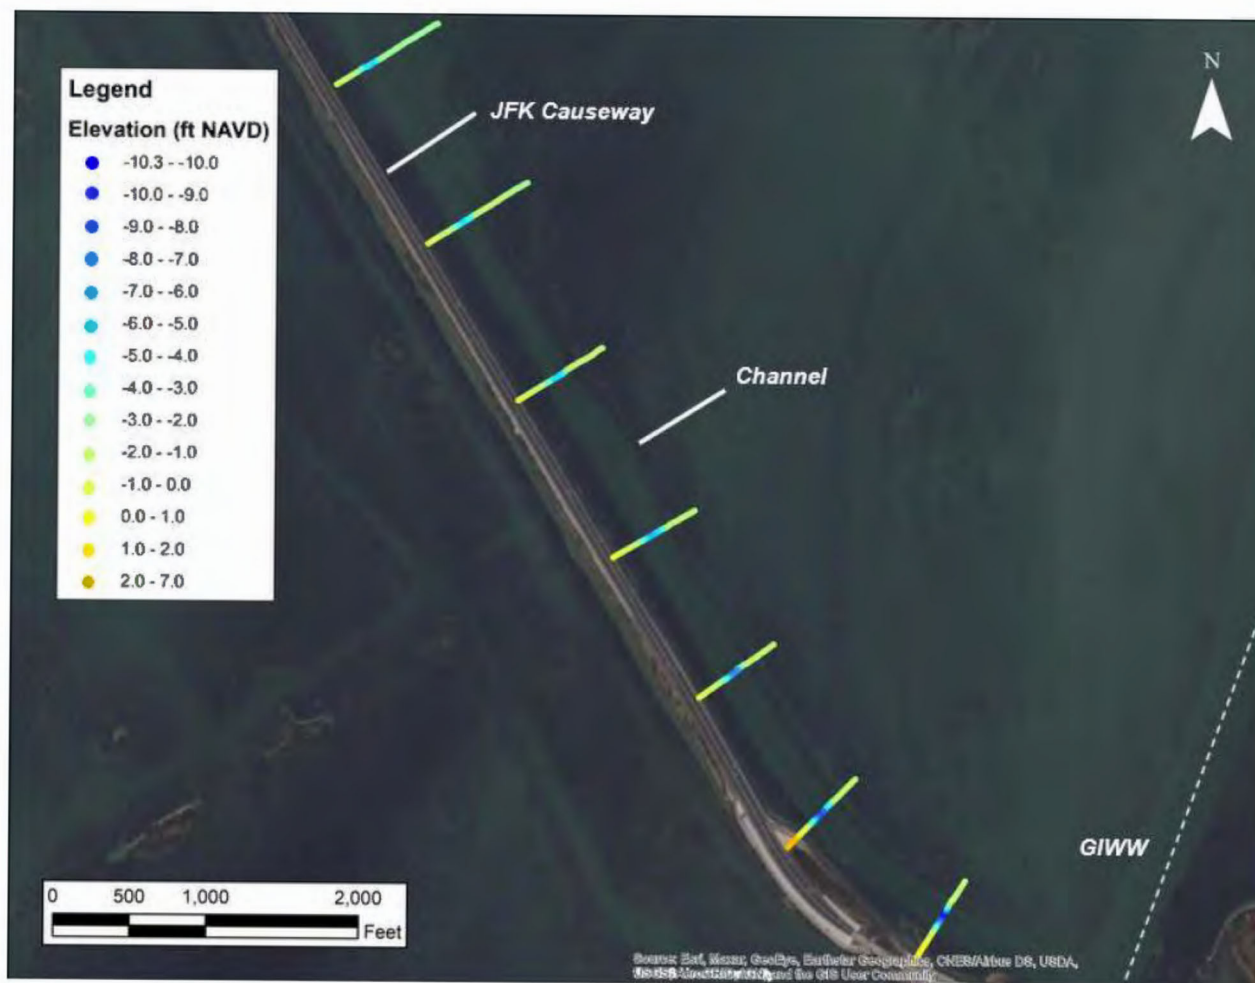
Figure 5. Bathymetric and topographic survey data for access channel

Elevations within the entrance of the relic channel (relative to the JFK causeway) range from -3 ft to -4.0 ft and deepen to centerline elevations of -4.5 ft to -5.0 ft closer to the island. In the channel adjacent to the causeway, deeper elevations are shown in transects within closer proximity to the GIWW (Gulf Intracoastal Waterway), reporting center depths of -10.0 ft that become shallower to around -6.0 ft in transects approaching the relic channel towards Tern Rookery Island (Figure 5).

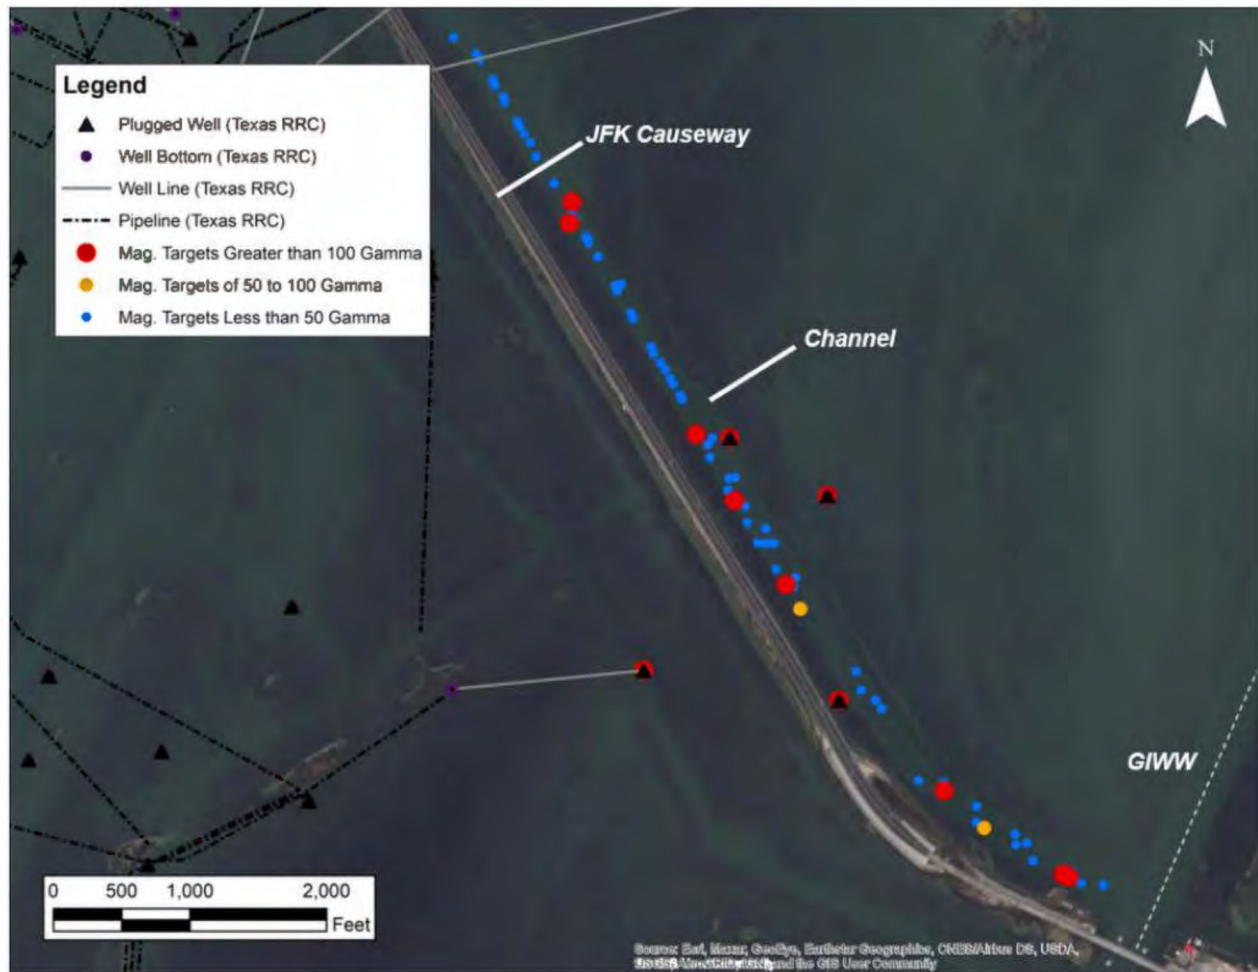
Figure 6. Hazard survey results for access channel

Magnetometer survey results are shown in Figure 6 and Figure 7. These figures indicate several anomalies around the island. Included in the anomalies identified by TBS are 7 gas wells and 3 pipelines. A map of the existing pipelines was obtained from the Railroad Commission of Texas (RRC) online mapping system to help identify the anomalies. The RRC database indicates that the wells are plugged, and the pipelines are abandoned. It should be noted that the intensity of the magnetometer measurement value (expressed in the unit “gamma”) decreases exponentially with distance from the target, so individual readings do not necessarily reflect size of the object. Additional probing is recommended during later project phases to provide more accurate horizontal and vertical locations of oil and gas infrastructure at the project site.
