# Performance Monitoring at the Galveston Island State Park Marsh Restoration and Protection (Phase I & Phase II) Project (CEPRA 1601)

Post Construction  
Monitoring Report: Year 5

8/31/2023

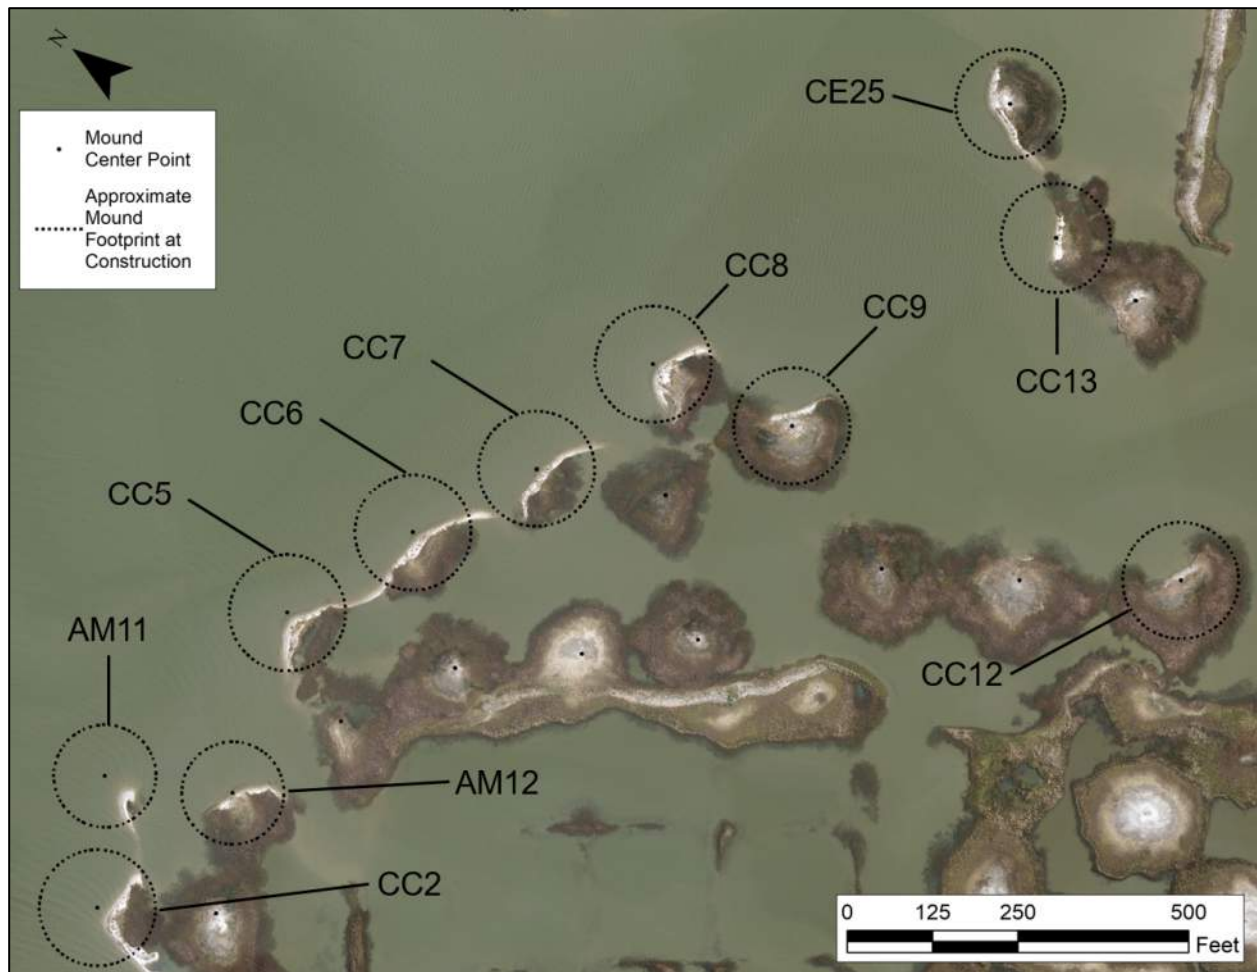
**Figure 11. Reshaping at perimeter mounds in Area A, Area B, and Area C.**

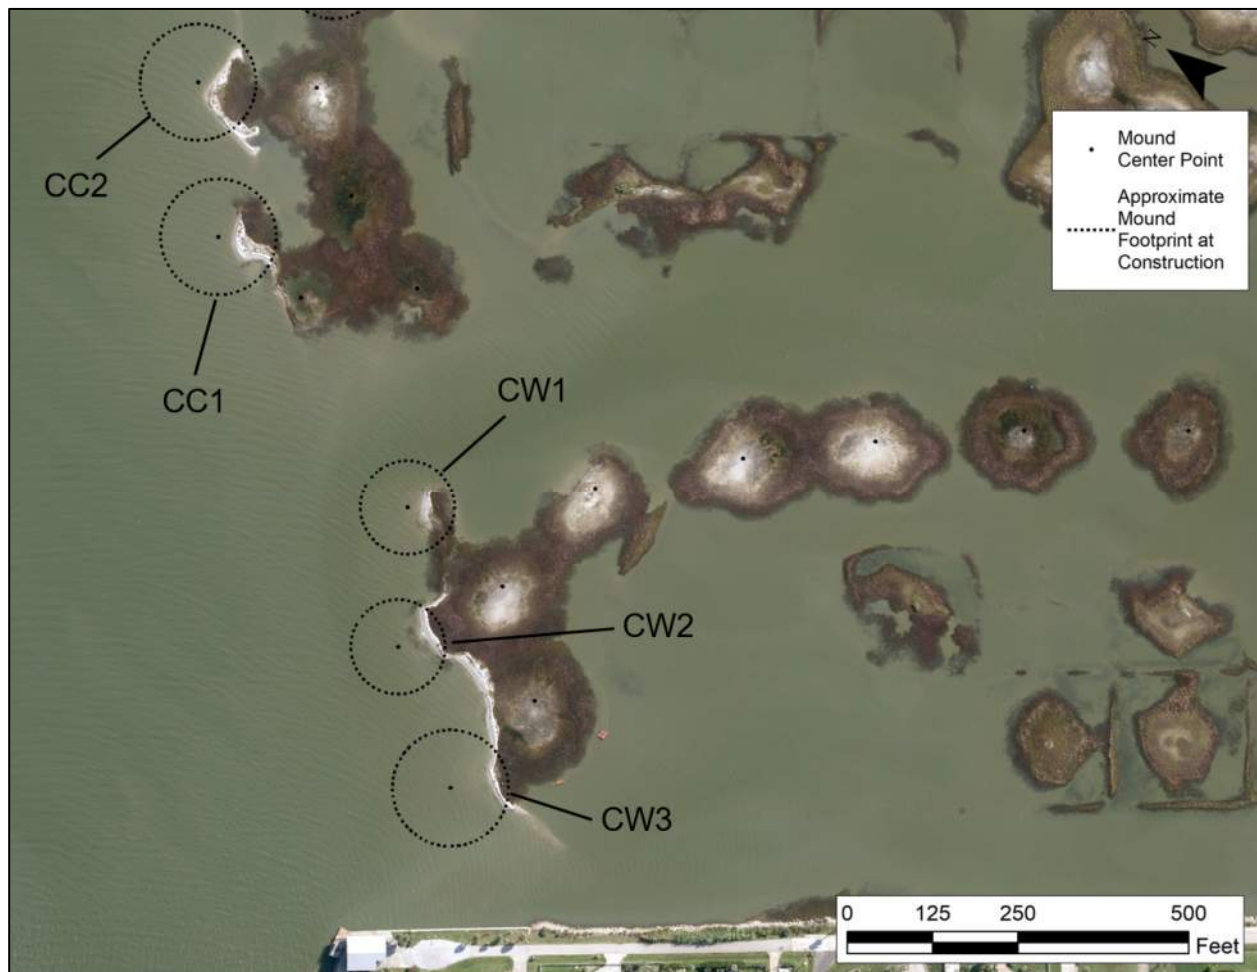
**Figure 12. Reshaping at perimeter mounds in Area C and Area D.**

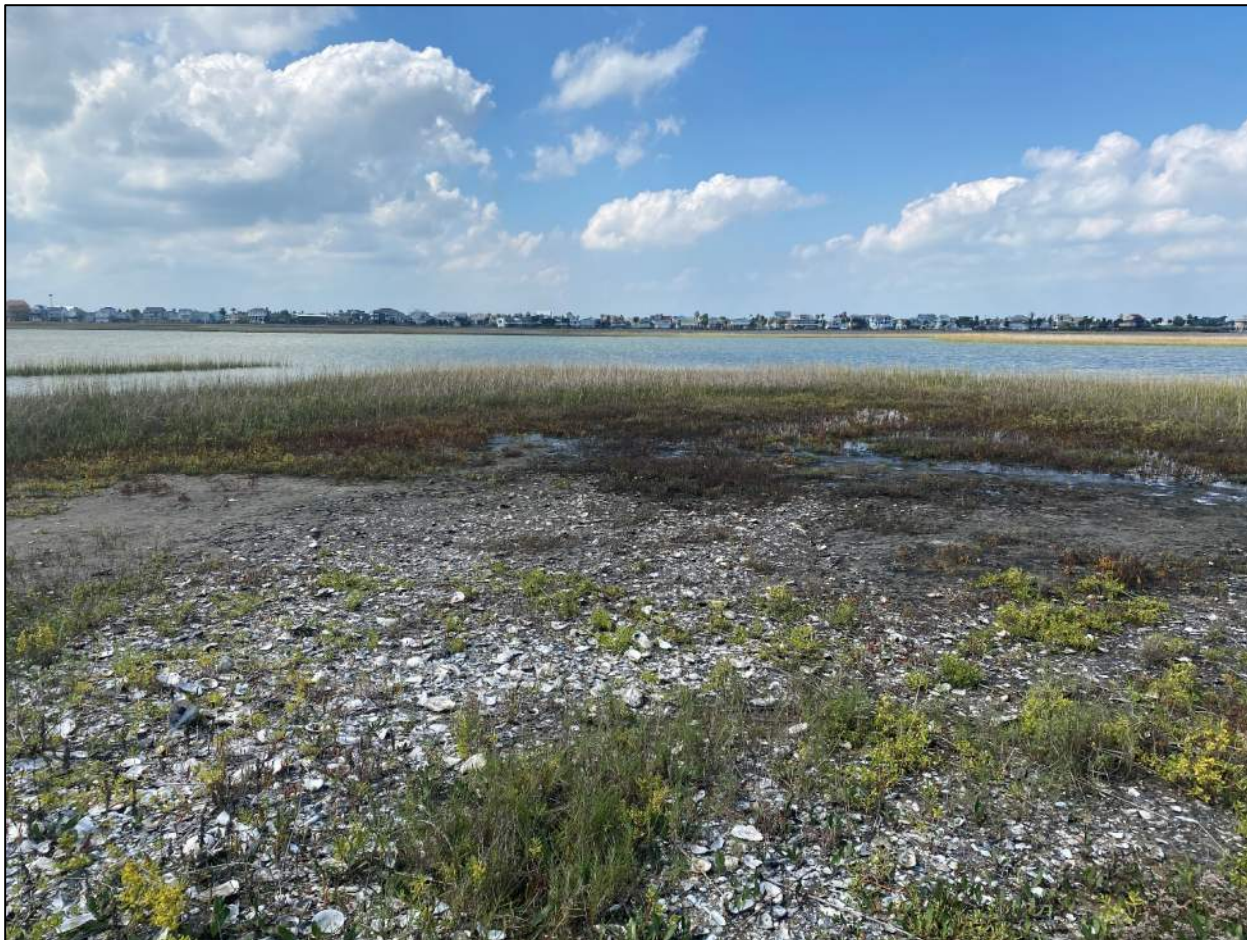
The sediment composition of each mound was observed to verify that the mounds are predominantly composed of sand, shell hash, and/or shell as opposed to silt and clay. All 81 mounds met this criterion and consisted of predominately firm non-cohesive sediments. The amount of shell hash and/or shell varied among the mounds. In general, more shell was visible in bayward perimeter mounds (see Figure 14), likely due to natural sorting of sediments caused by the greater exposure to wave action. Overall, the mounds in Area A typically contained more shell than mounds in other areas (for example, see Figure 15), likely due to variations in the borrow area.

**Figure 15. Typical mound composition of sand, shell, and shell hash on Mound CC15 in Area A. Photo facing west.**

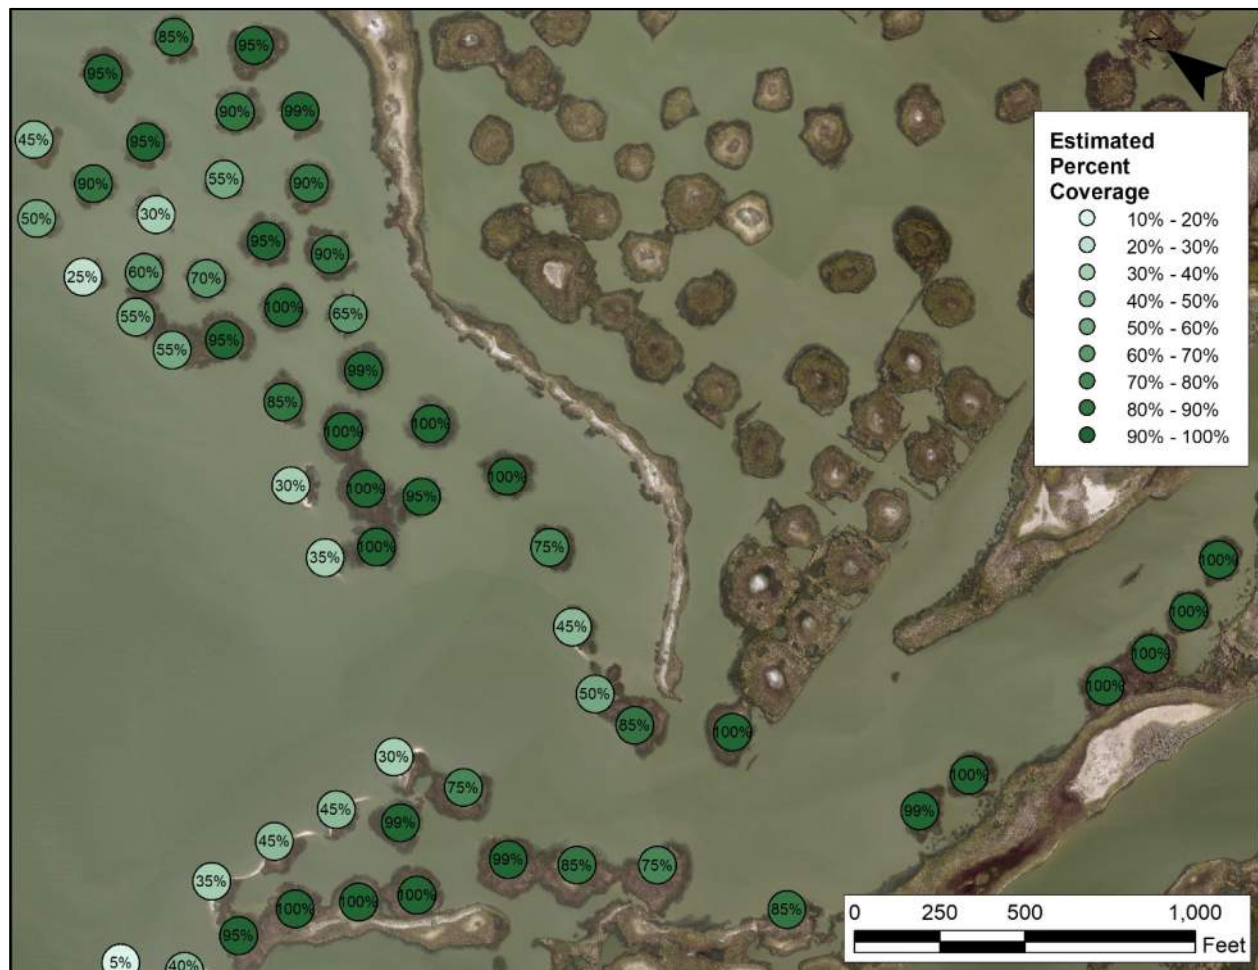
Percent aerial coverage was estimated only for the planted intertidal zone (approximately +0.8 ft NAVD to +1.6 ft NAVD). Of the 81 mounds, 55 mounds (68%) met the performance criteria of 70% aerial coverage. The overall average estimated coverage was 76% and the median was 90%, a decrease of 1% and no change from Year 4, respectively. Between the Year 4 and Year 5 site visit, 31% of mounds increased in vegetative coverage, 41% remained the same, and 28% decreased in coverage. Of mounds that decreased in coverage, 28% still met the 70% coverage threshold. Percent coverage increased significantly between the Year 1 and Year 2 site visits; no mounds met the coverage criteria in Year 1 and 52 met the criteria in Year 2. Increase in coverage appears to have leveled off somewhat since Year 2, although natural propagation has continued to increase and is expected to continue as the project matures and will likely increase the percent of vegetation coverage and the vegetation density on each mound. As of the Year 5 monitoring effort, natural seeding and propagation by rhizomes has increased the vegetation coverage on nearly all mounds since planting took place. Although the overall estimated coverage in the planted area remained constant, vegetation density appeared to have increased between Year 4 and Year 5. Additionally, propagation increased vegetation coverage outside of areas planted for the project including coalescing areas between mounds and areas that have been reshaped by waves and currents. Figure 16 and Figure 17 show estimated vegetation coverage in the intertidal region and Figure 18 shows a yearly aerial comparison of coverage between Year 0 and Year 5 in Area A. Refer to Table 1 for a summary of vegetation coverage.

**Figure 16. Estimated percent vegetation coverage in intertidal region for Area A, Area F, and Area H.**

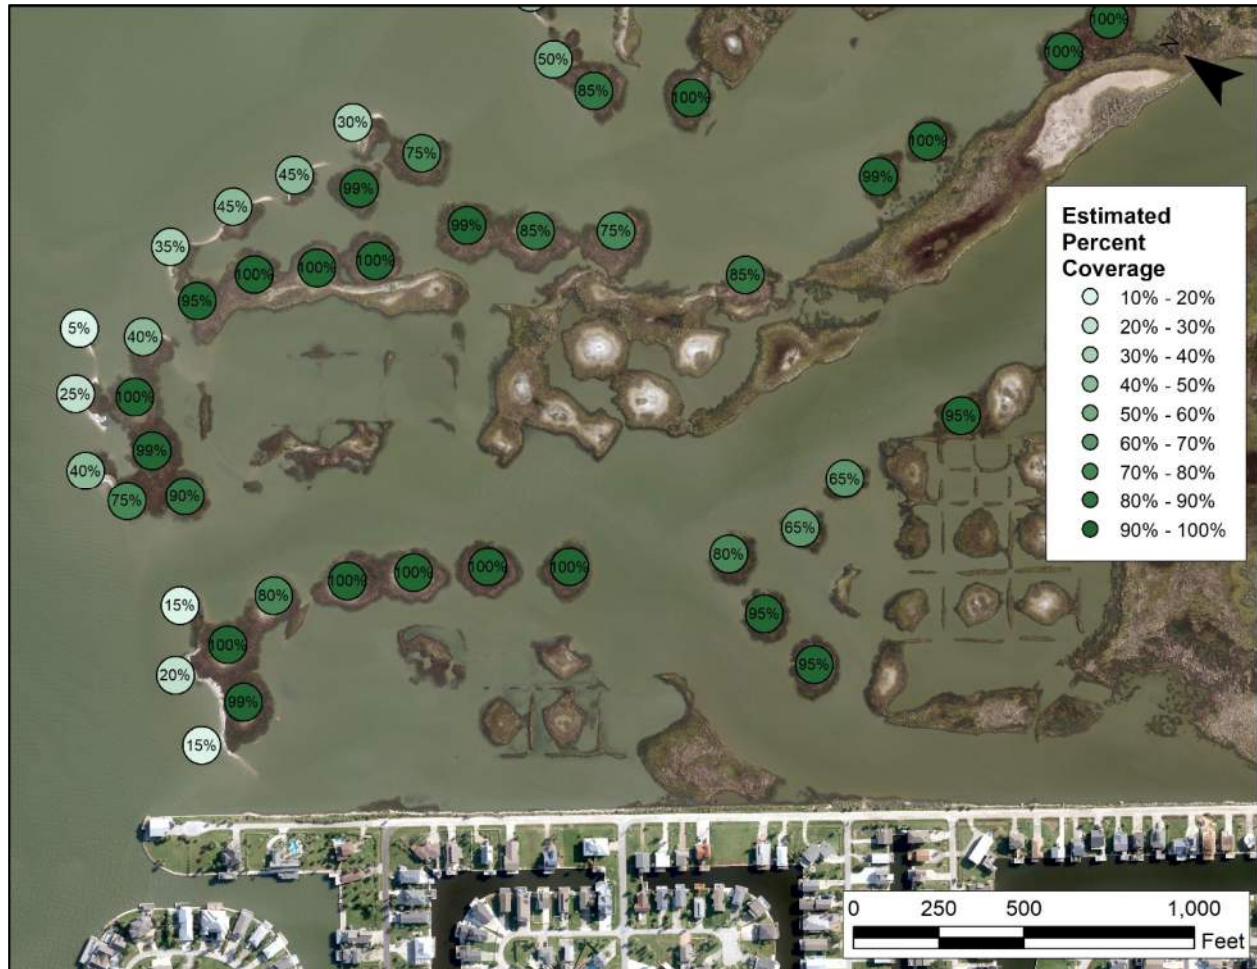
**Figure 17. Estimated percent vegetation coverage in intertidal region for Area B, Area C, Area D, Area E, and Area G.**

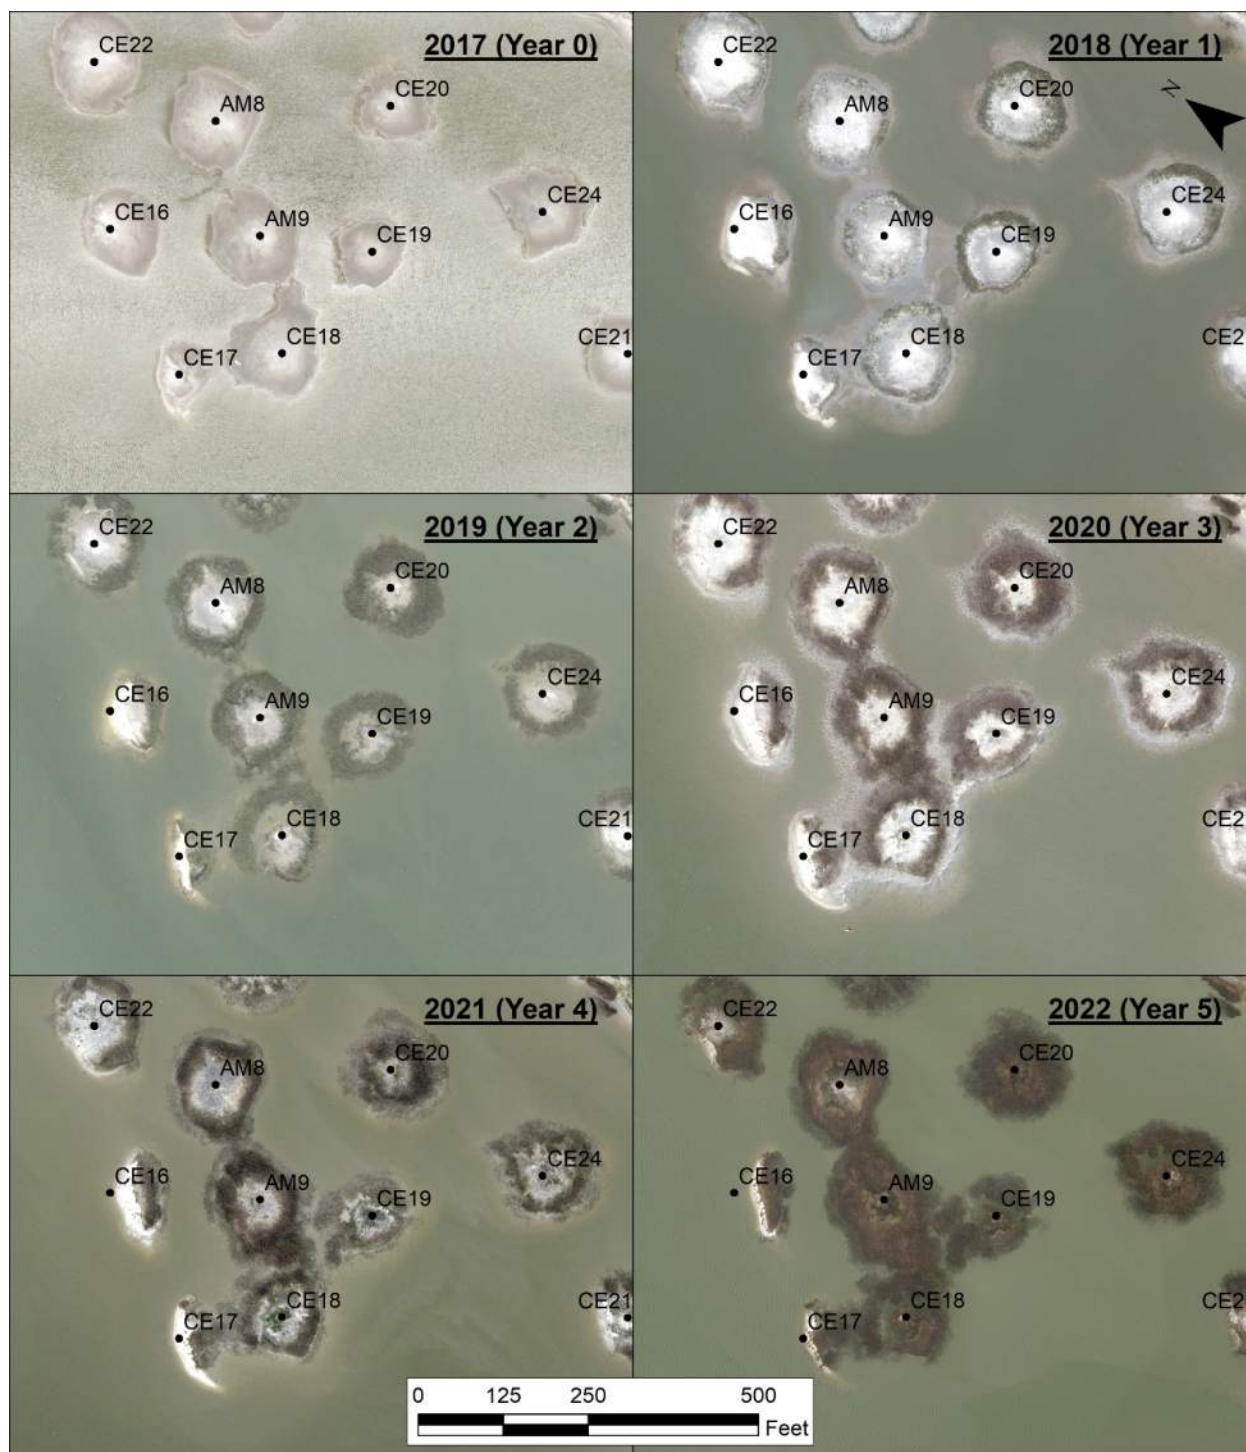
**Figure 18. Yearly aerial comparison of vegetation coverage in Area A between Year 0 and Year 5.**
