# DRAFT Post-Construction Monitoring Report: Year 4

Galveston Island State Park Marsh Restoration  
and Protection Phase III

CEPRA 1637

HDR Engineering, Inc.  
TBPELS Firm  
Registration No. F-754

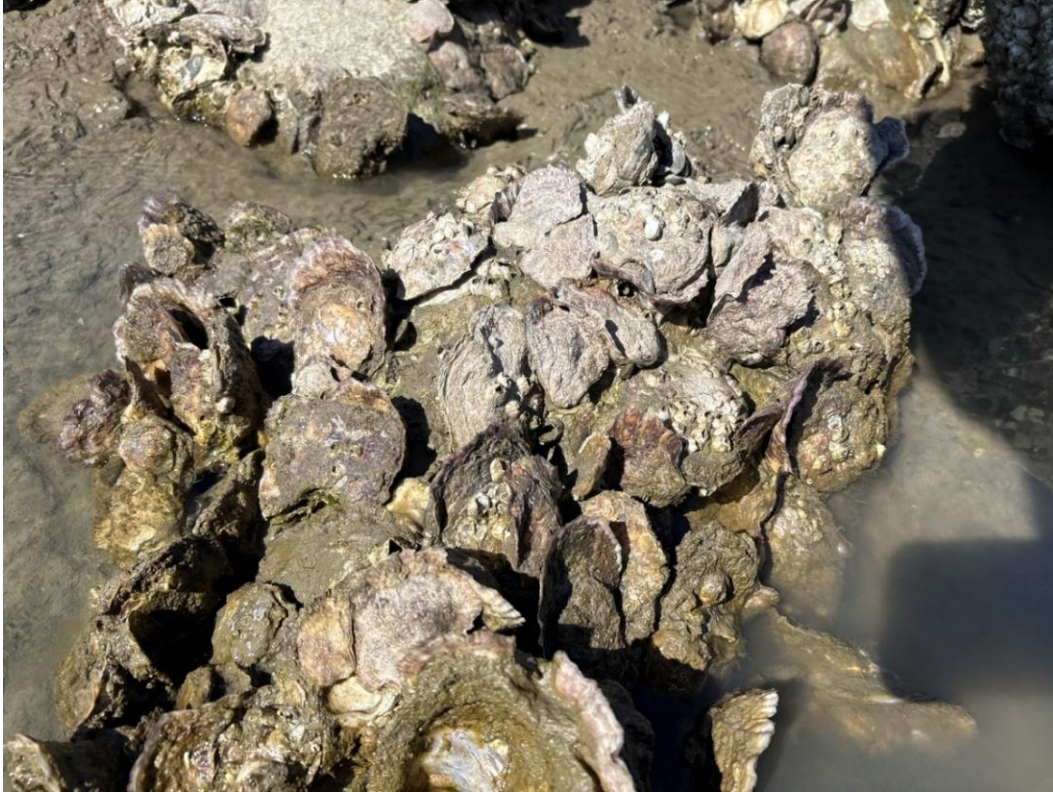
Figure 14. Oysters and barnacles on Butterowe Bayou breakwater.

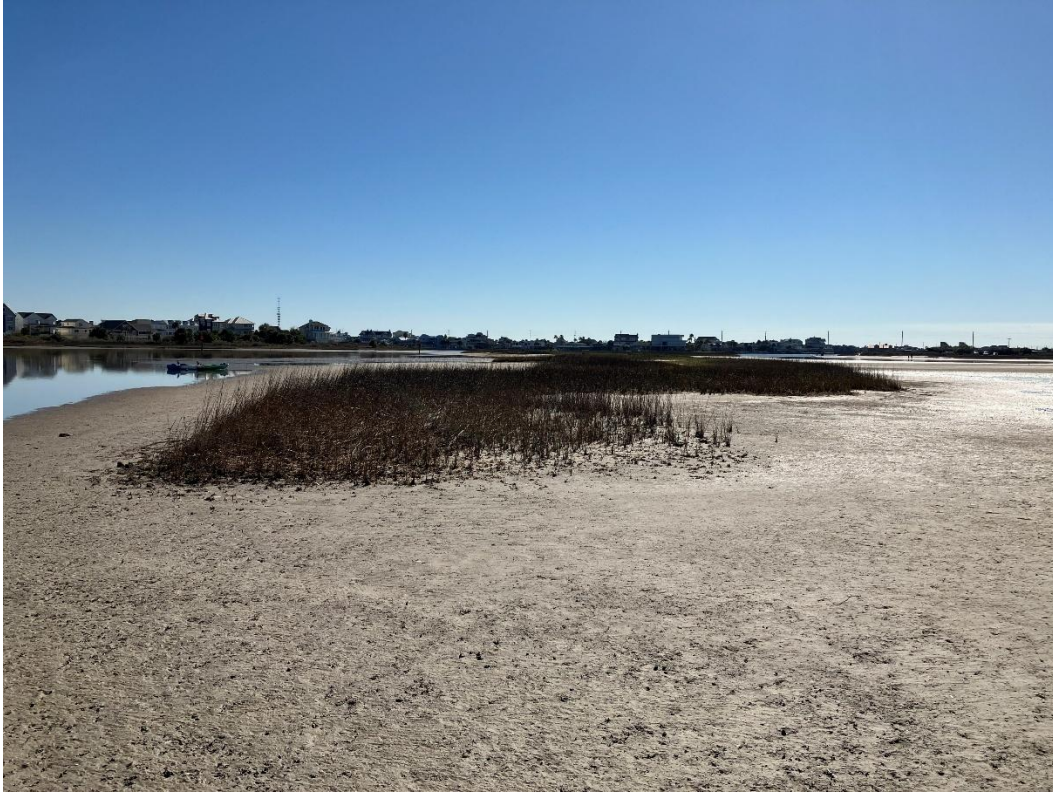
Figure 20. Previously submerged marsh edge at Area I.

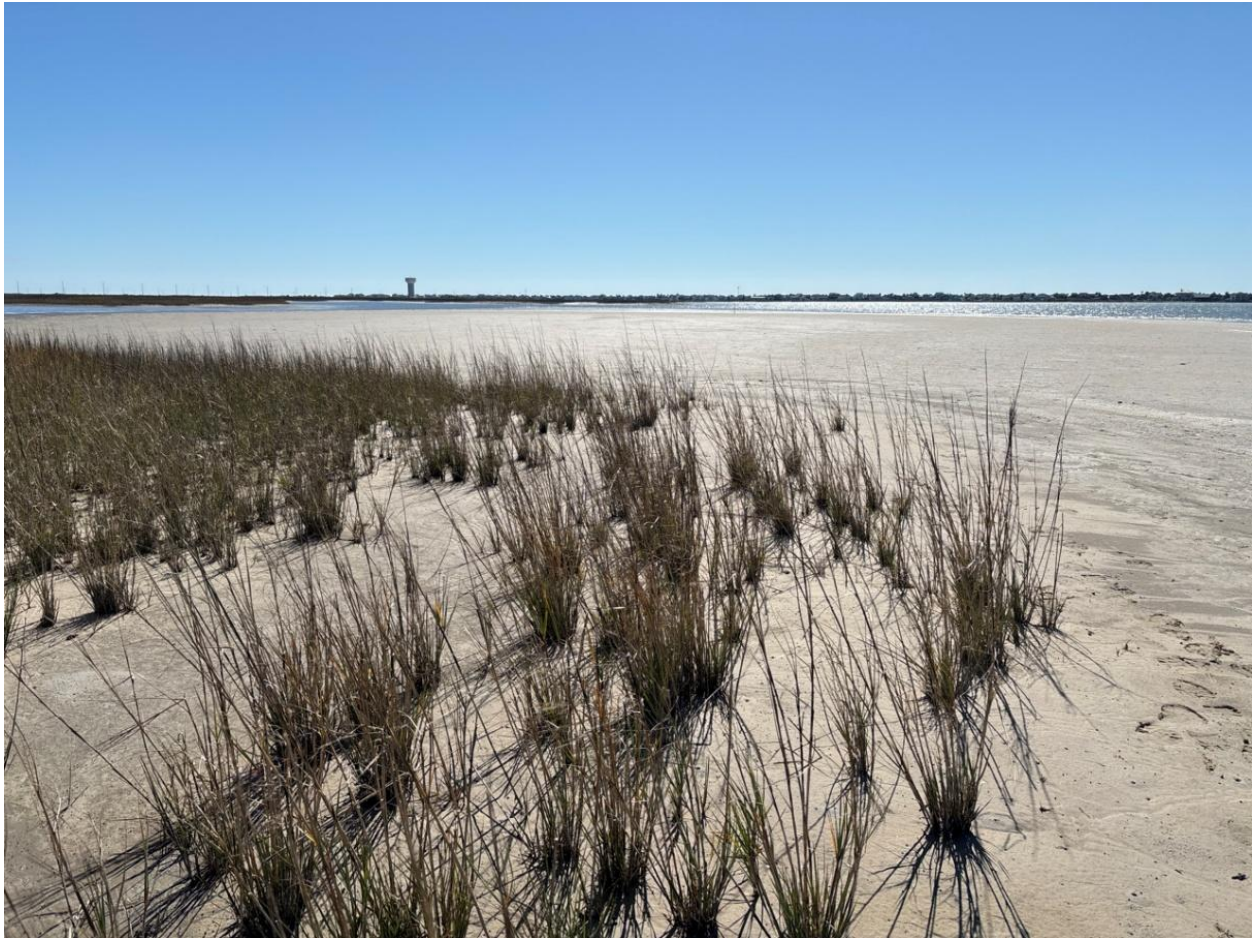
**Figure 25. Sand/Mud flat northeast of Area A.**

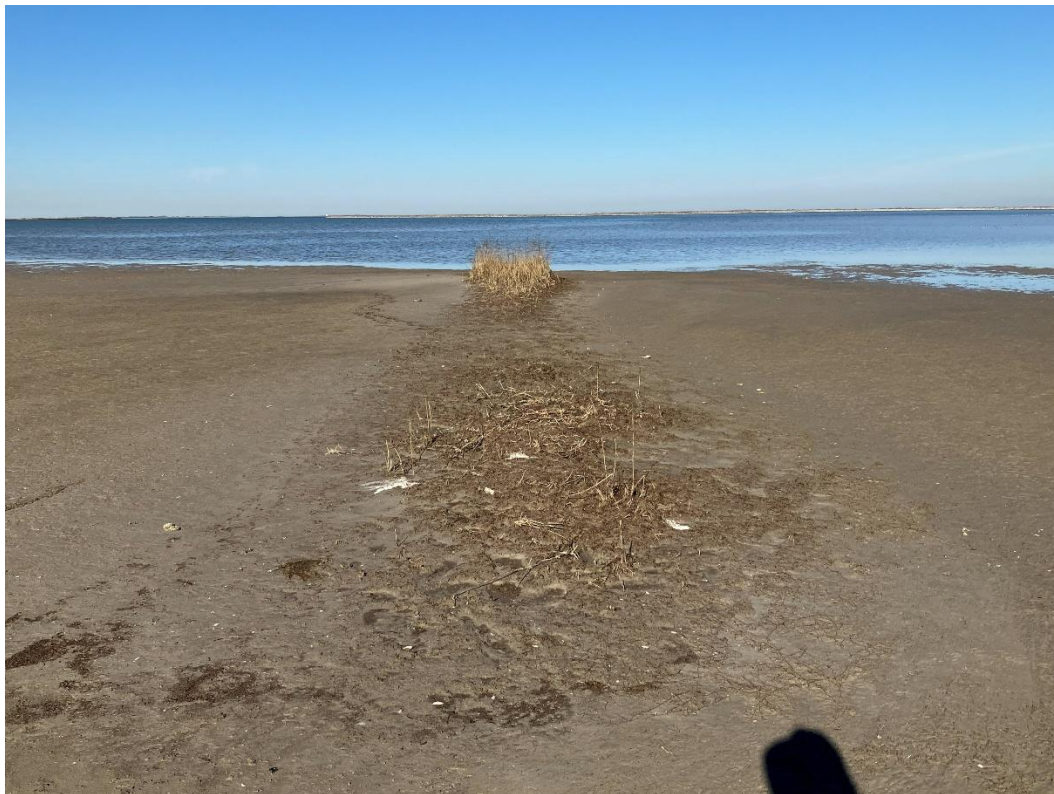
Figure 44. Area L looking north.

During the Year 4 Monitoring, Area L experienced an average of -2.5 feet of change in marsh edge position. The islet was separated into an eastern and western segment due to the loss of vegetation within the center of the islet (see Figure 44). Due to the damaged vegetation and the elevation relative to the surrounding land, the eastern segment of Area L is likely submerged during high tide. This segment experienced up to -5.0 feet of marsh edge recession from its Year 3 position. The western segment is still covered by some partially submerged low marsh vegetation. The shoreline along this segment are scarped and experienced up to -5.0 feet of recession from its Year 3 marsh edge position. The most significant recession occurred at its northwest tip where the marsh edges receded -10.5 feet.
