# FINAL REPORT

## Texas High School Coastal Monitoring Program: 2021-2022

**Bureau of Economic Geology**

August 2022

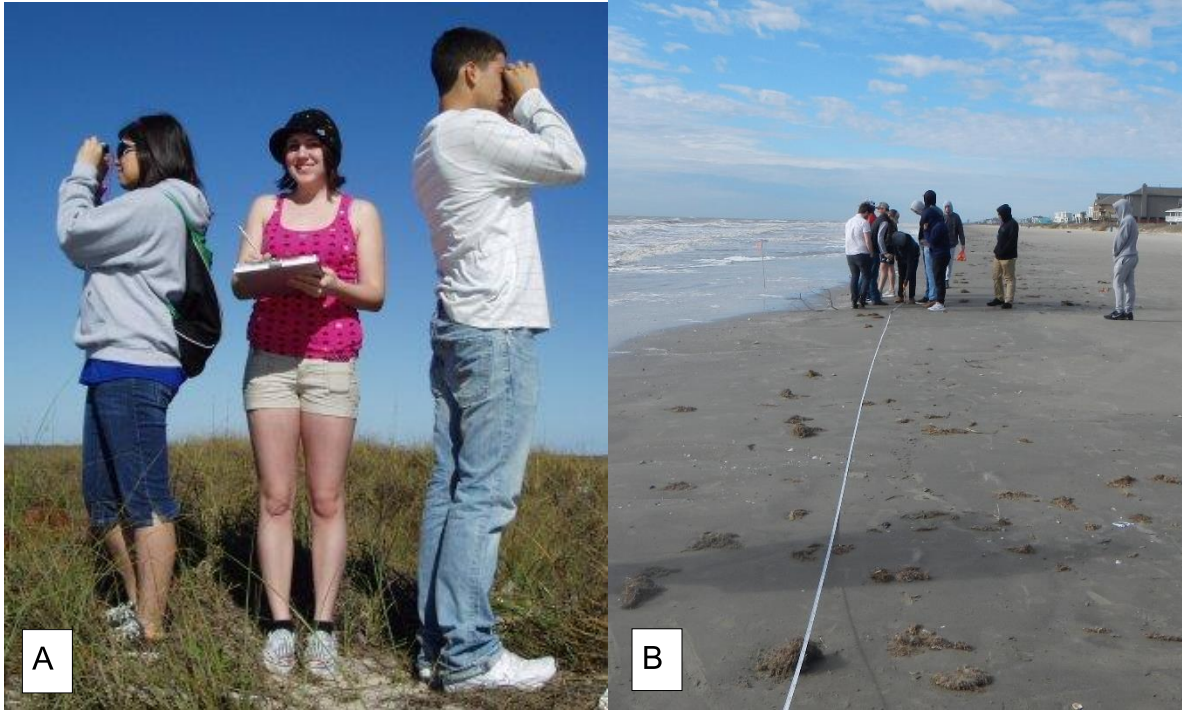
**Figure 4.** Students (A) using a sighting compass to measure dune orientation and (B) measuring how far along the shoreline the float (an orange) drifted to determine longshore current.

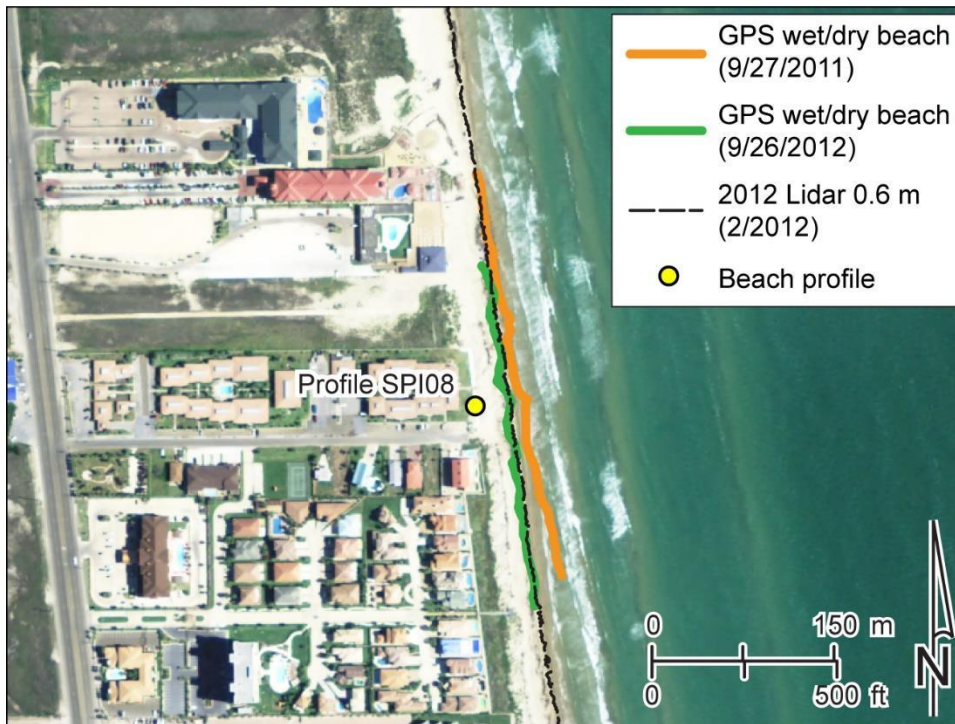
**Figure 13.** Shoreline position comparison at South Padre Island site SPI08. Shorelines include the wet-beach/dry-beach boundary mapped on September 27, 2011, and September 26, 2012, by THSCMP students using GPS and the shoreline proxy extracted from airborne lidar data acquired in February 2012. Shorelines are superimposed on NAIP imagery acquired on April 23, 2012. From Paine and other (2014).

shorelines collected by THSCMP students were used to confirm the elevation of the 2012 shoreline position proxy that was used for shoreline change calculations. For example, on South Padre Island (**Fig. 13**; Paine and others, 2014), there is positional agreement between the 2012 lidar-extracted shoreline; the wet-beach/dry-beach boundary as interpreted using National Agriculture Imagery Program (NAIP) aerial imagery acquired on April 23, 2012; and the wet-beach/dry-beach boundary surveyed via GPS by THSCMP students on September 26, 2012. The 2016 shoreline was determined from 2016 NAIP aerial imagery and a lidar survey conducted by the U.S. Army Corps of Engineers (USACE) between September 9 and October 10, 2016, using the CZMIL airborne lidar system (USACE, 2017). A shoreline positional check, which addressed the relative position of the shoreline proxy and the wet-beach/dry-beach boundary, was accomplished by superimposing the lidar-derived shoreline proxy and GPS-based, wet-beach/dry-beach boundary data acquired in fall 2016 by the THSCMP on georeferenced 2016 NAIP imagery (Paine and Caudle, 2018).

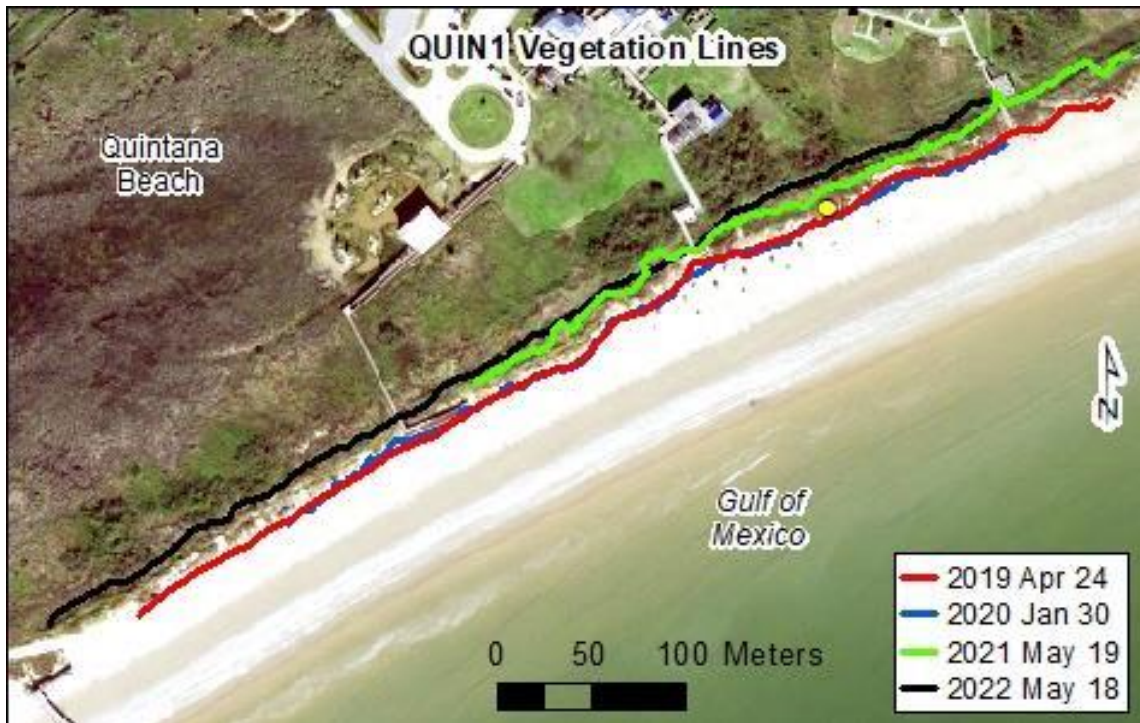
**Figure 22.** GPS mapping by Brazosport HS students of (A) shoreline positions at SURF2 and (B) vegetation line positions at QUIN1 from April 2019 through May 2022.

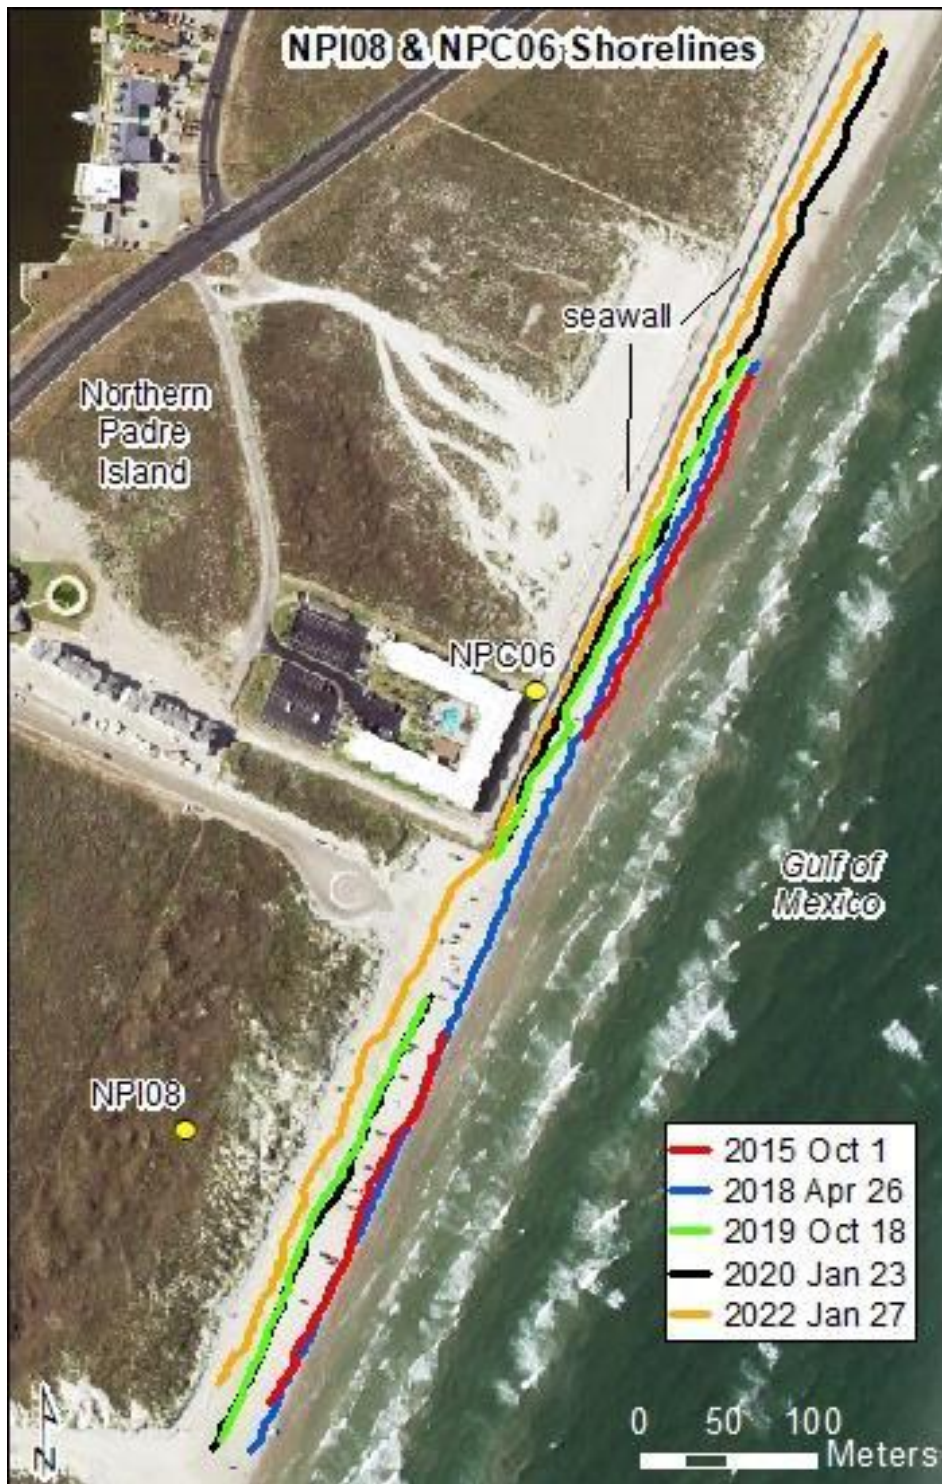
**Figure 31.** Shoreline position change between 2015 and 2022 along southern end of North Padre Island seawall and adjacent beach.

The site NPC06, near the southern end of the North Padre Island seawall (**Fig. 10**), was added in 2015 to track the effects of nourishment projects and maintenance activities on the beach in front of the seawall and the adjacent natural area (NPI08). The beach in front of the seawall is periodically nourished with beneficial use material from maintenance dredging of Packery Channel. Cunningham students have mapped the landward movement of the shoreline position in front of the seawall and the adjacent area with a natural dune system (NPI08) since the last beach nourishment (**Fig. 31**). During the spring 2022 field trip, students were unable to conduct a beach profile or map the shoreline at NPC06 due to elevated water levels which reached the base of the seawall.
