FINAL REPORT

Texas High School Coastal Monitoring Program: 2024–2025

Bureau of Economic Geology

March 2026

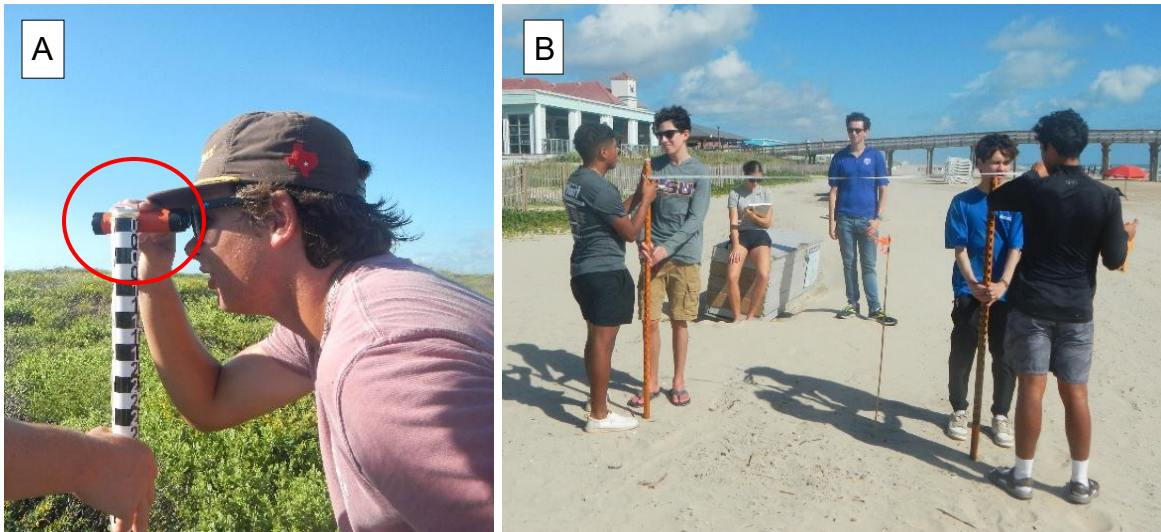
Figure 2. Students use (A) a sighting level to determine vertical offset between Emery rods and (B) a metric tape to measure horizontal distance.

Beach profile: Students use a pair of Emery rods, a metric tape measure, and a hand level to accurately survey a shore-normal beach profile (**Fig. 2**; Emery, 1961; Krause, 2004; O'Connell, 2001). The students begin the profile at a pre-surveyed datum stake so that they can compare each new profile with earlier profiles. Consistently oriented photographs are taken with a digital camera. The beach profiles provide detailed data on the volume of sand and the shape of the beach.

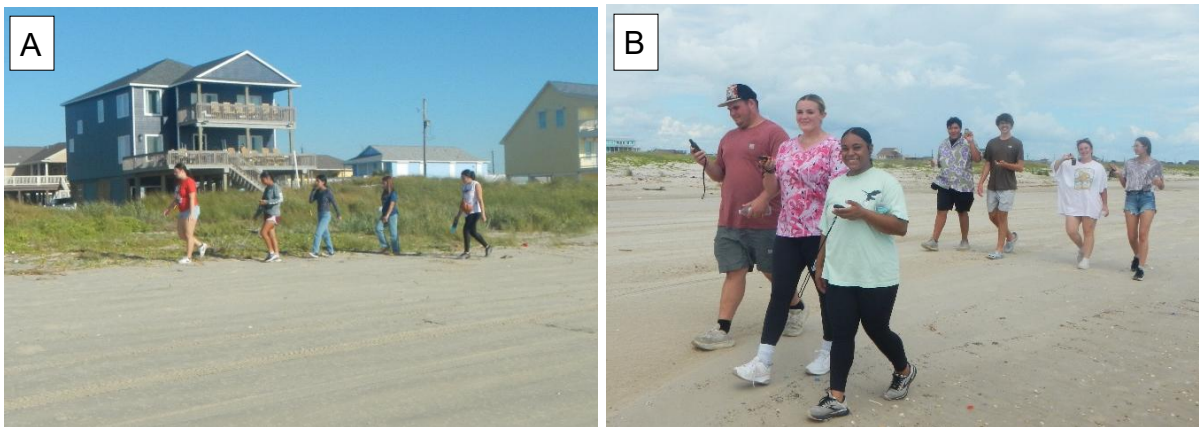
Figure 3. Students mapping (A) the vegetation line and (B) the shoreline (wet/dry line) using handheld GPS units.

Shoreline and vegetation-line mapping: Using handheld Global Positioning System (GPS) units, students walk along the shoreline (wet/dry line) and vegetation line, mapping these features for display on aerial photography (**Fig. 3**). GPS mapping can be used to measure the rates of change to these features. By comparing positions determined through GPS mapping over time, students can visualize shoreline and vegetation-line changes.

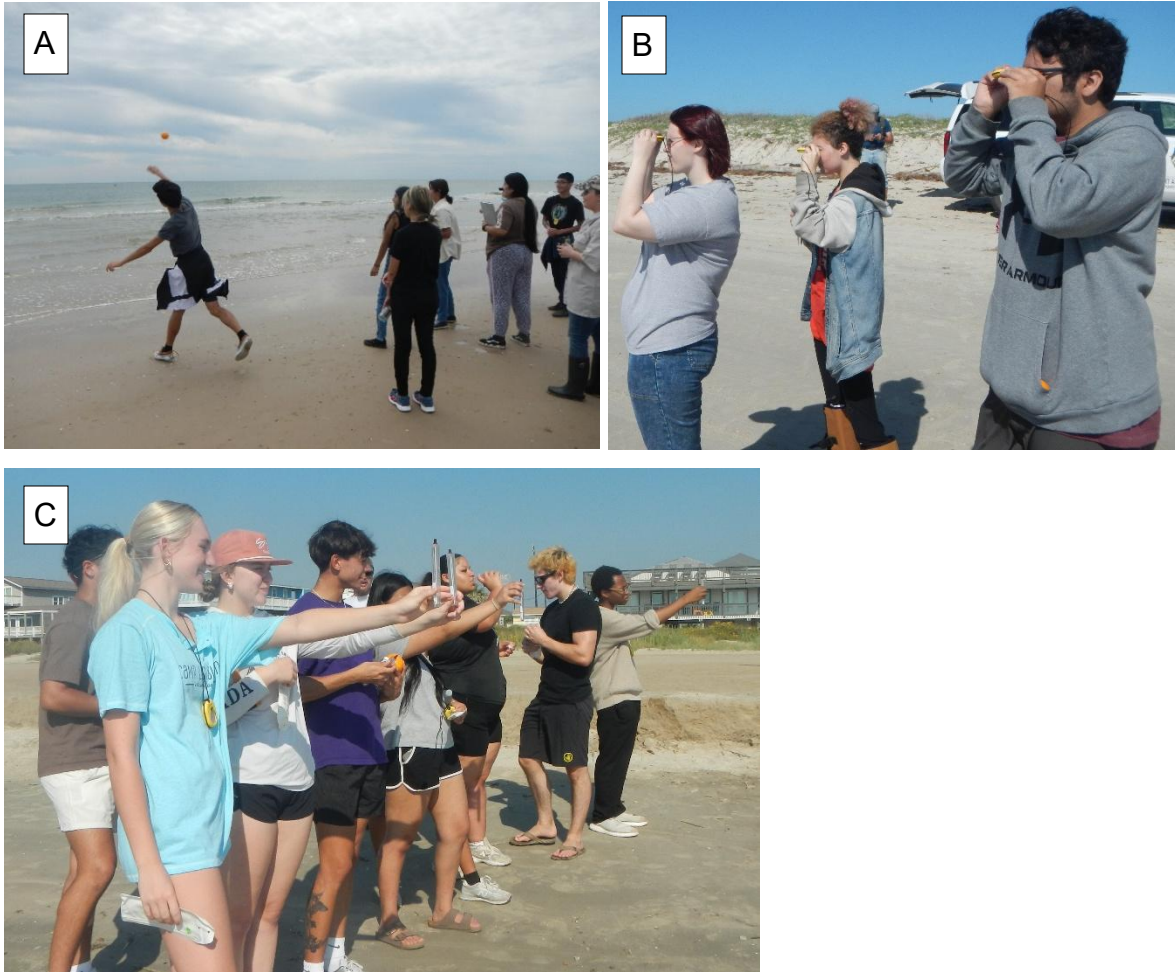
Figure 4. Students (A) throw an orange into the surf to determine longshore current speed and direction, (B) using a sighting compass to determine wind and wave direction, and (C) measuring wind speed using a Dwyer hand-held wind meter.

Beach processes observations: Students measure wind speed and direction, estimate the width of the surf zone, and observe breaker type. They note wave direction, height, and period and they estimate longshore current speed and direction using a float, stopwatch, and tape measure (**Fig. 4**). From these measurements, they can infer relationships between physical processes and beach changes in time and space.

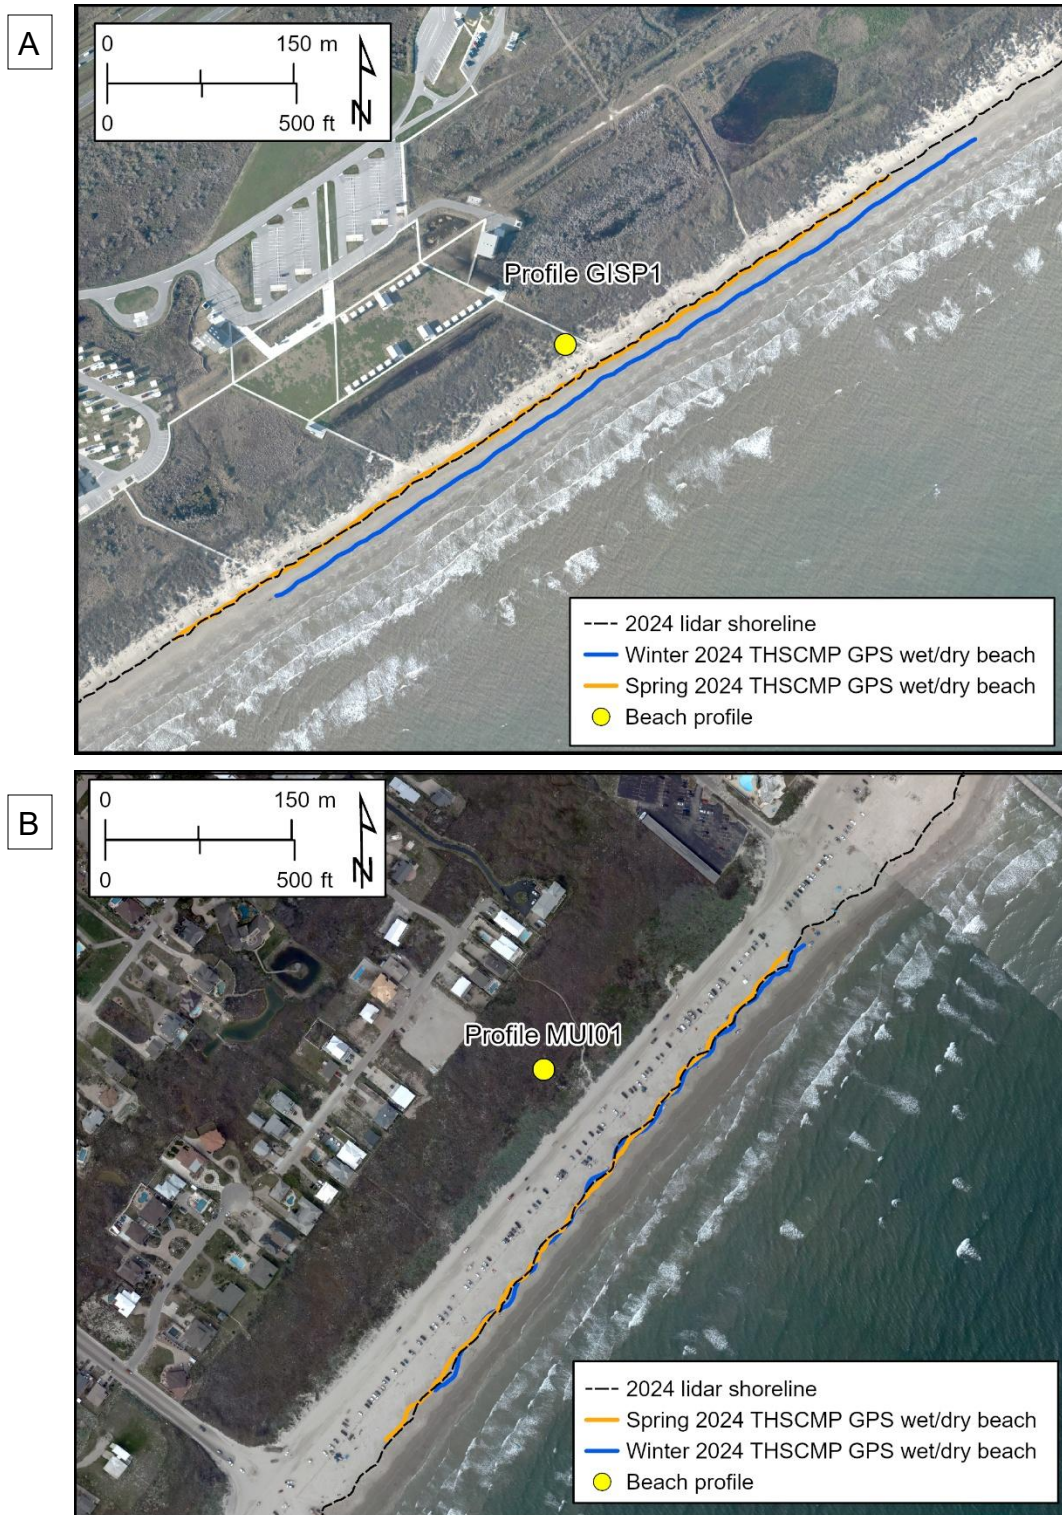
Figure 12. Shoreline position comparisons at (A) Galveston Island State Park site GISP1 (fig. 6) and (B) Mustang Island site MUI01 (fig. 9). Shorelines include the wet-beach/dry-beach boundaries mapped by THSCMP participants using ground GPS and the 1.16 m (3.8 ft) NAVD88 shoreline proxy extracted from the lidar data superimposed on the 2024 Bureau imagery. From Paine and others, 2025.

The shoreline position extracted from 2024 lidar data was verified by visually comparing the shoreline proxy contour elevation with the wet-beach/dry-beach boundary as shown on georeferenced 2022 and 2024 NAIP aerial photographs and imagery acquired during the airborne survey. We used beach profiles and the GPS-mapped shorelines acquired by THSCMP students near the dates of the lidar survey to compare the observed wet- and dry-beach positions. Comparisons of lidar-extracted shoreline and wet-beach/dry-beach positions were conducted for THSCMP beach profile sites at Bolivar Peninsula, Galveston Island State Park, Follet's Island, Matagorda Peninsula, Mustang Island, and northern and southern Padre Island. The Galveston Island State Park profile site GISP1 and Mustang Island profile site MUI01 (**Fig. 12**; Paine and others, 2025) are representative of data comparisons along the Texas coast. At GISP1 there is excellent agreement between the 2024 lidar-derived shoreline and the GPS-based wet-beach/dry-beach boundary mapped on April 30, 2024 by Ball High School students (THSCMP) at profile site GISP1 (**Fig. 12A**). The lidar-derived shoreline proxy also coincides with the 2024 Bureau-acquired aerial imagery. Lidar, imagery, and GPS comparisons on Mustang Island (**Fig. 12B**) show excellent agreement between the lidar-extracted shoreline from the 2024 survey and the wet-beach/dry-beach boundary evident on the Bureau imagery. GPS surveys of the wet-beach/dry-beach boundary acquired by Port Aransas High School THSCMP students on February 22 and April 25, 2024 indicate shoreline positions that coincide with the lidar-extracted shoreline.

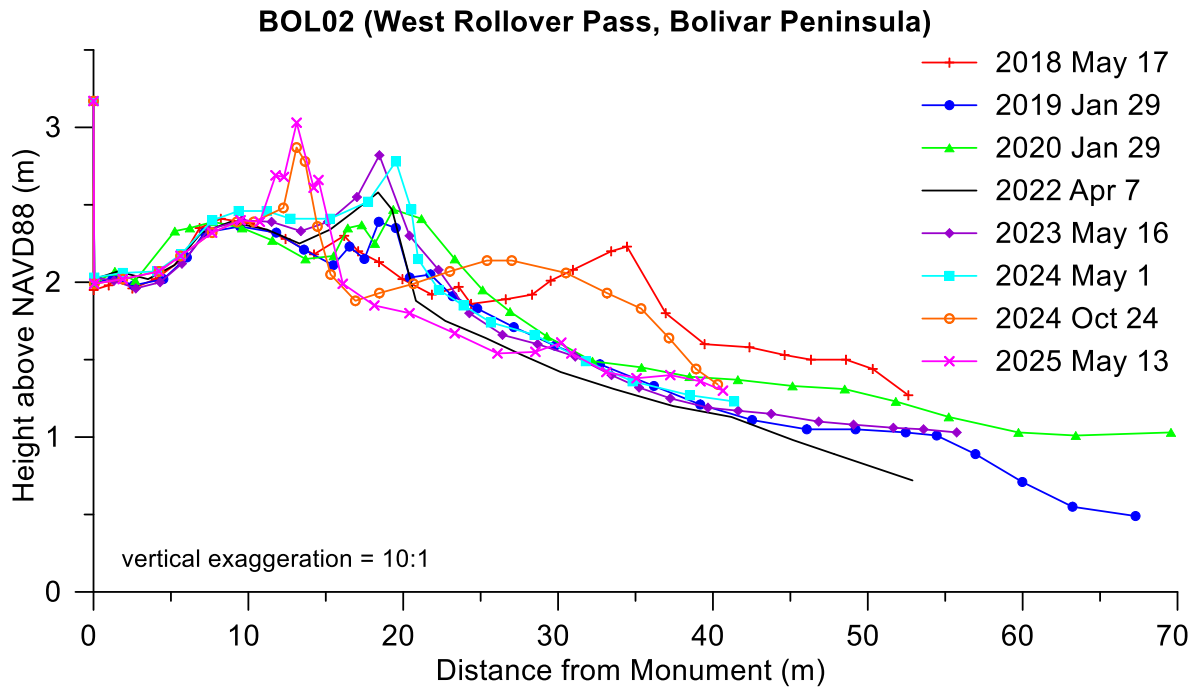
Figure 15. Changes to the beach profile at BOL02 west of Rollover Pass on Bolivar Peninsula.

High Island High School students also monitor sites adjacent to Rollover Pass (**Fig. 5**). Students have been monitoring the changes in the incipient dune at BOL02 on the west side of Rollover Pass. A small, vegetated dune was developing at this site between when the program began at High Island HS and the spring of 2024 (**Fig.**

15). During the October 2024 field trip, it was documented that a new, narrower push-up dune had been created adjacent to Keith Avenue (the profile crosses the road), the vegetation line had moved landward (new vegetation on the dune), and that the shape of the beach profile was significantly different with a narrower beach but higher berm elevation (Fig. 15).

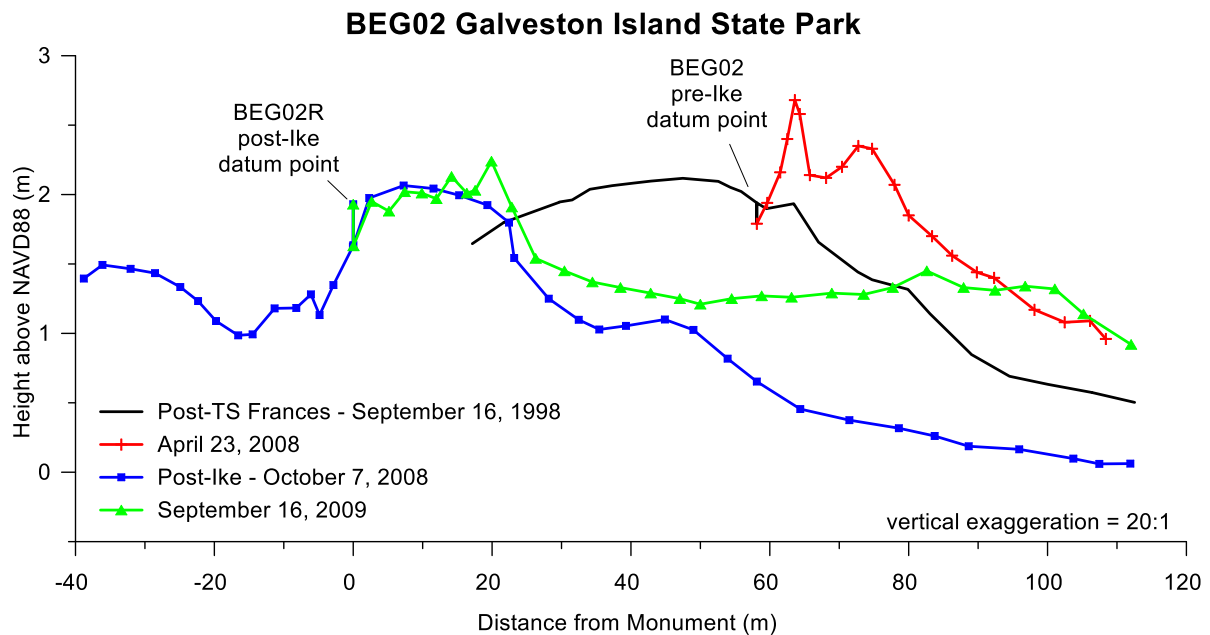
Figure 16. Beach-profile plots from BEG02 in Galveston Island State Park comparing the post-Hurricane Ike profile with a pre-storm profile from early 2008 and the post-Tropical Storm Frances profile from September 1998. Data from September 2009 (1-year post-storm) is also included.

The upper Texas coast was severely affected by the landfall of Hurricane Ike in September 2008. Galveston Island experienced significant beach and dune erosion, as well as extensive damage to property and infrastructure. Ball High School students from the 2007–2008 academic year provided extremely valuable pre-storm profile data that have been used to determine how much the beach and dunes changed after Hurricane Ike. **Figure 16** is a profile plot at BEG02 comparing the Ball High School pre-storm profile (April 2008) with the post–Hurricane Ike profile measured on October 7, 2008. The post–Tropical Storm Frances profile from September 16, 1998, is also plotted for comparison. At Galveston Island State Park, the dune system was destroyed; the shoreline (wet-beach/dry-beach boundary) moved 53 m landward between April 23, 2008, and October 7, 2008; the vegetation

line moved 56 m landward; and the old datum point was 1.14 m above the post-storm surface of the beach (**Fig. 16**; Caudle and Paine, 2017). Data from 1-year post-storm is also included. This profile shows that the elevation of the beach has been restored, the beach width (dunes to waterline) has increased, and incipient dunes are beginning to form (**Fig. 16**).

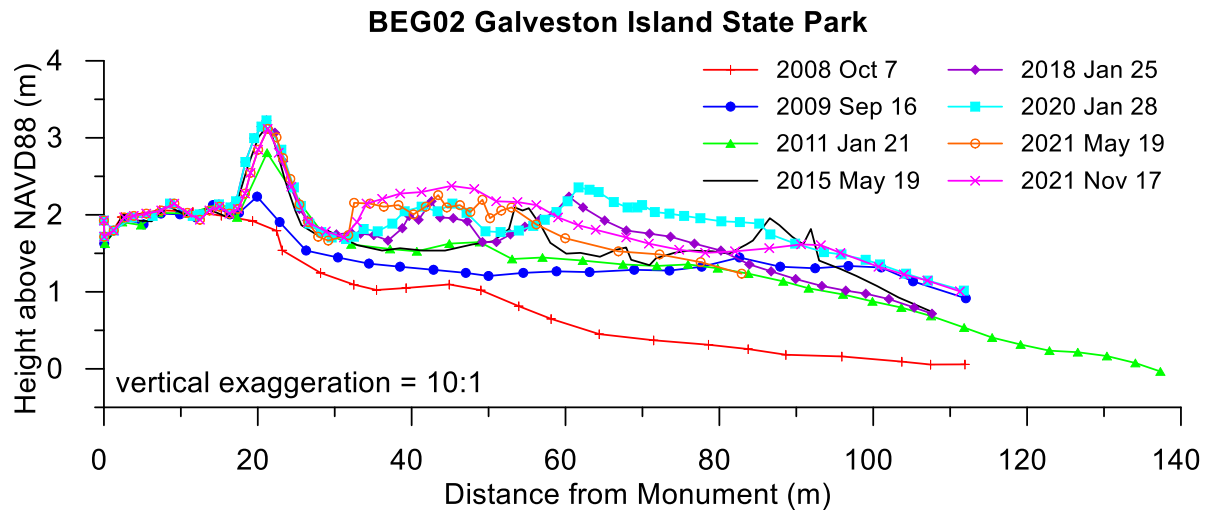
Figure 17. BEG02 profile data collected by Ball High School students. Students are monitoring recovery of the beaches and dunes at this site.

A new profile location (GISP1) was established in 2023 due to a redesign of the state park's Gulf-facing facilities that closed the beach access to BEG02. Data from the new site can be found in Appendix B and C and on the THSCMP website.

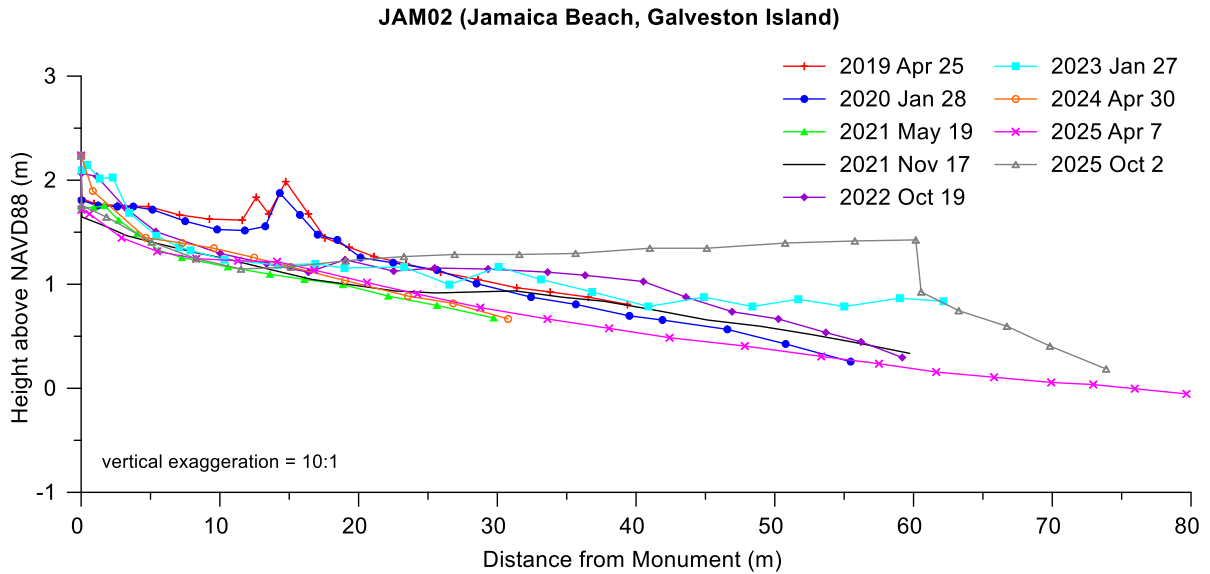
Figure 18. Erosion of the dune at JAM02 in Jamaica Beach due to the 2020 hurricane season. Student data is currently monitoring the performance sand fencing that was installed in 2022 and a beach nourishment project that was completed in summer 2025. Notice the prominent scarp present in the October 2, 2025 dataset.

The 2020 hurricane season caused beach and dune erosion at all the sites Ball High School students monitor. At the site JAM02 in Jamaica Beach (**Fig. 6**), a community just to the south of Galveston Island State Park, the reconstructed dune was noticeably eroded and the vegetation line moved landward (**Fig. 18**). Sand fencing was installed seaward of the vegetation line in 2022 (removed in 2024) to trap windblown sand and promote dune growth (**Fig. 19A**) The dune at the Dellanera RV Park (DEL01, **Fig. 6**) that was created as part of a large nourishment and dune restoration project that took place in 2015, experienced significant erosion between January 2020 and May 2021 (**Fig. 20**). Over half the volume of sand in the beach/dune system was removed. Recent data collected at both JAM02 and DEL01 is monitoring the performance of beach nourishment projects (**Figs. 18** and **20**). The project in Dellanera RV Park was completed in 2023 and in Jamaica Beach in summer 2025. The data collected by Ball High School students in October 2025 at Jamaica Beach, documented a prominent scarp near the shoreline (**Figs. 18** and

19B). These features are often present after beach nourishment placement as the beach sand is redistributed to reach equilibrium.

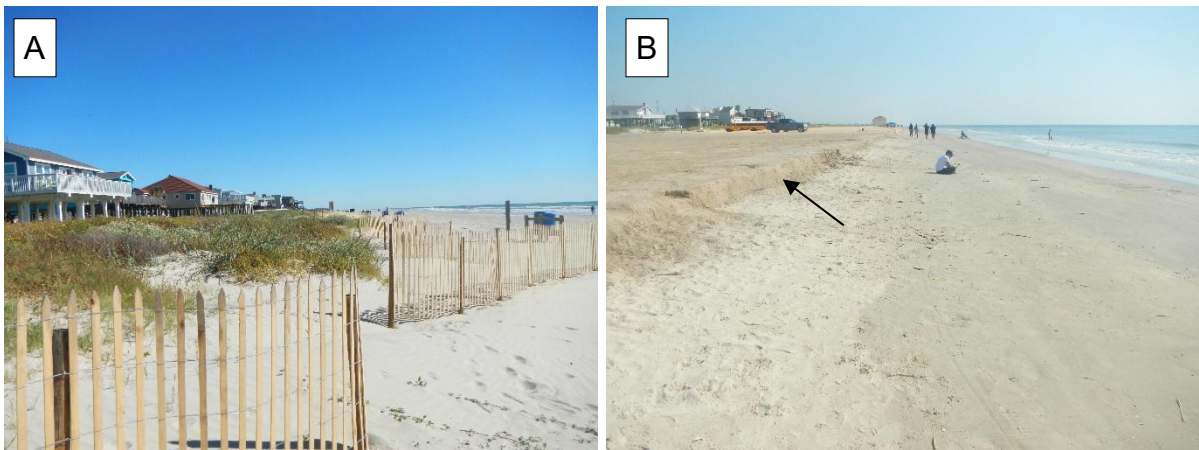
Figure 19. (A) Photo looking north along the vegetation line in Jamaica Beach on October 19, 2022 showing the newly installed sand fencing. (B) Photo looking north along the wet/dry line on October 2, 2025. The arrow points to the scarp in the beach face.

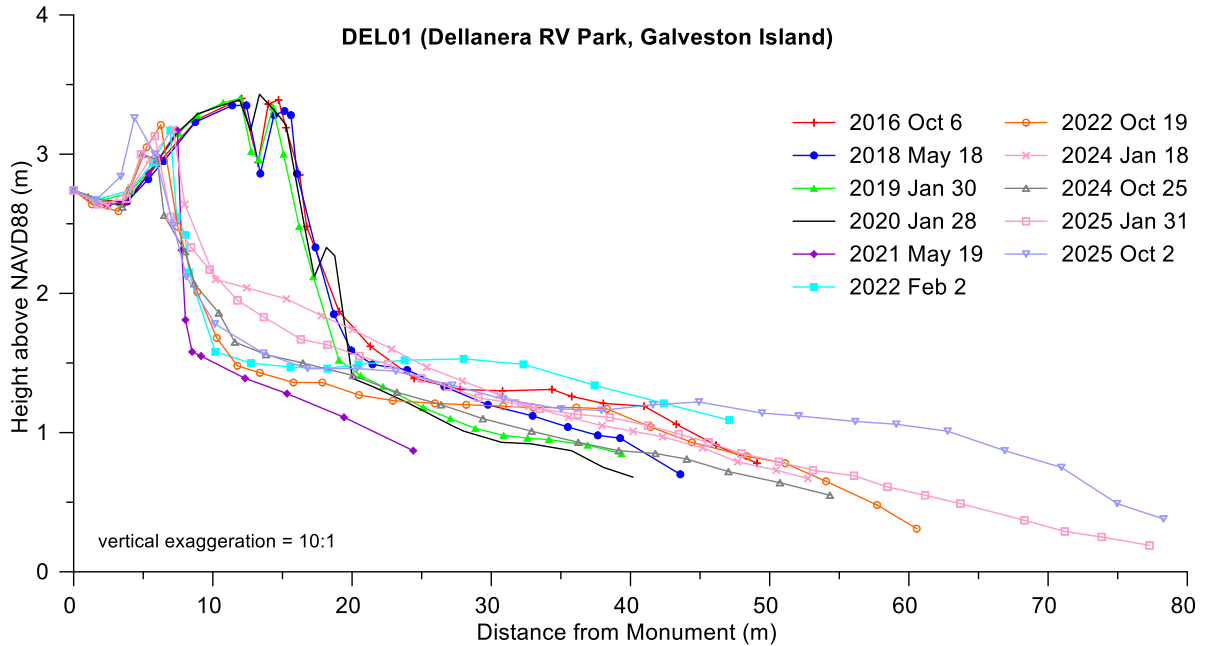
Figure 20. Erosion of the dune at DEL01 in the Dellanera RV Park due to the 2020 hurricane season and performance of the 2023 beach nourishment project.

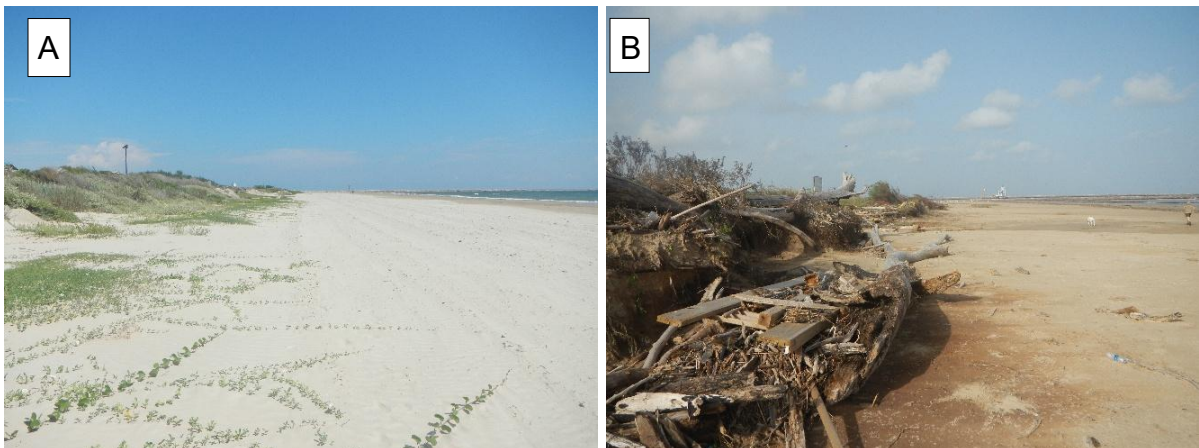
Figure 22. Photos looking north along the vegetation line in Quintana Beach County Park in (A) September 2023 and (B) after the landfall of Hurricane Beryl July 2024.

Brazosport High School in Freeport, Texas, joined the THSCMP during the 2018–2019 academic year, allowing the program to expand to a section of the developed coast that was previously not monitored (**Fig. 7**). Significant changes to the beach and small dune system on Follet’s Island and Quintana Beach have been documented during Brazosport’s short monitoring period. At the QUIN1 location in Quintana Beach County Park, the small foredune that was present when the profile was established had been destroyed and the vegetation line moved 15 meters landward between January 2020 and May 2021 (**Fig. 21**). The park sustained further damage from Hurricane Beryl in July 2024. Student mapping of the vegetation line at this site shows it moved up to 15 m landward following the storm. Additionally, a large amount of debris was washed ashore and deposited at the edge of the vegetation line in the park (**Fig. 22**).

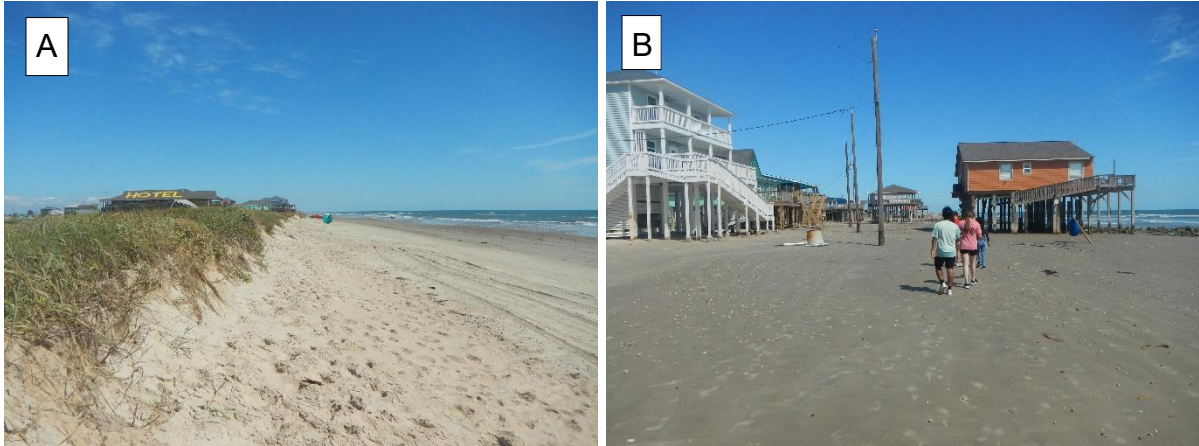
At SURF2, the vegetation line also moved landward and the elevation of the profile was lowered at the datum point following the 2020, 2021, and 2024 hurricane seasons (**Fig. 23A**). Students map the shoreline position of a segment between

Surfside Jetty County Park and a rock revetment protecting Beach Drive. The shoreline position (wet/dry line) is often mapped beneath or behind structures that are located on the beach (**Fig 23B**).

Figure 23. Photos of (A) the scarped dune at SURF2 after Hurricane Beryl and (B) students mapping the shoreline position near structures on the open beach by Jetty Park.

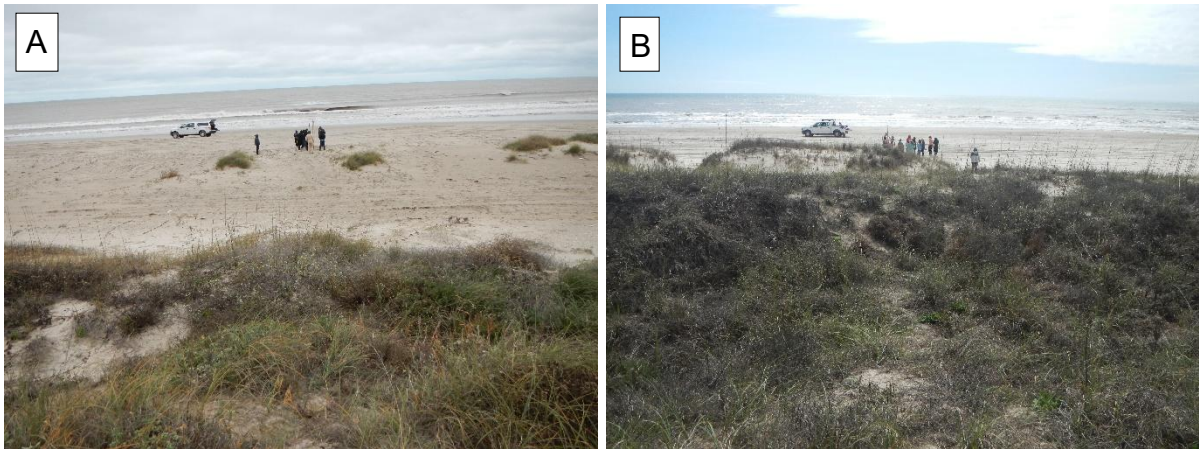
Figure 24. Photos looking toward the Gulf of Mexico from the primary foredune crest at MAT01 in (A) October 2015 and (B) February 2024. Between these two dates a secondary foredune and coppice dunes formed seaward of the primary foredune.

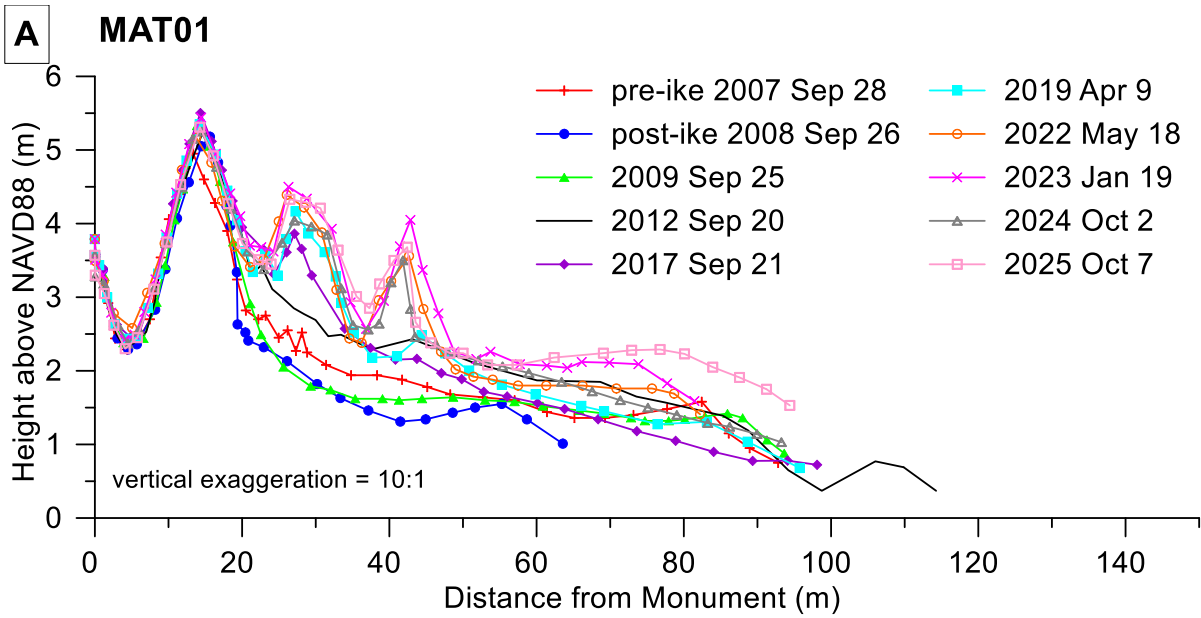
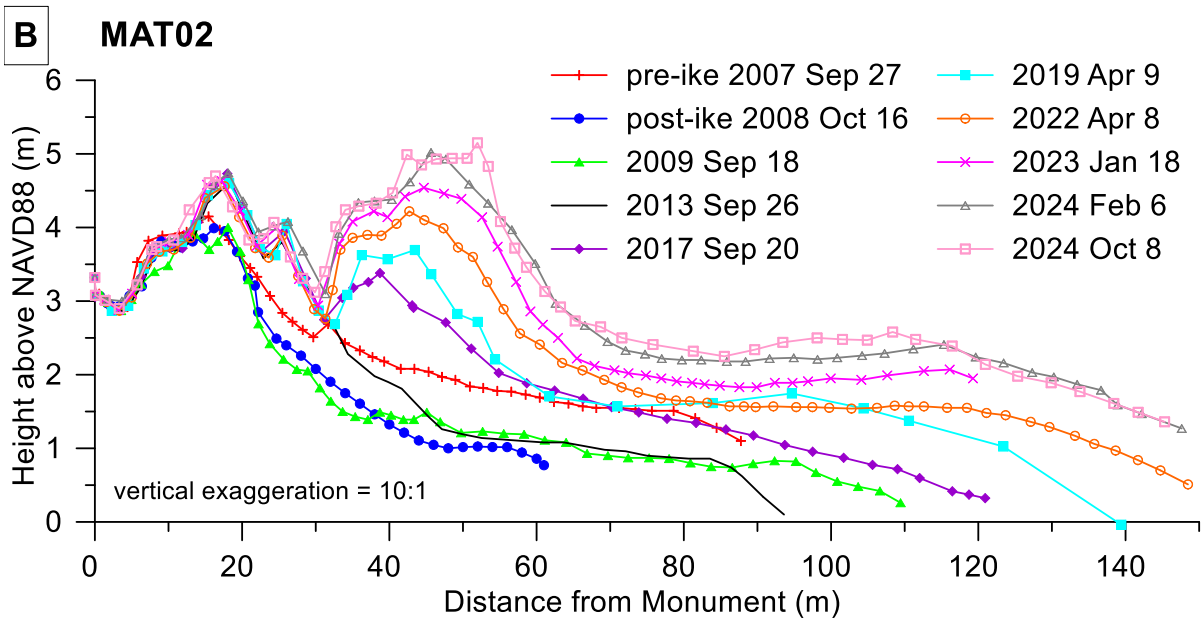
Figure 25. Profile data collected by Van Vleck High School students at (A) MAT01 and Palacios High School students at (B) MAT02. Students are monitoring post-Ike recovery and growth of the foredune at these sites.

elevated water levels caused by the storm surge eroded the foredune at MAT01, the site closest to Three Mile Cut, but no indication of storm erosion at MAT02 (**Fig. 25**).

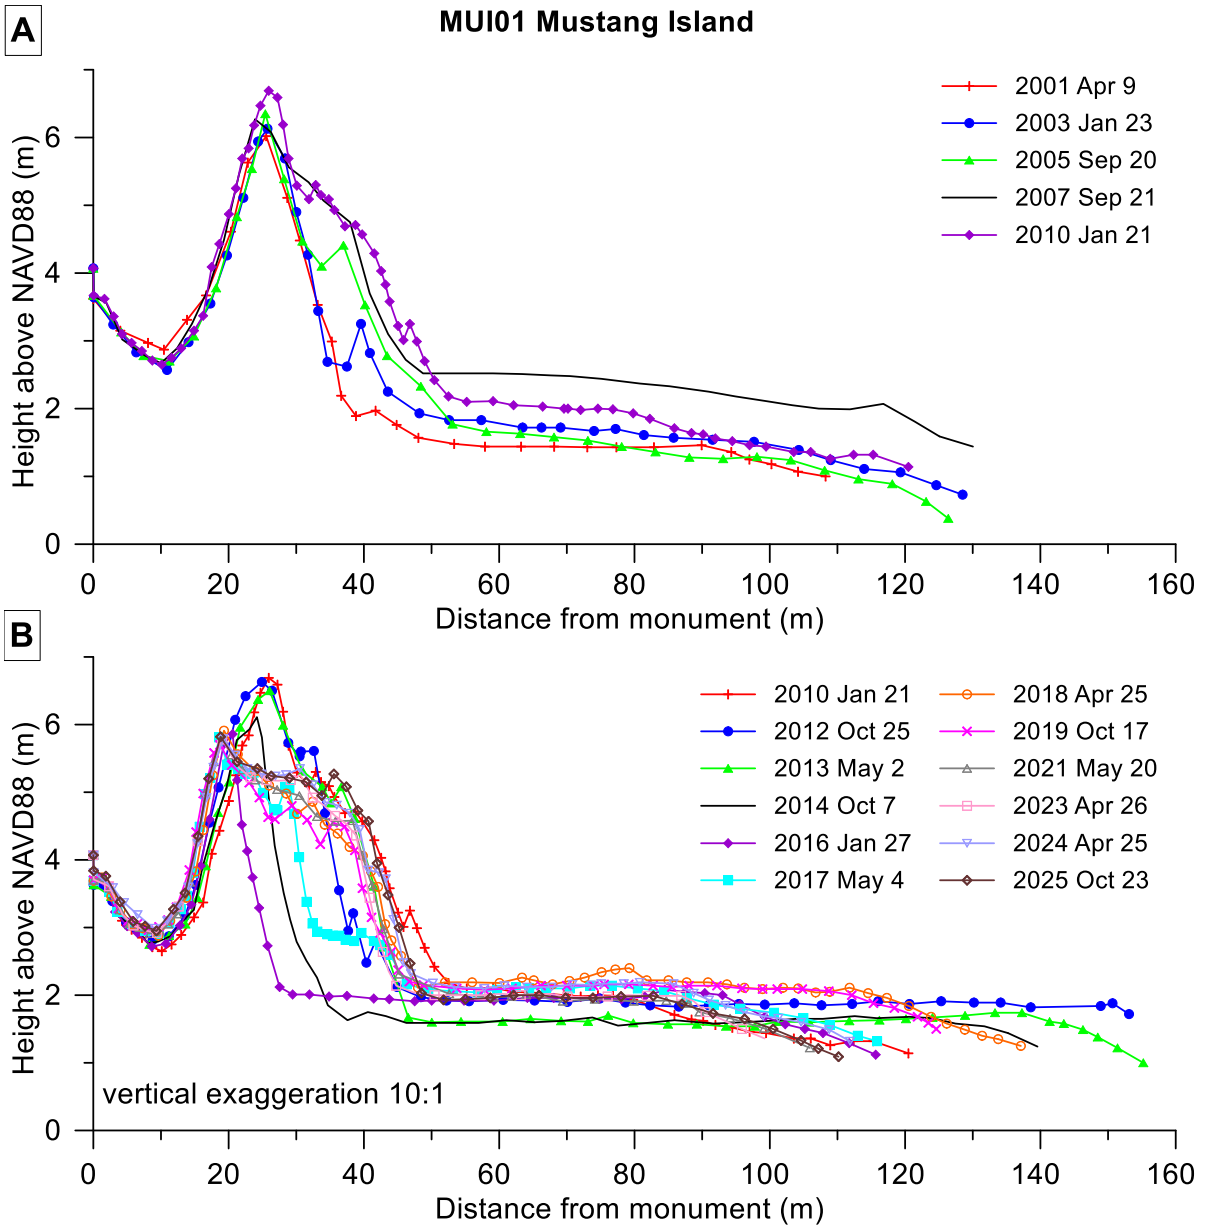
Figure 28. Changes at MUI01 on Mustang Island. (A) Expansion of the foredune between 2001 and 2009. (B) Changes in the foredune due to the beach-maintenance practice of dune notching between 2012 and 2017. Beach profile has been stable with minimum change since 2018.

Beach maintenance practices vary along the island and have changed over time, which the students have documented through their data collection. Several beaches on Mustang Island, particularly within the City of Port Aransas boundaries, are regularly scraped to remove seaweed (*Sargassum*) from the forebeach. At the MUI01 site students documented the cycles of a process called “dune notching” between 2012 and 2018. Dune notching is a beach-maintenance practice where a portion of the foredune is excavated and then refilled over time with the sand and seaweed debris removed from along the shoreline (**Figs. 28B** and **29A**). By the end of the 2018–19 academic year, the foredune at MUI01 was revegetated and stabilized. Between 2019 and 2024, beach profile volume, shoreline position, and vegetation line position have been stable (**Fig. 28B**) although the current width of the foredune is narrower with less sediment volume in the profile than when THSCMP began monitoring this site in 1999 (see change plot in Appendix B).

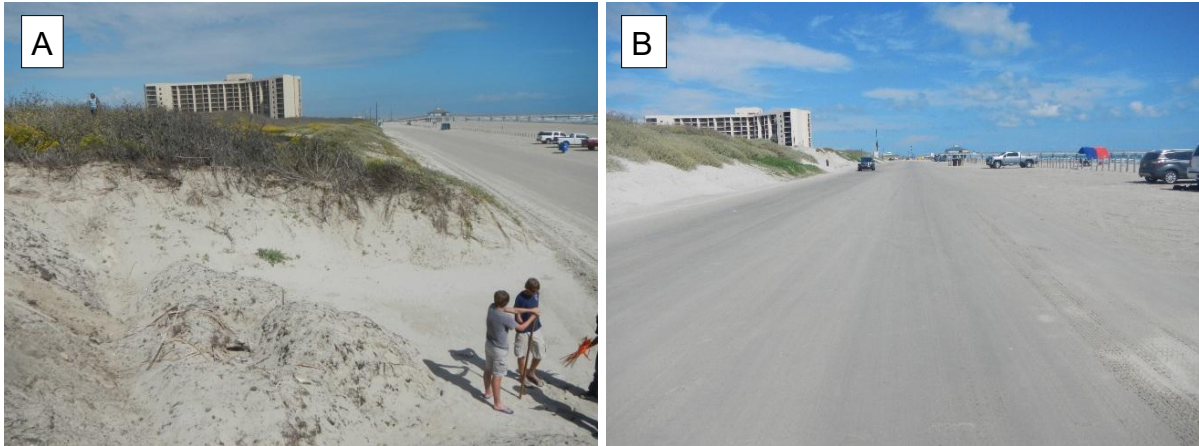
Figure 29. (A) Photo from October 25, 2012 of the excavated dune at MUI01 on Mustang Island looking north toward Horace Caldwell Pier. (B) Beach road at MUI01 (view toward north) between the toe of the dune and bollards on October 23, 2025.

The MUI01 location also has shore-parallel bollards that have been installed on the backbeach to confine vehicles to the upper portion of the backbeach. The placement of these bollards has restricted further seaward advancement of the foredune complex and the vegetation line by maintaining a fixed location of the Mustang Island beach road starting at the toe of the dune (**Figs. 28B, 29B**, and Appendix B). Beach maintenance practices such as grading and dune notching and the impacts of the fixed position of the beach road will continue to be monitored by Port Aransas students at MUI01 and compared with the natural processes that occur elsewhere on Mustang Island.

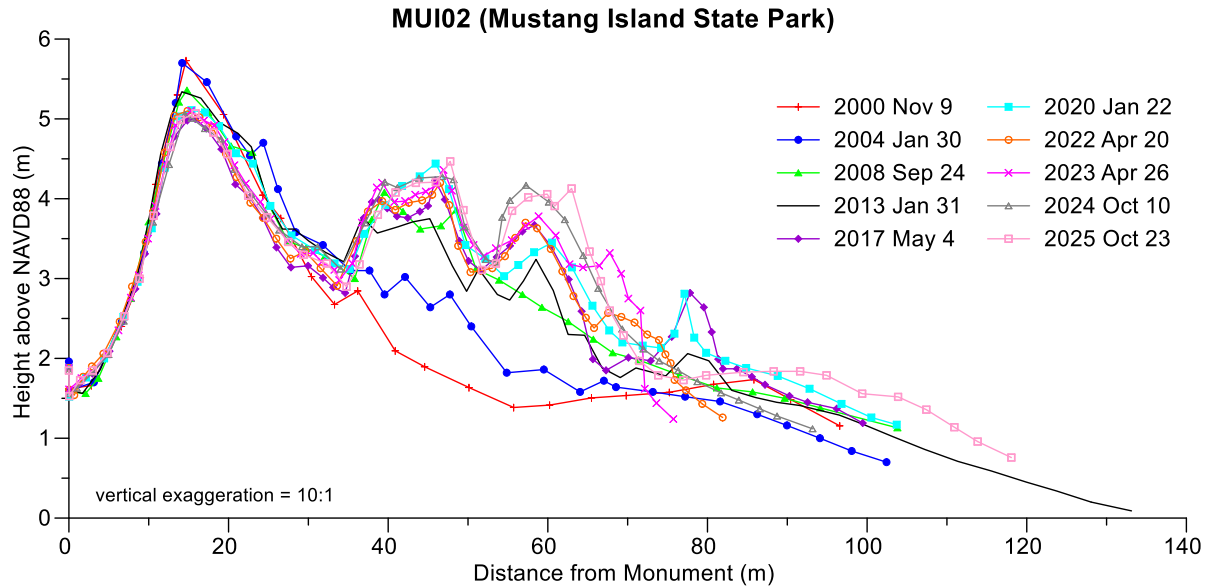
Figure 30. Student monitoring at MUI02 documents an increase in volume of the dune system and seaward migration of the vegetation line.

conditions in April 2023 (**Figs. 30** and **31A**) and increased dune height with the addition of overwash sediment in October 2024 (**Figs. 30** and **31B**). The over wash on the seaward-most dune was completely vegetated by October of 2025.

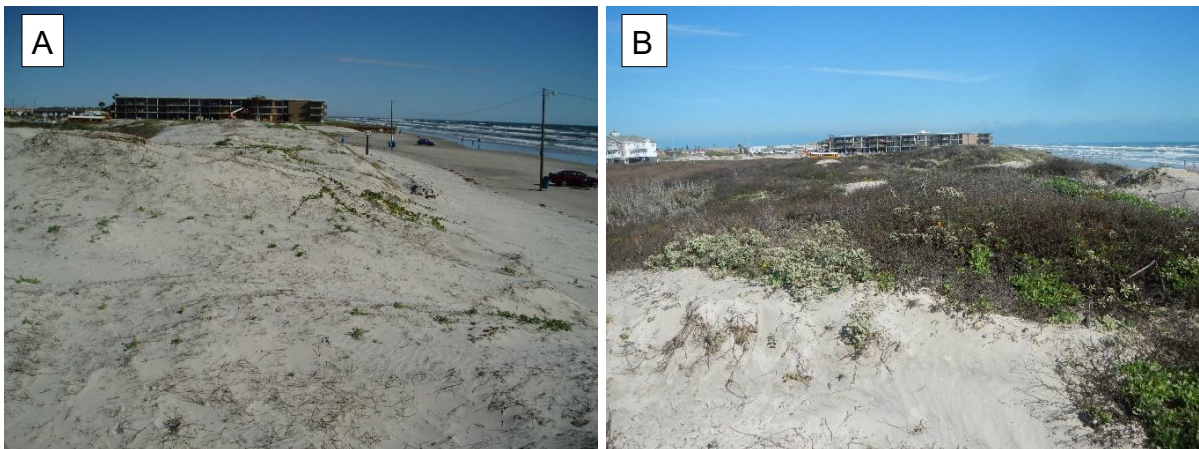
Figure 32. Changes in vegetation density and coverage on the foredune crest at NPI08 (A) October 2009 and (B) January 2023.

Cunningham Middle School at South Park students monitor sites on North Padre Island (**Fig. 10**) that are interesting to compare with the well-vegetated foredunes on Mustang Island to the north. The students have documented many changes at the NPI08 profile location, which is located adjacent to the northern Padre Island seawall. The dune crest at this site is sparsely vegetated (**Fig. 32**) which creates an opportunity for prevailing winds to constantly rearrange and alter the shape and height of the dune crest. When the program began at Cunningham in 2009, a new profile marker was established along the profile azimuth directly behind the foredune to shorten the profile for the middle school students. Within the first year of monitoring, sand was transported from the top of the foredune down the back slope of the dune so that the landward toe of the dune buried the new datum pipe. Until vegetation covers the crest of this dune, it will remain a dynamic site. Students used the original datum marker for several years until it was lost to corrosion of the pipe. Due to safety concerns of working with middle school students in knee to waist high vegetation landward of the large foredune, a new datum marker was not installed at NPI08. The students continue to collect GPS vegetation line and shoreline data at this location.

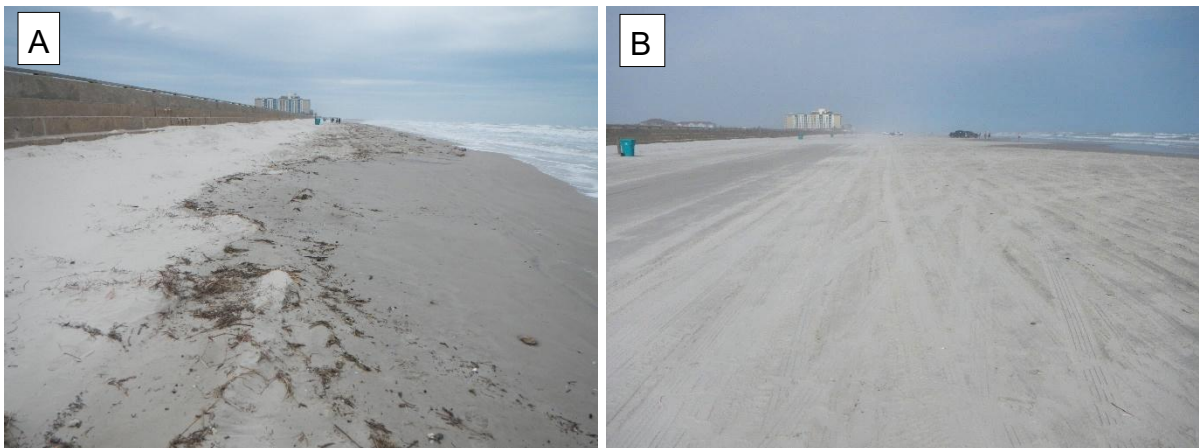
Figure 33. Change in beach width at NPC06 at the southern end of the North Padre Island seawall (A) in January 2022 before a beach nourishment project and (B) February 2024 after the project was completed.

The site NPC06, near the southern end of the North Padre Island seawall (**Fig. 10**), was added in 2015 to track the effects of nourishment projects and maintenance activities on the beach in front of the seawall. During the spring 2022 field trip, students were unable to conduct a beach profile or map the shoreline at NPC06 due to elevated water levels which reached the base of the seawall. The beach in front of the seawall is periodically nourished with beneficial use material from maintenance dredging of Packery Channel (**Fig. 33**). Cunningham students have mapped the landward movement of the shoreline position in front of the seawall and the adjacent area with a natural dune system (NPI08) since the last beach nourishment (**Fig. 34**). A new profile location was added on the northern end of the sea wall that is easily accessible for the middle school students (NPISW, **Fig. 10**). The new site adds additional monitoring of the beach nourishment projects performance as well as a comparison with the typically narrow beach at the southern end of the seawall.

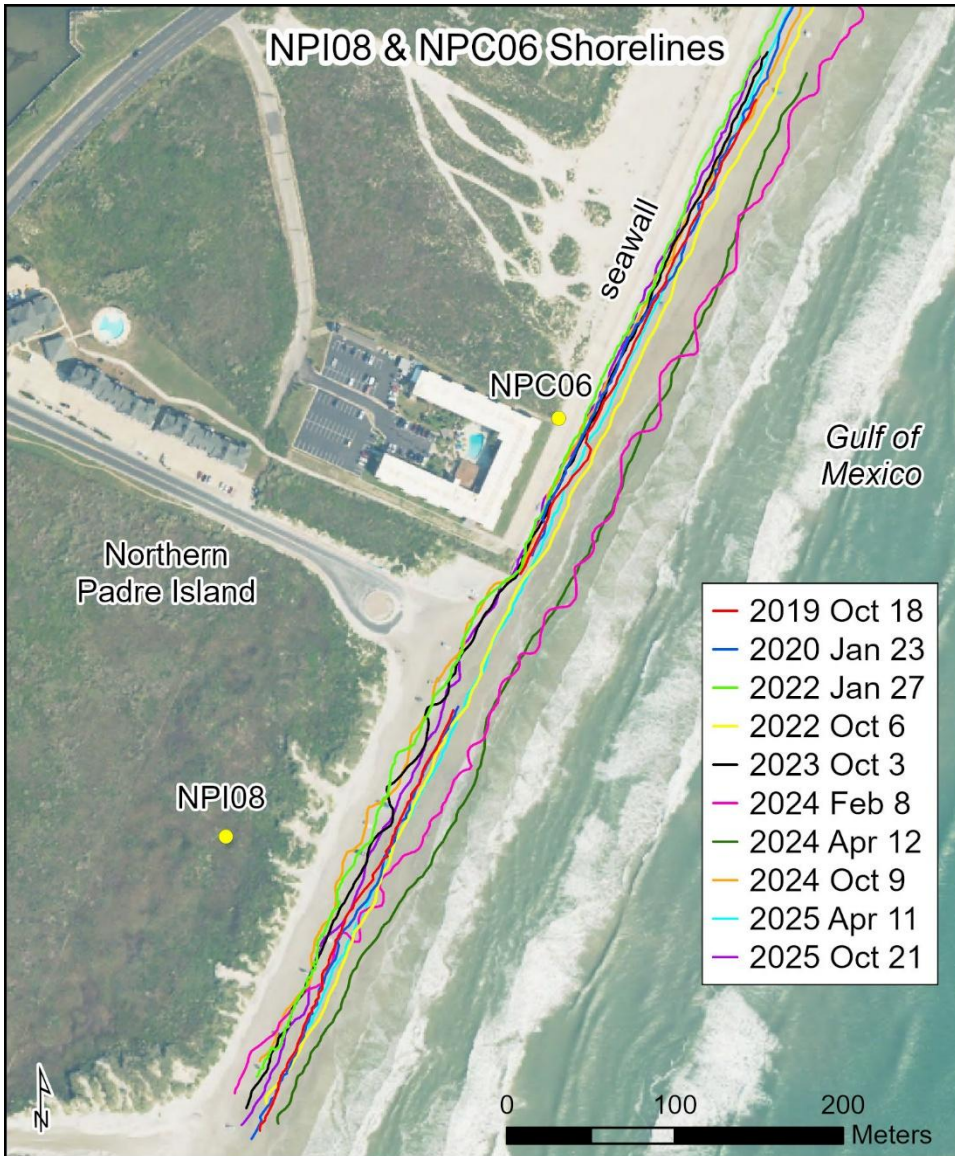
Figure 34. Shoreline position change between 2019 and 2025 along southern end of the North Padre Island seawall and adjacent beach.

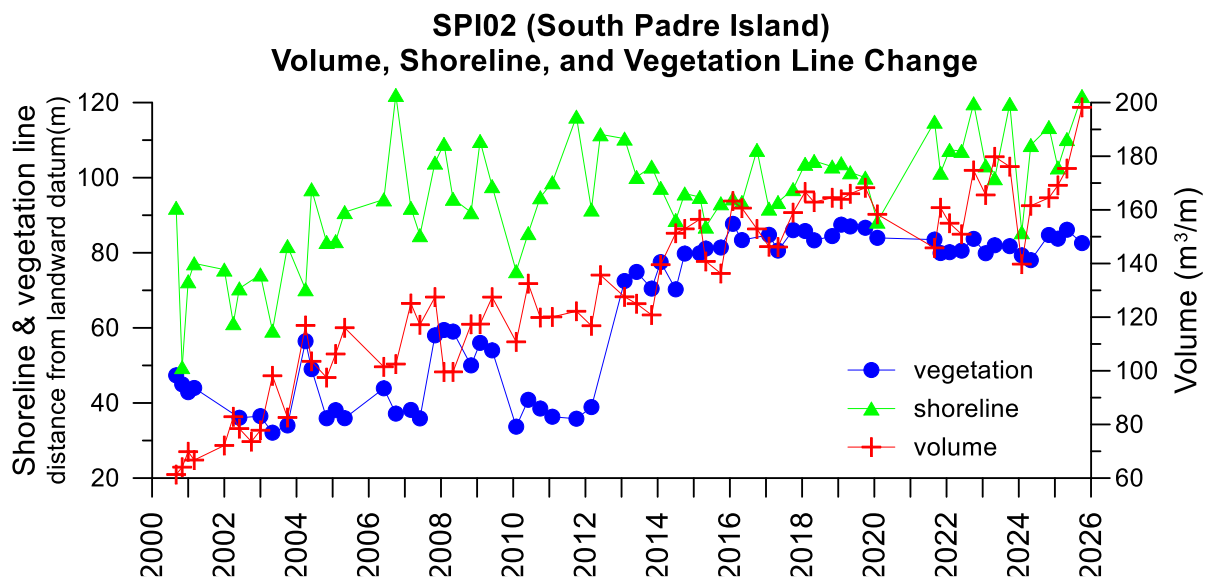
Figure 35. Changes in sand volume and in shoreline and vegetation-line positions at SPI02 on South Padre Island due to beach nourishment projects and the installation of sand fences.

The SPI02 (**Fig. 11**) monitoring site has been used by students and scientists to monitor the growth of dunes (sand volume) and shoreline movement. When SPI02 was established in August 2000, there were no dunes between the retaining wall and waterline at this location. Since that time, student-collected data has been quantifying the effects of sand fence installations, vegetation planting, beach maintenance practices, and numerous BUDM nourishment projects (**Fig. 35**). Port Isabel data have documented an overall trend of shoreline and vegetation line advancement and sediment-volume increase throughout the study period (Caudle and others, 2014, 2019). A dune crossover was constructed at this site in 2017. The construction project slightly flattened the profile and caused the loss of vegetation in the dunes (**Fig. 36A**). The vegetation quickly recovered at this site which quickly recovered. The position of the shoreline and vegetation line and the volume of sediment in the beach profile has remained stable for the past several years. Students monitoring is documenting the performance of a dune planting project that was completed before the April 2024 field trip (**Fig. 36B**).

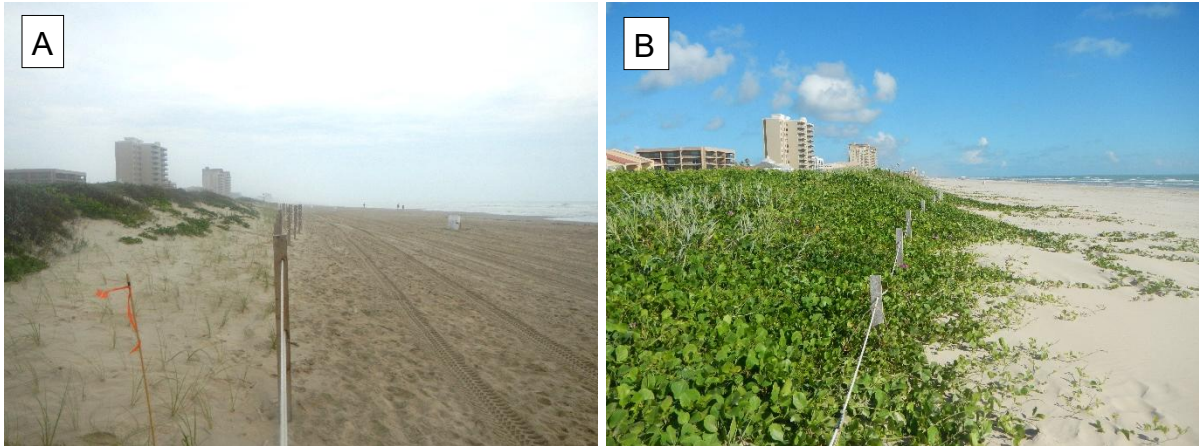
Figure 36. (A) View toward the north at SPI01 from April 2024 showing newly planted vegetation and protective fencing. (B) Photo from September 2025 reveals that the vegetation has filled in the dune face. Wind-blown sand has accumulated adjacent to the fence and vegetation is spreading seaward.
