FINAL REPORT

Texas High School Coastal Monitoring Program: 2024–2025

Bureau of Economic Geology

March 2026

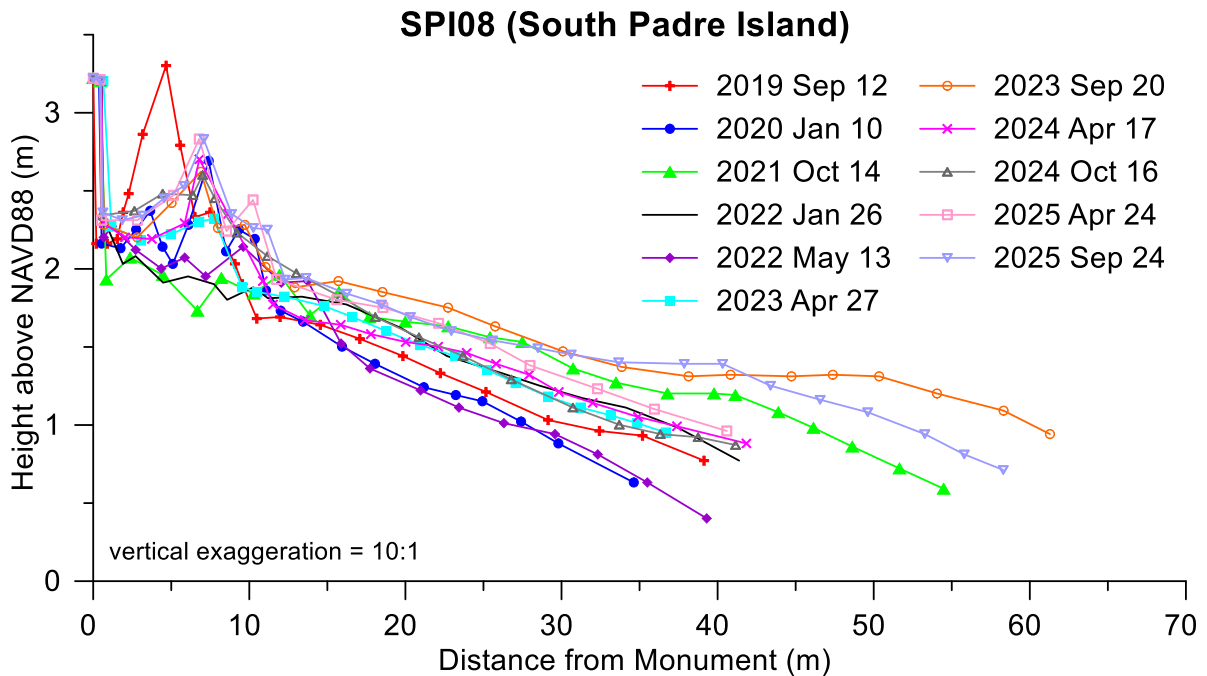
Figure 37. Beach profiles from before and after the latest nourishment project at SPI08.

SPI08 is a chronically eroding location in front of the Tiki Condominiums near the north end of the City of South Padre Island (**Fig. 11**). This site has a narrow beach backed by a retaining wall and regularly receives nourishment sand from road maintenance north of the City or from the dredging of Brazos Santiago Pass. Students from Port Isabel have been documenting cycles between beach nourishment, dune creation by beach maintenance practices, and the long-term shoreline erosion trend at this site (**Fig. 37**). The most recent nourishment took place between January 2020 and August 2021. The beach was much wider than had been previously documented. Fencing was installed and vegetation planted before the winter 2022 field trip. Students have documented that wind-blown sand is accumulating around the base of the sand fencing and vegetation is expanding to cover the coppice dune area.

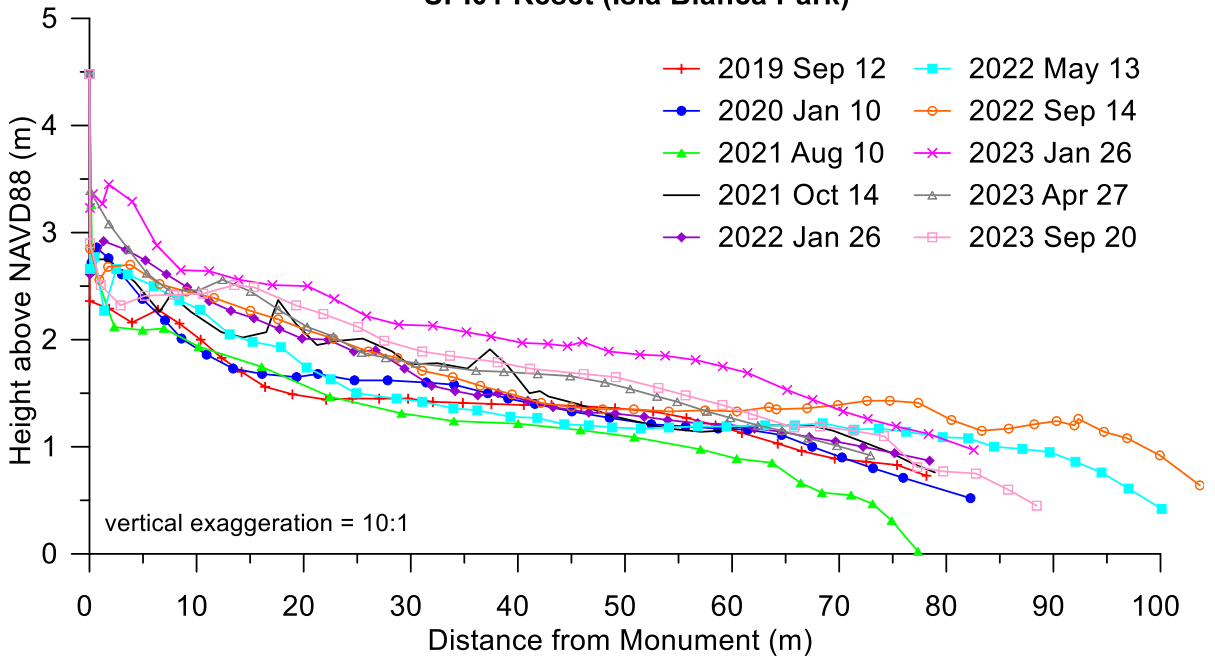
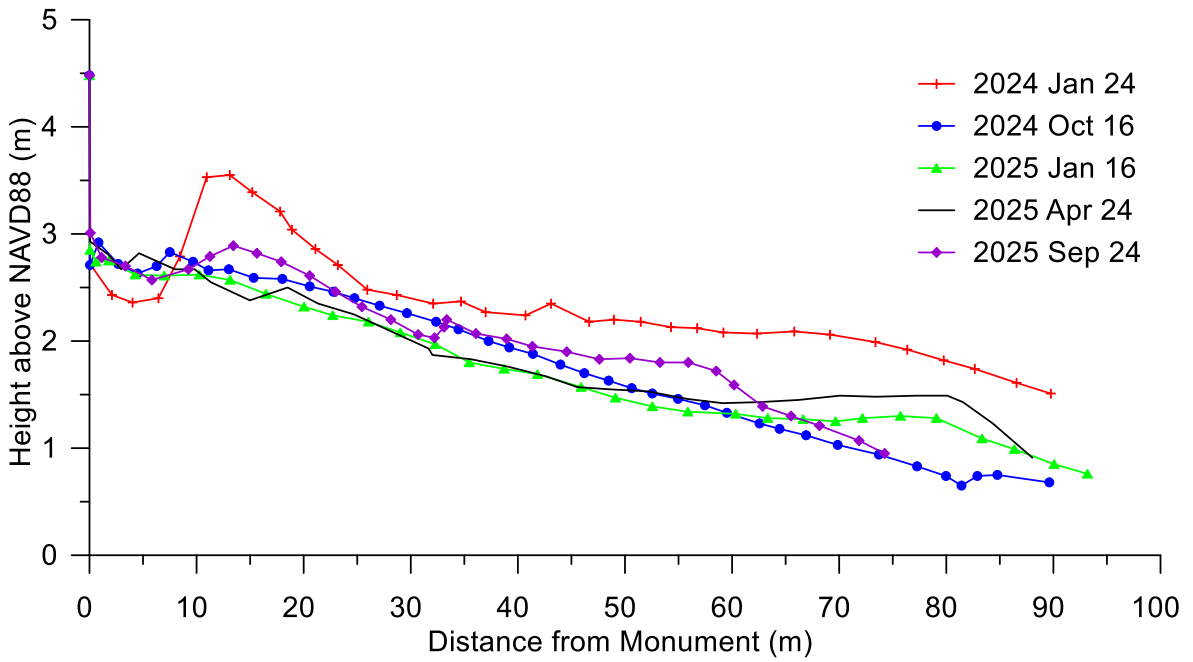
SPI01R

SPI01 Reset (Isla Blanca Park)
