# DRAFT Post-Construction Monitoring Report: Year 4

Galveston Island State Park Marsh Restoration  
and Protection Phase III

CEPRA 1637

HDR Engineering, Inc.  
TBPELS Firm  
Registration No. F-754

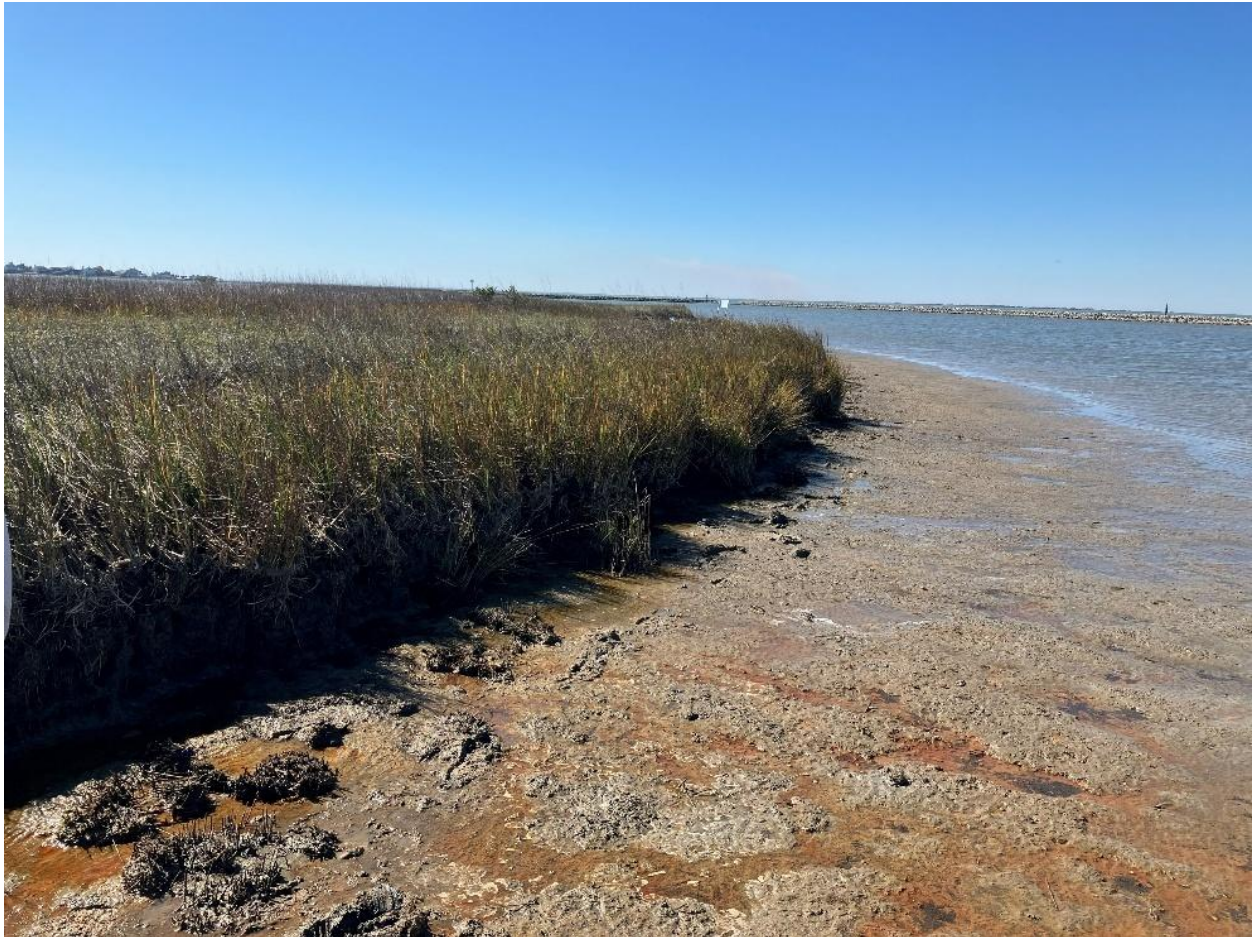
Figure 5. Typical ground digital photo of marsh edge.

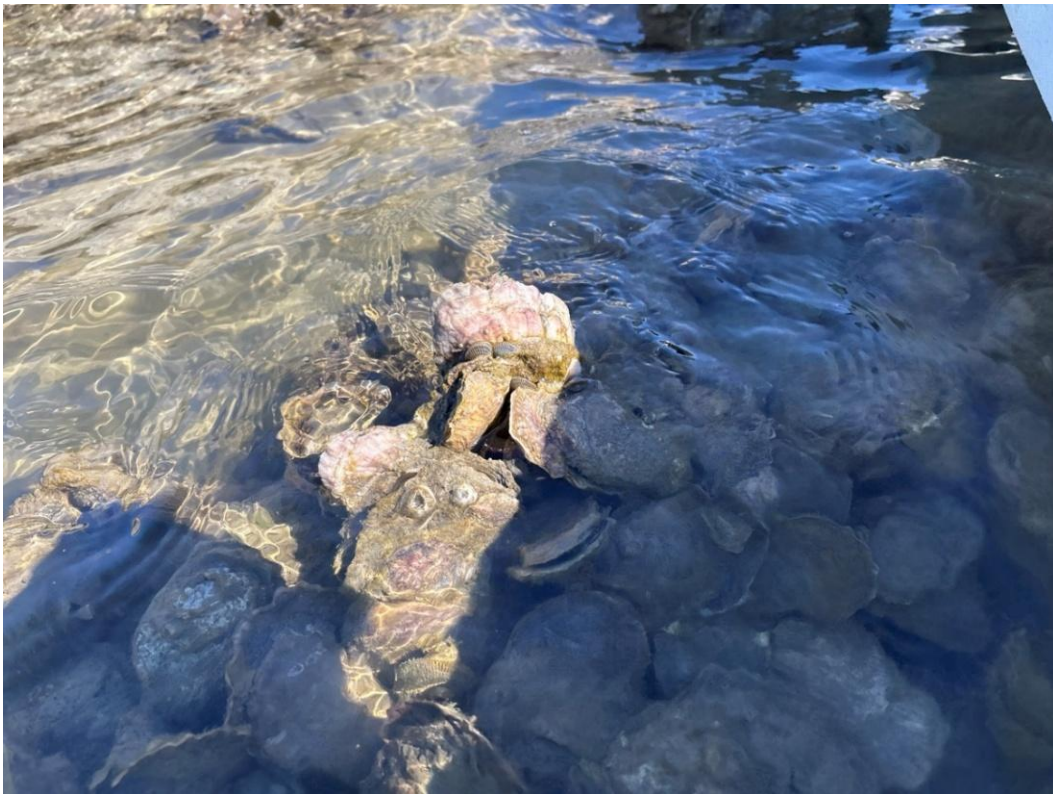
Figure 15. Oyster and algae on Dana Cove breakwater.

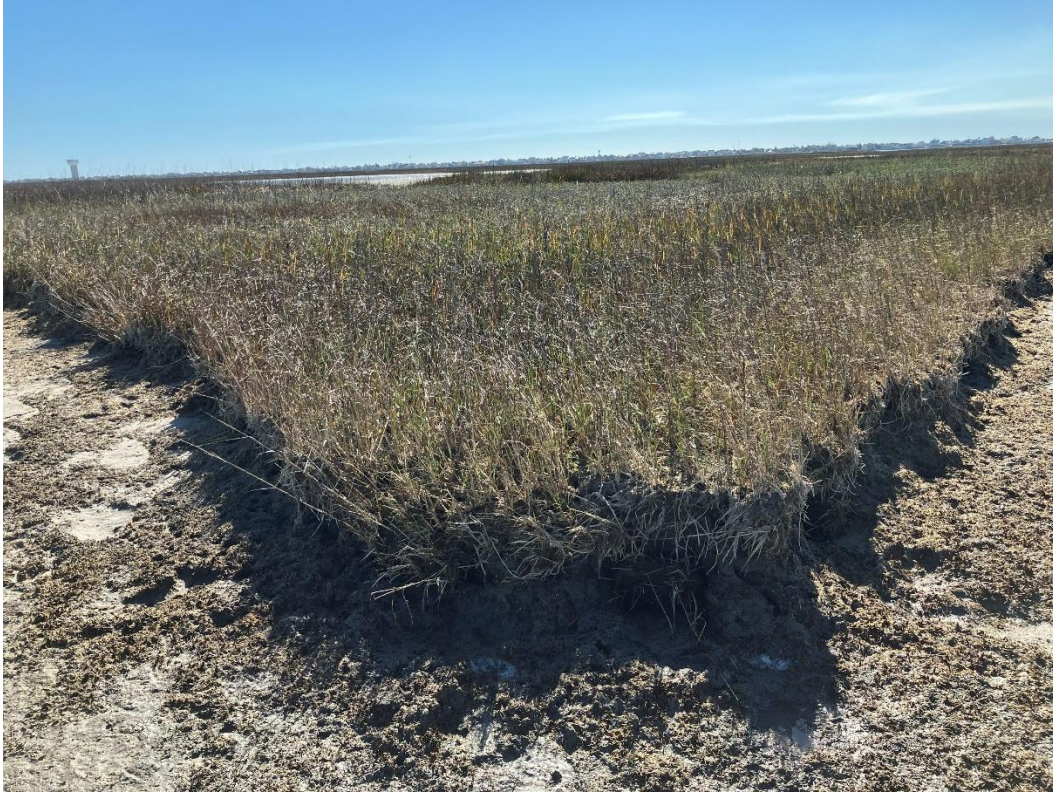
**Figure 18. Vertical scarp along marsh shoreline at Area B.**

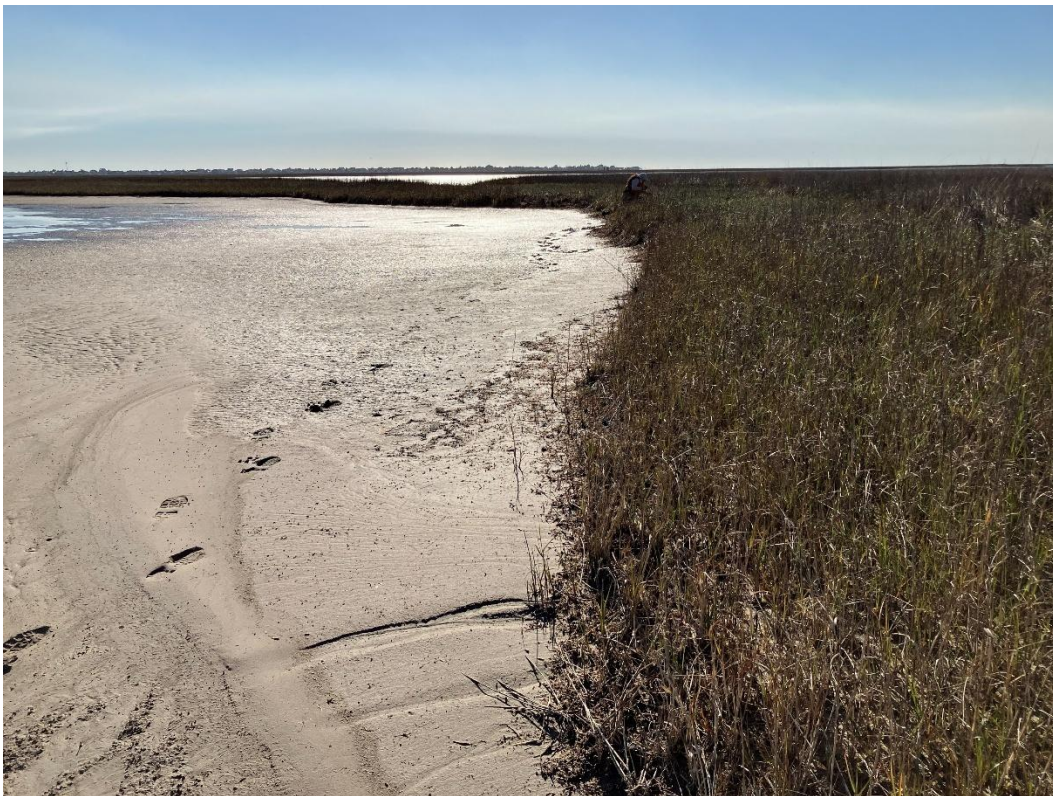
**Figure 19. Exposed shallow bay bottom sloping gently up to marsh edge at Area E.**

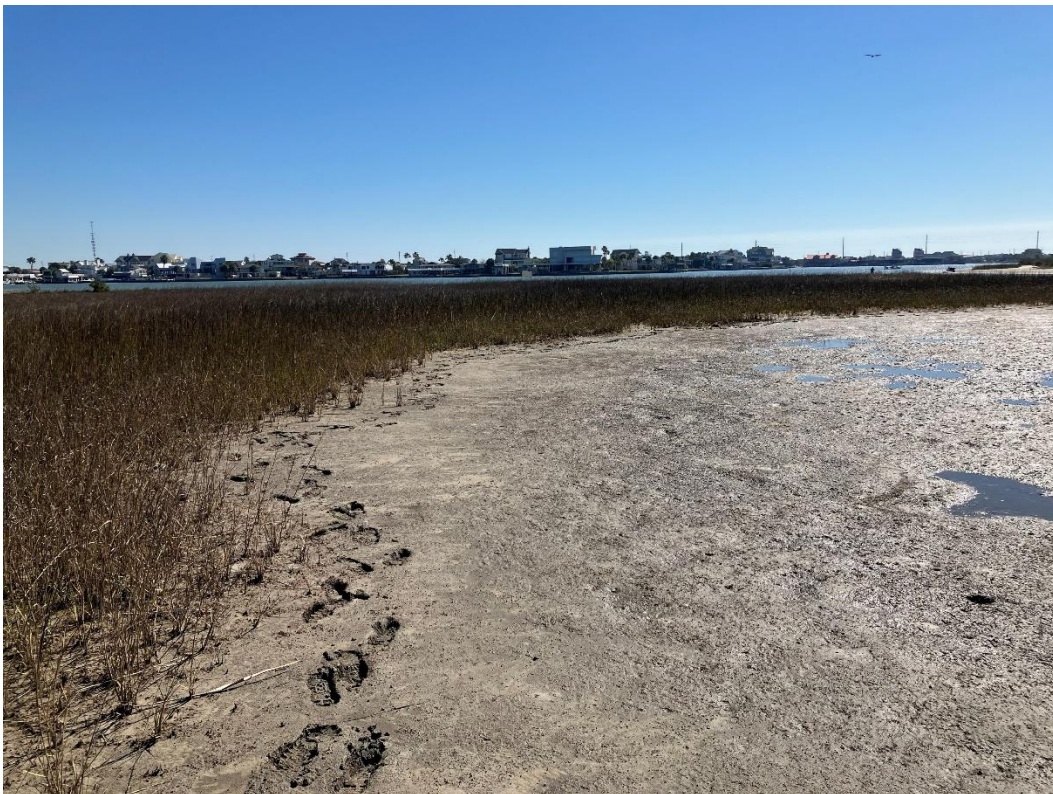
Figure 21. Exposed shallow depths surround Area J near the sand bar.

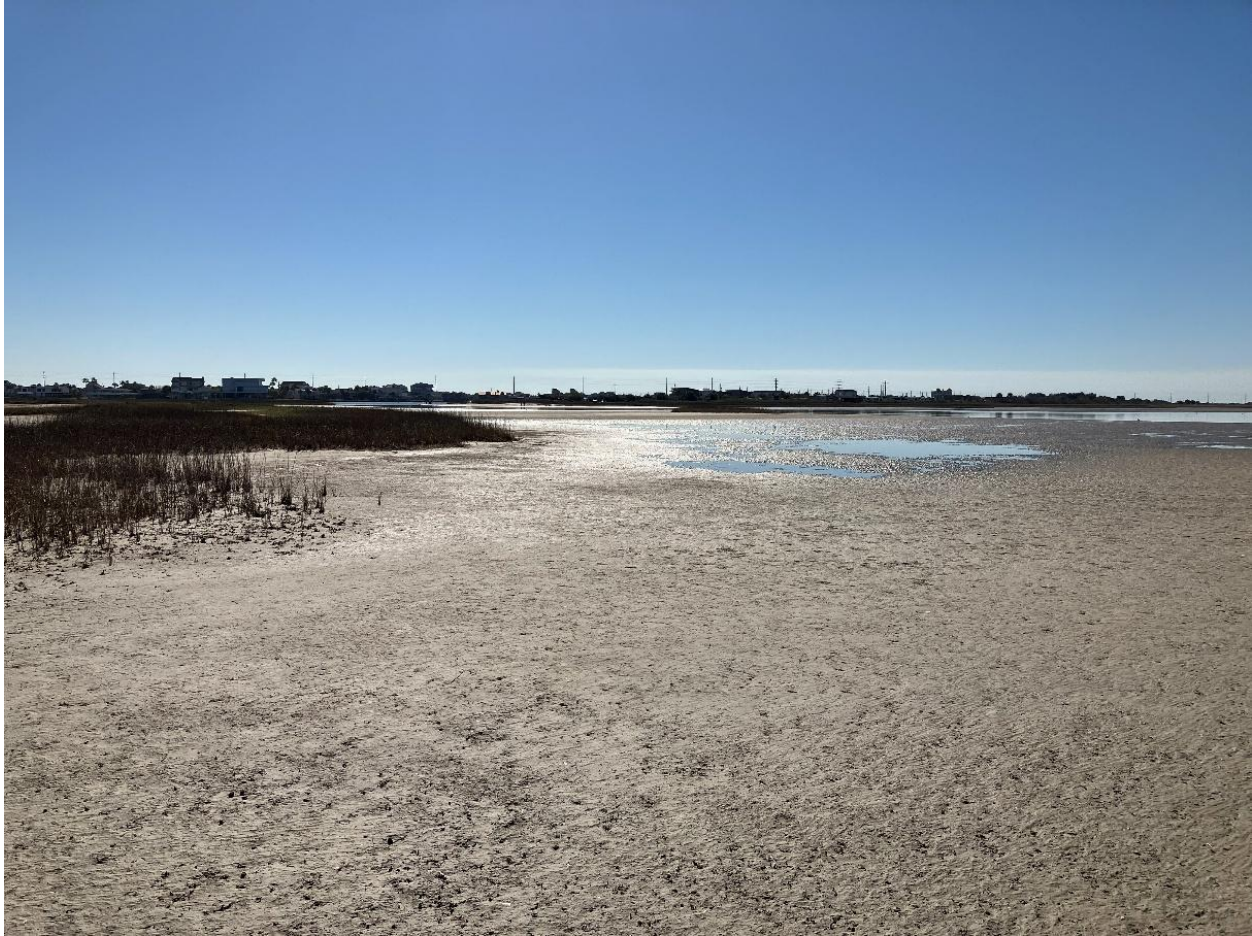
Figure 26. Sand/Mud flat northeast of Area I.

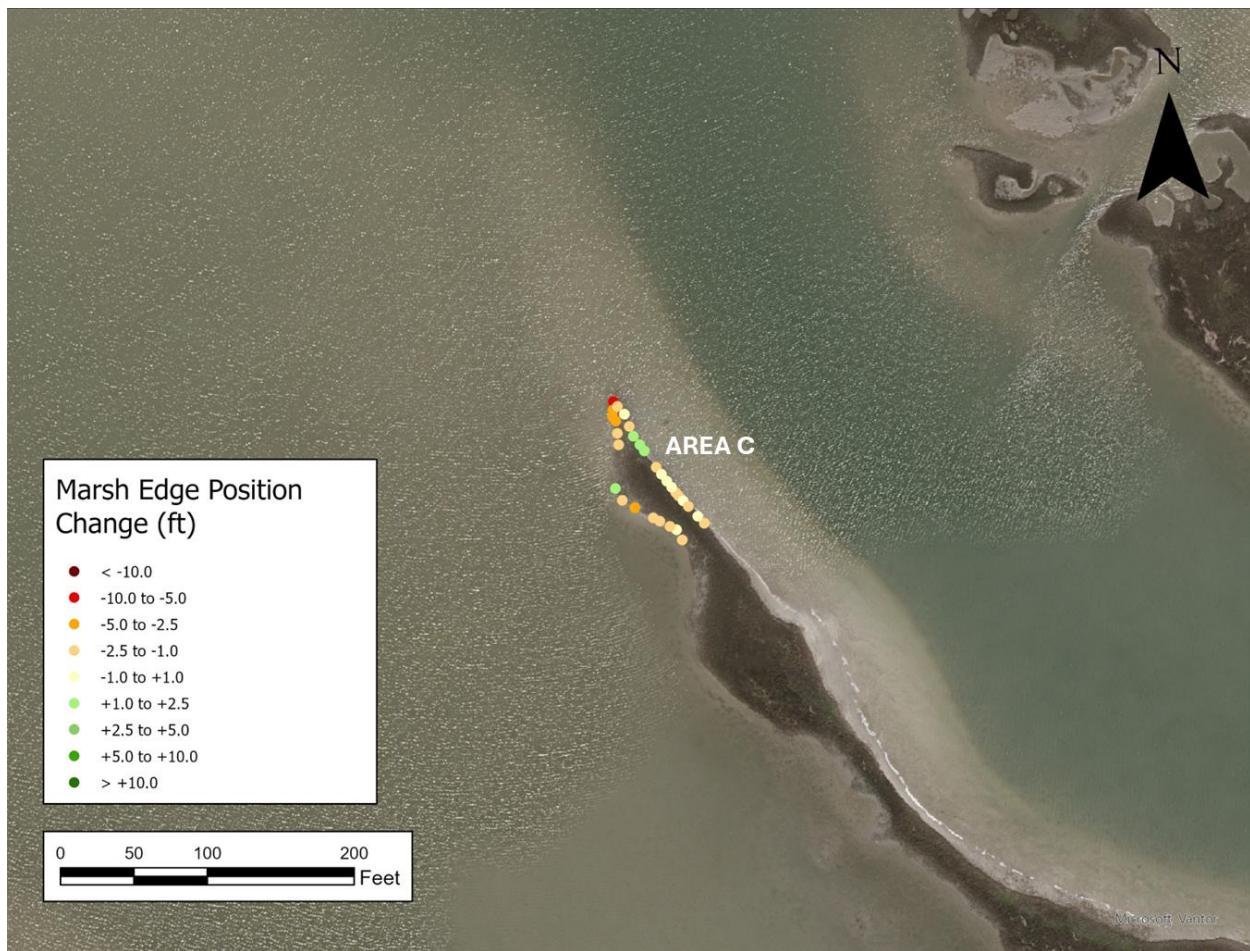
Figure 36. Marsh edge position change for Area C.

According to the Year 4 Monitoring data, Area C has experienced an average of -1.5 feet of marsh edge retreat. This recession rate follows trends present during the Year 1 and Year 2 Monitoring periods. Both eastern and western marsh edges have experienced up to -5.0 feet of recession. The northern tip of Area C receded about -10.0 feet south from its Year 3 position. This was the most significant shoreline change that occurred in the area (see Figure 36).

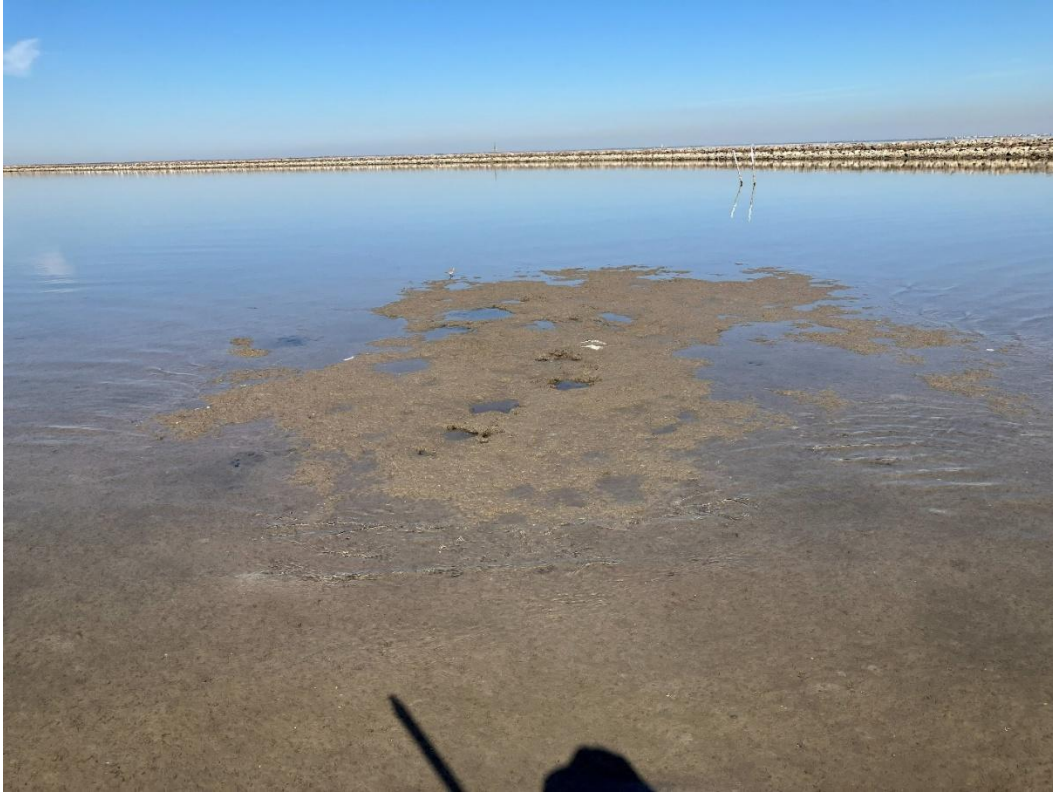
Figure 38. Area F footprint

During the Year 4 site visits the low water levels provided an opportunity to photograph the footprints of Areas F and G (e.g. Figure 38 and Figure 39). The photographs confirm that these islands have been eroded to the elevation of the surrounding bathymetry. Area H also experienced similar erosion but was not photographed during the site visit.

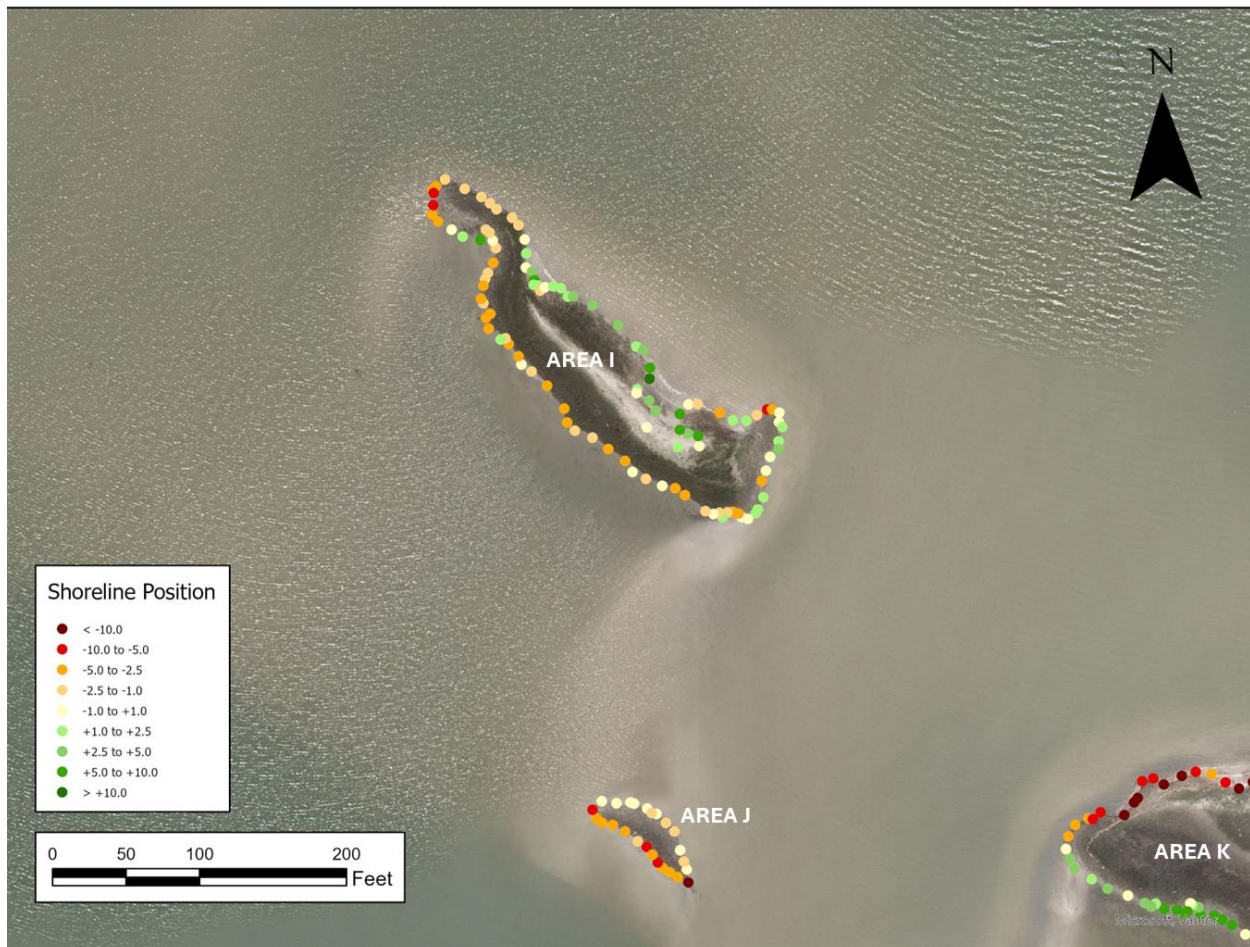
Figure 40. Marsh edge change for Area I.

During the Year 4 Monitoring period, the Area I marsh edges experienced an average marsh edge position change of -0.31 feet. The western and northwestern marsh edges experienced -1.0 feet to -5.0 feet of recession with some points along the northwest experiencing -7.0 feet of recession. The eastern and southeastern marsh edges advanced between +1.0 foot and +5.0 feet, with the partially submerged vegetation advancing about +11.0 feet to the southwest.

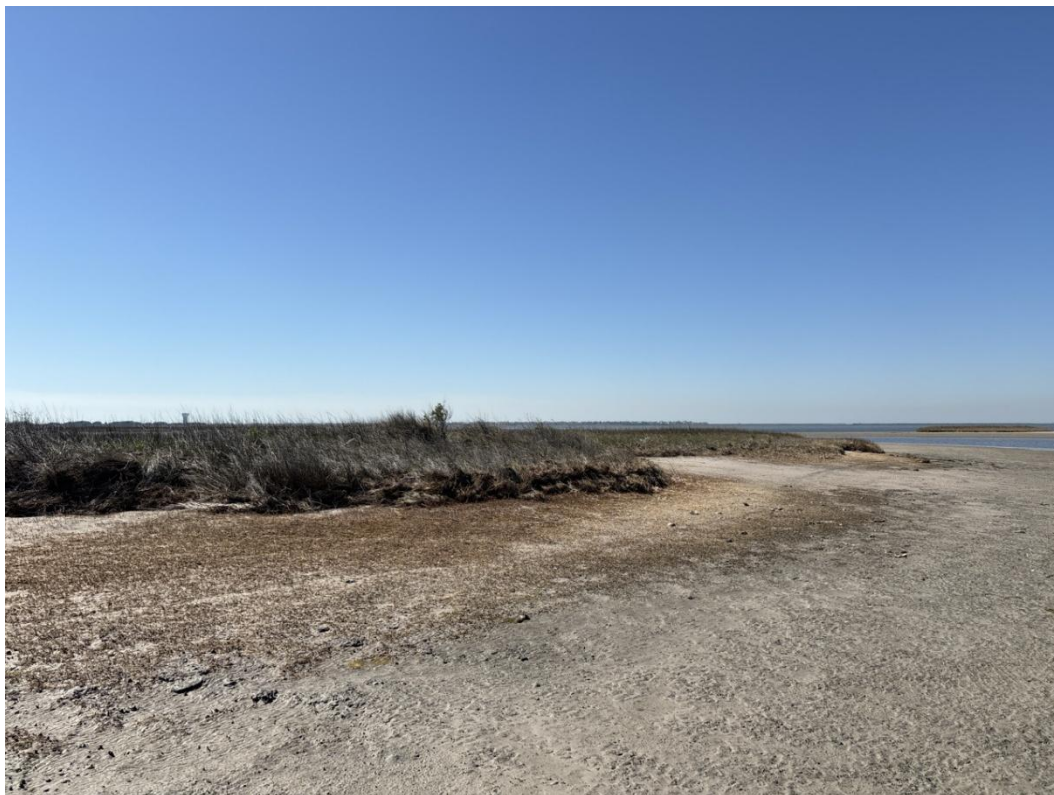
During the Year 4 Monitoring period, Area K experienced an average change in marsh edge position of +0.35 feet. The south, east, and west marsh edge advanced up to +10 feet with the largest advancement of +12.6 feet occurring along the southern marsh edge. The northern shoreline continued to recede up to -15.8 feet in some locations (see Figure 41). Similar to Year 3, vegetation along the northern marsh edge showed signs of significant damage (see Figure 42).

Figure 42. Vulnerable marsh shoreline in Area K.

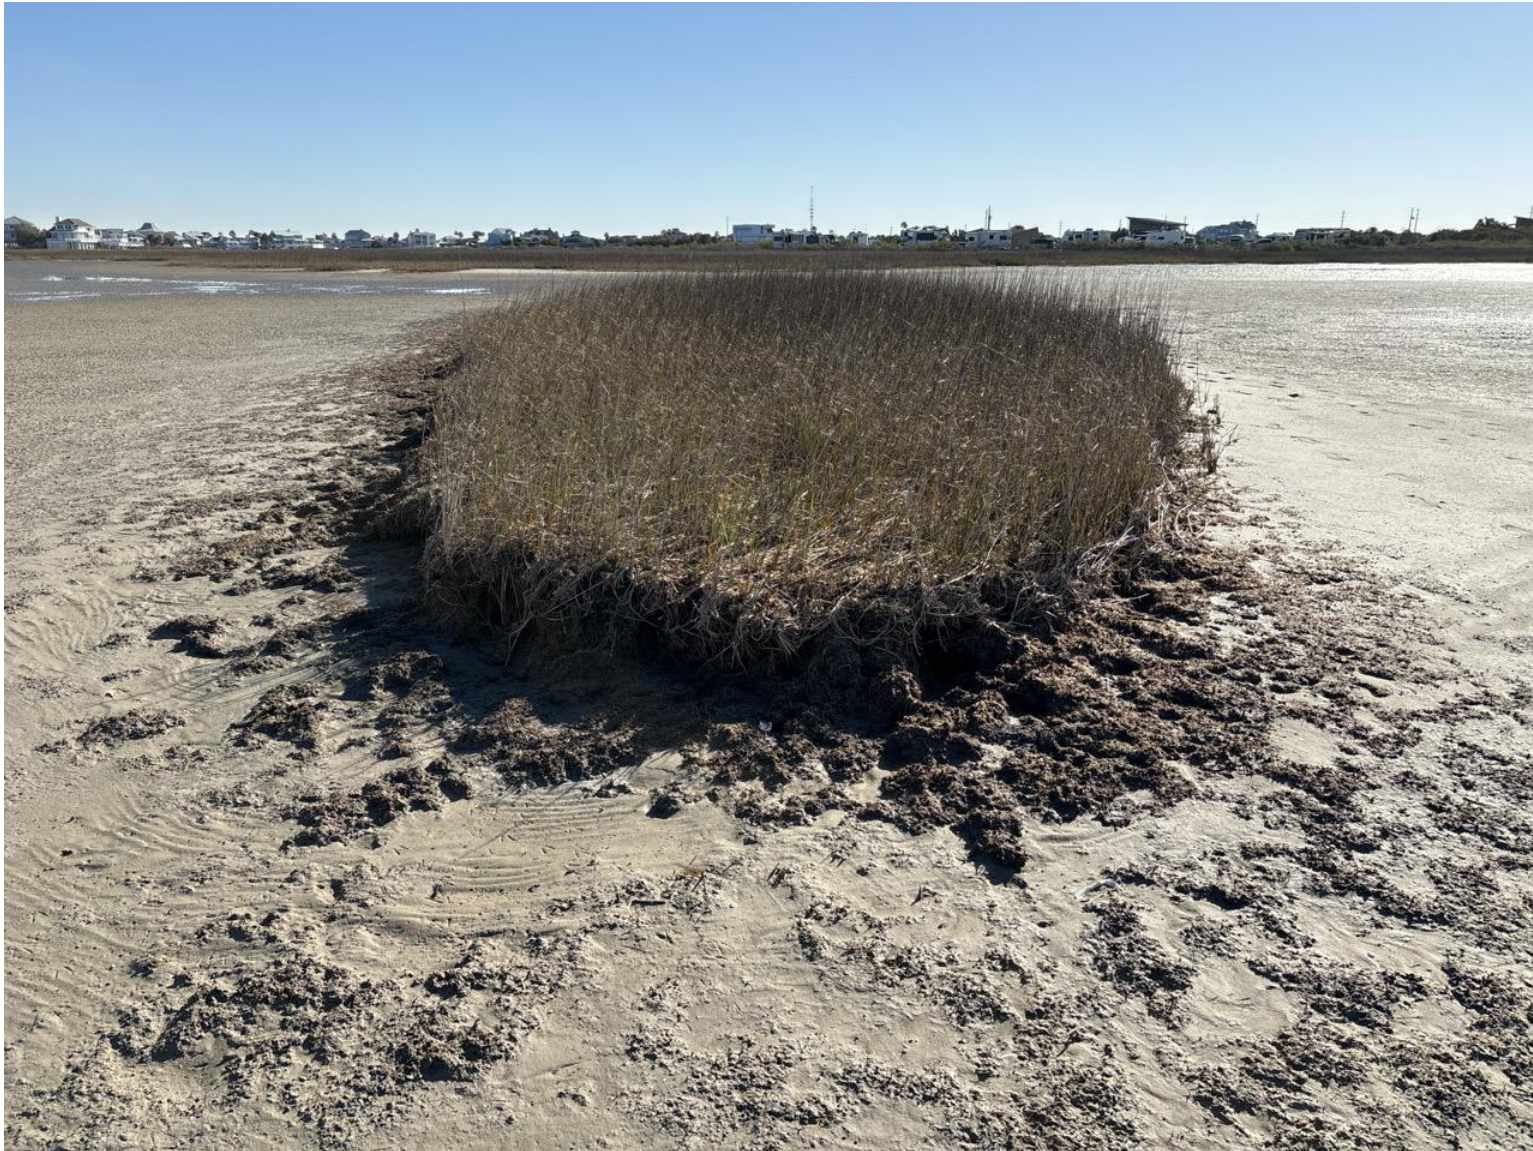
Figure A46. Area L – Year 4

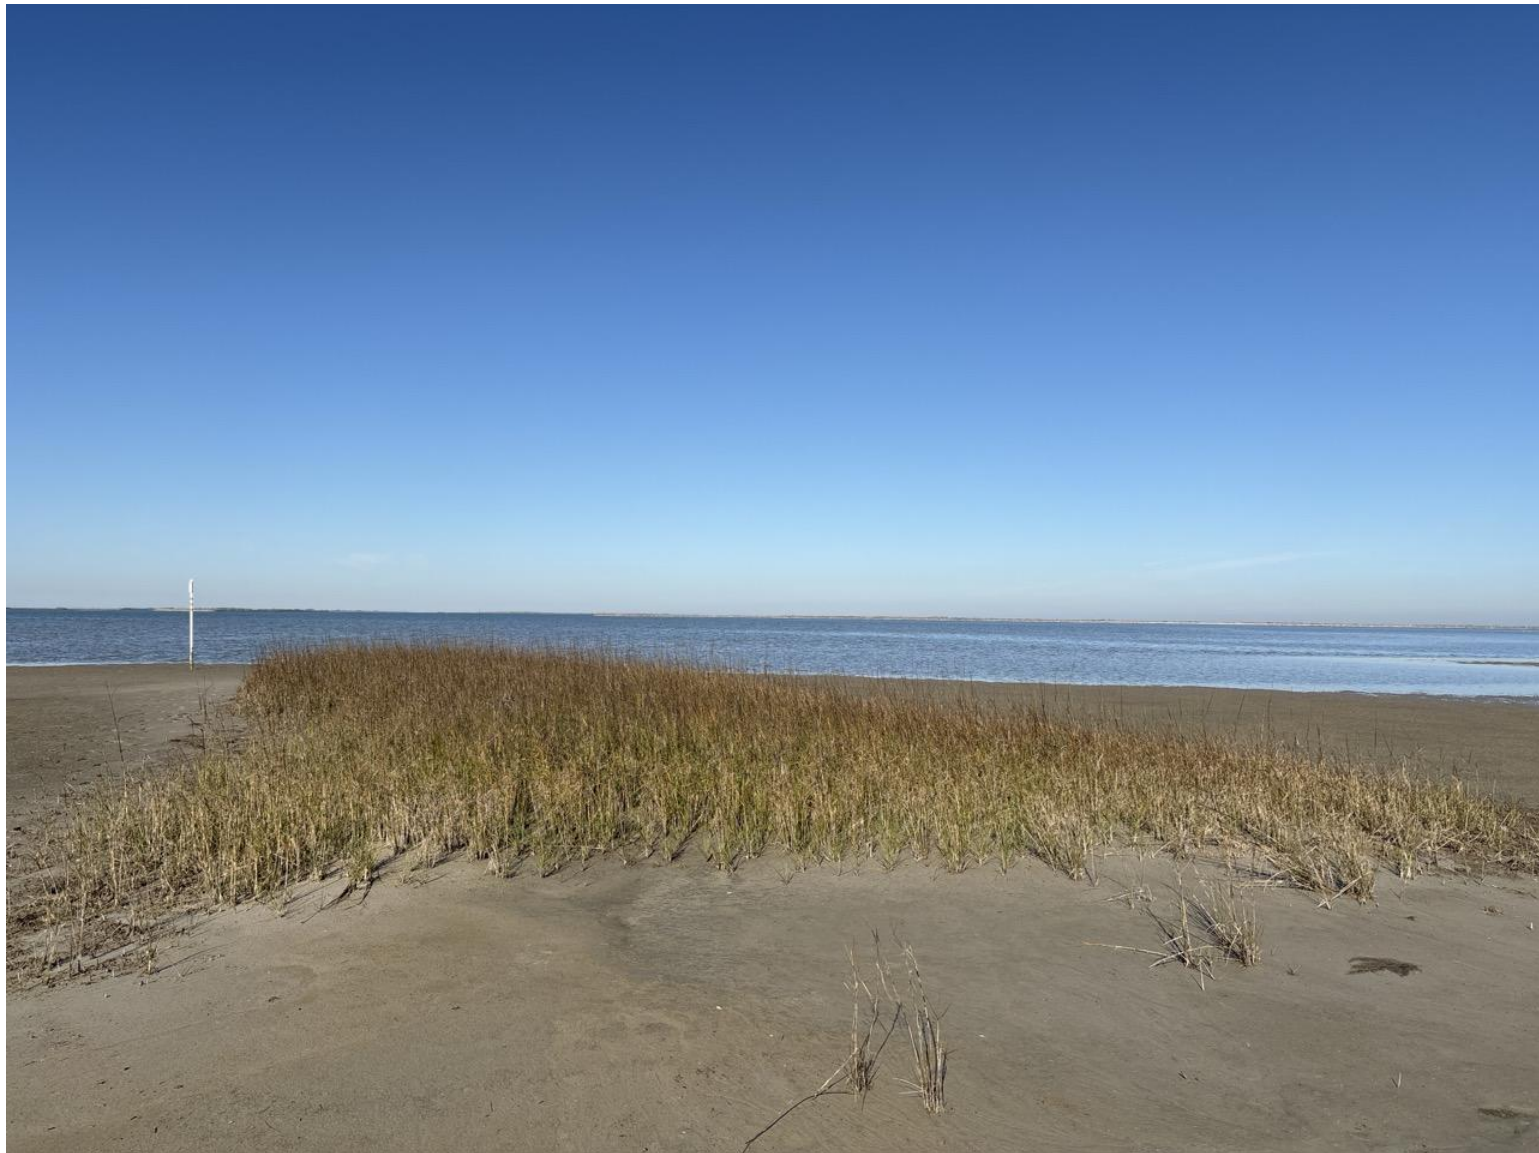
Figure A47. Area M – Year 4

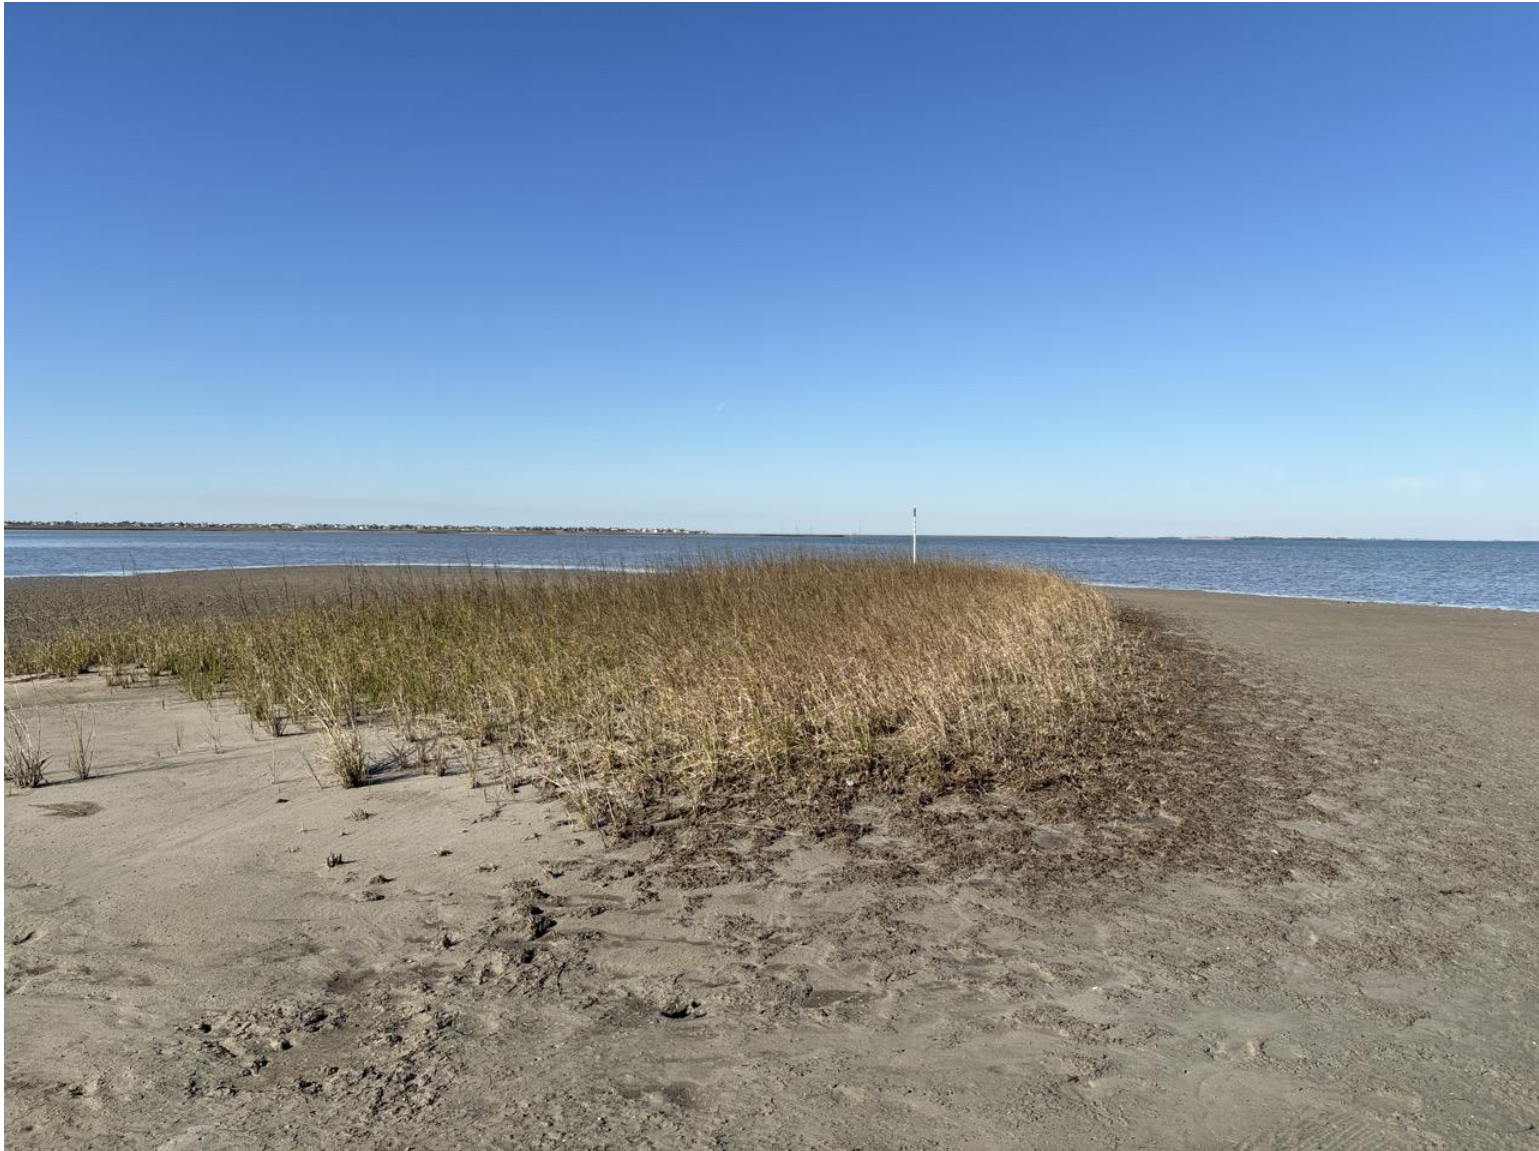
Figure A48. Area M – Year 4

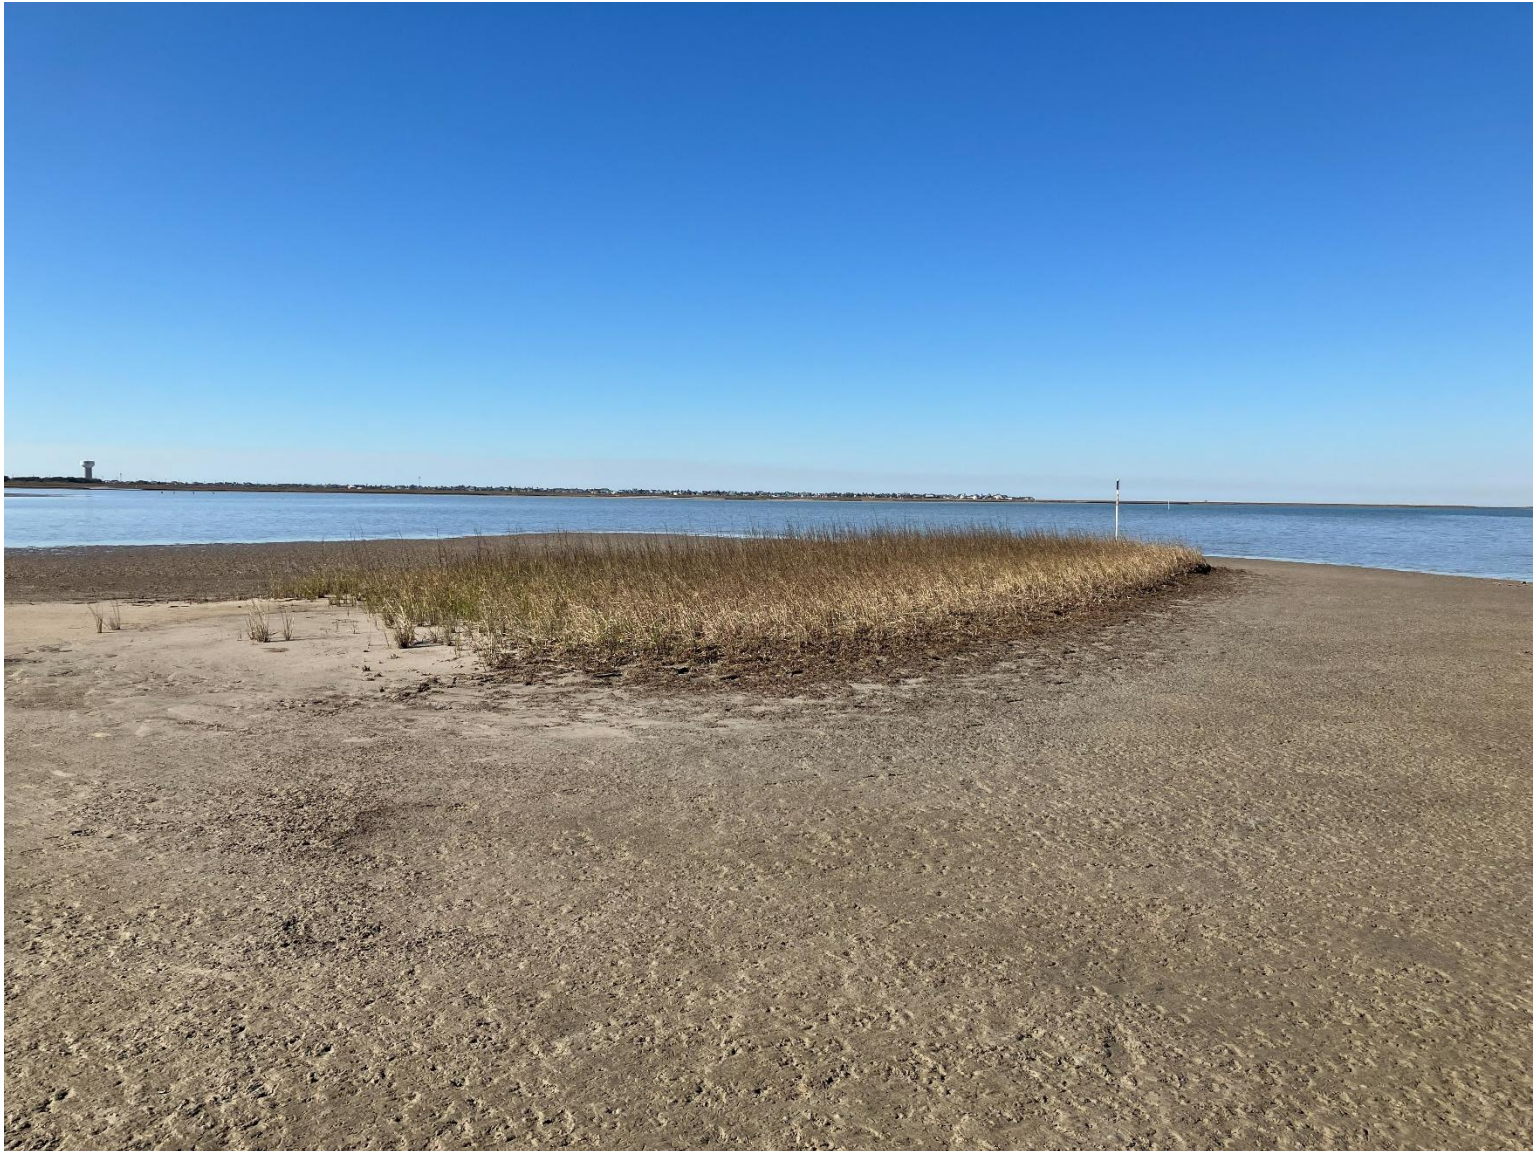
Figure A49. Area M – Year 4
